THROUGH THE FLAK

A RIVETING QUESTION

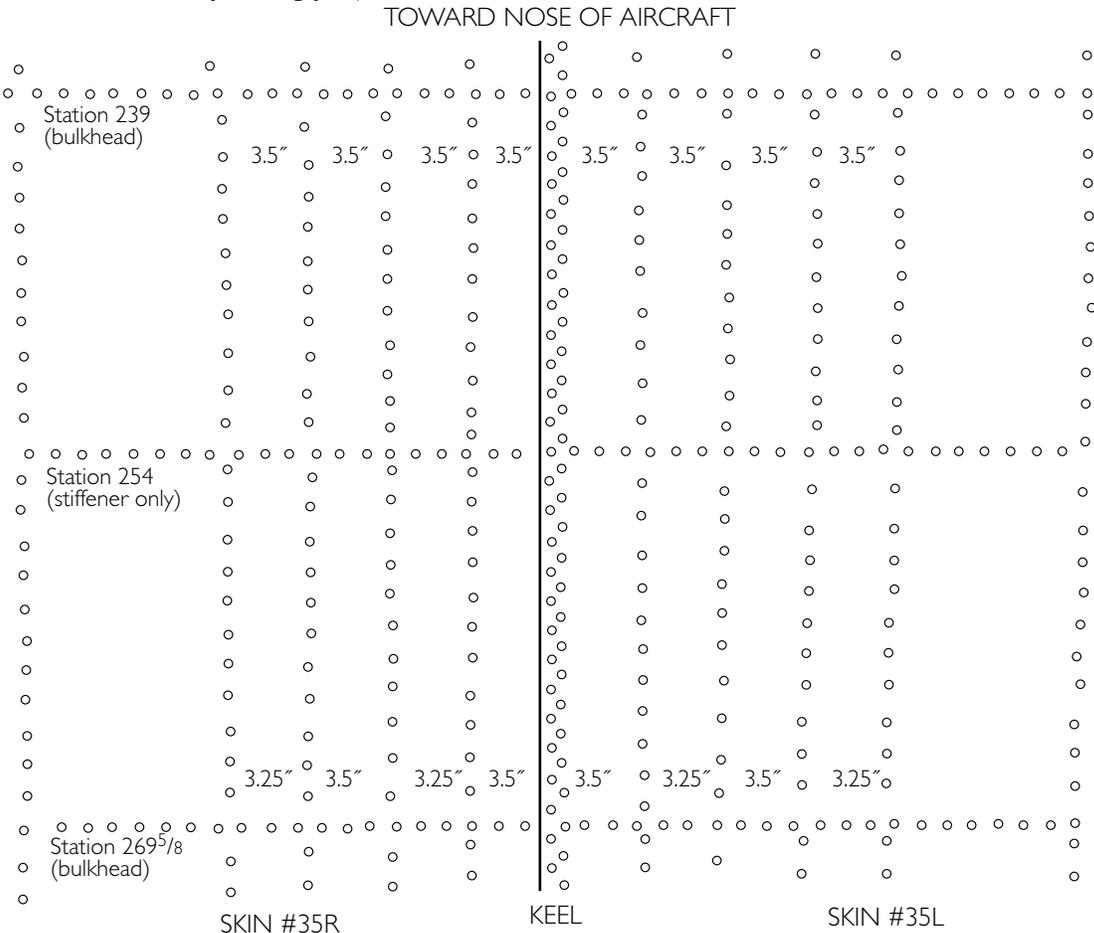
The area in question is a .032" section of 24ST Alclad attached with AN455 AD 3/3 rivets on the belly of the Electra between Fuselage Stations 239 and 269⁷/₈. As it came from the factory, that section of the belly of a Lockheed 10 looked like this (imagine the airplane standing on its tail with the belly facing you):

The two skins overlap at the keel and are attached with a double row of rivets. The vertical (nose to tail) rivets have a pitch (space between individual rivets) of 1.5 inches and attach to stringers, four on each side of the keel, which taper together slightly as they go aft (because the fuselage tapers). The horizontal rivets are spaced one inch apart and are attached to bulkheads at Stations 239 and 269⁷/₈. At Station 254, however, the rivets attach only to stiffeners on the interior surface of the skin. There is no bulkhead at that location.

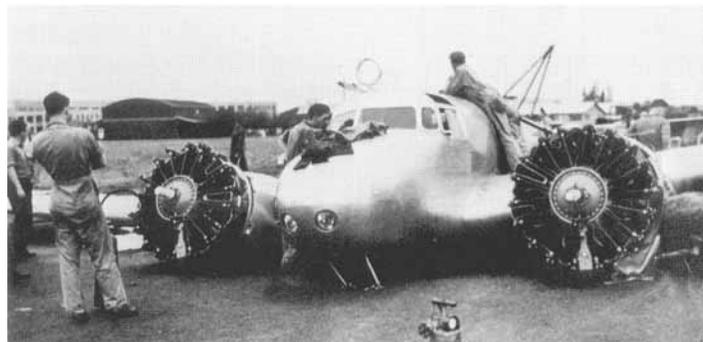
Luke Field, Hawaii, March 20, 1937

At 5:45 a.m. on March 20, 1937, Earhart's first attempt to fly around the world came to an abrupt end when the aircraft ground-looped on take-off from Luke Field, Hawaii. Early in the take-off run, according to the official U.S. Army Air Corps report of the accident, the aircraft swung

slightly to the right. Earhart corrected by reducing power on the left engine. The aircraft then swerved sharply to the left, tilting right wing low so that it ran along for "50 or 60 feet" supported only on the right main gear. The right gear collapsed under the excessive load, followed quick-

ly by the left gear, and the aircraft "spun sharply to the left on its belly ... amid a shower of sparks from the mat ... coming to rest headed about 200 degrees from its initial course." The mat referred to was the pierced steel matting which comprised the runway surface at Luke Field. Some fifty square feet of the mat was torn up and had to be replaced. The aircraft fared worse.

Amelia had cut the switches when she saw that a crash was imminent so that, although both props were bent, there appears to have been no serious damage to the engines. The right wing, however, was a total loss as was the entire right-hand underside of the belly where it had scraped and spun along the torn steel matting. In addition, eight inches of the left-hand side of the belly would have to be rebuilt. Earhart and company did not stick around for the accident investigation but sailed for California at noon that same day aboard the S.S. *Malolo*. The airplane followed a week later, on March 27, 1937 aboard the S.S. *Lurline* and by early April was back at Lockheed in Burbank for repairs.

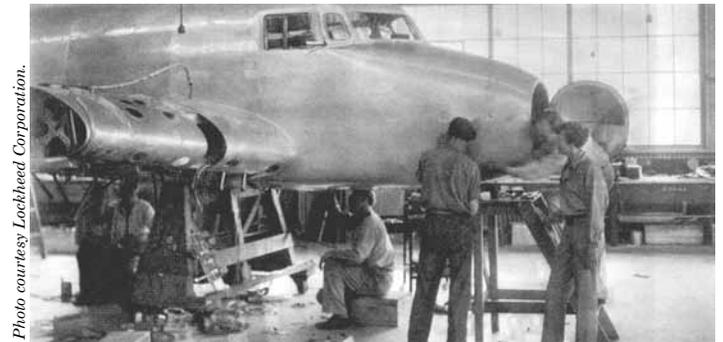
NR16020 under repair at Lockheed Burbank, April/May 1937.

Upon arrival at Burbank the airplane was evaluated and Engineering Repair Orders providing a general narrative description of the work to be performed were written by James Gerschler, Assistant Chief Engineer.

Although the damage required an almost complete rebuild of the belly, returning the aircraft to the original construction jig was not an option. Not only was the jig occupied with new aircraft, but it could not accommodate an airframe once it had been mated with the center section. Consequently, the Earhart aircraft was repaired propped up on sawhorses (see photo below). The repairs were effected according to Lockheed Standard Design Handbooks which contained a wide selection of pre-approved repair techniques which could be selected at the discretion of the

men doing the work. These provided for substitutions in rivet size, pitch and spacing which would result in the same or greater structural integrity as the original design but afford more flexibility in a repair situation. Surviving official correspondence documents that substantial changes were made requiring new engineering drawings approved by the Bureau of Air Commerce on April 29, 1937. Unfortunately, none of these drawings of how the rivet pattern looked after the repairs were completed are known to survive. All that can be said for certain is that it did not look like the pattern on a standard Lockheed 10.

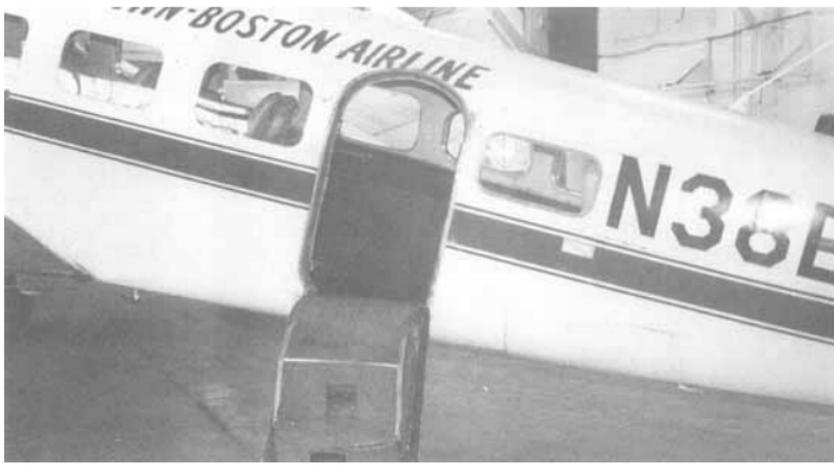
Lockheed 10A Electra N38BB at Oakland's Western Aerospace Museum, used for artifact comparison by TIGHAR's critics.

Two former Lockheed employees, recruited by the same person, have made highly publicized statements about how Lockheed would have repaired Earhart's airplane. However, neither of these individuals was involved in those repairs. Their remarks are entirely speculative and have been contradicted by equally qualified sources. None of these people has ever personally examined the artifact in question. The aircraft they used for a comparison with TIGHAR's artifact (or rather, with a plastic template based on photographs) is a standard Lockheed 10A. Of course, it didn't fit. Nor should it.

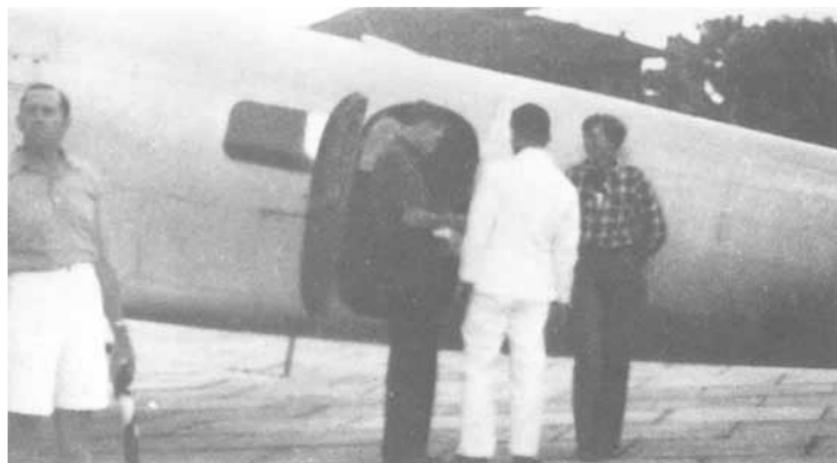
Earhart's modified and repaired Lockheed 10E Special NR16020 at Singapore on June 20, 1937.
