The Wreck Photo

We asked, “Is This Earhart’s Electra?” and offered a prediction:

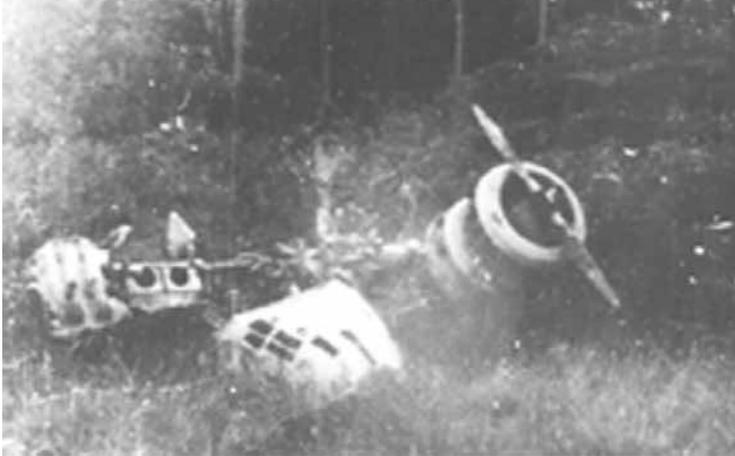
1. Much of the airplane is missing. The entire cabin from the cockpit roof aft is gone. The starboard engine and accessories from the firewall forward appear to have been ripped forward from the mounts with great force. The port engine, by contrast, is relatively intact and the propeller unbent.

2. The airplane did not crash but was landed with at least the left, and probably the right main gear legs extended. The damage apparent in the photo is, therefore, not the result of the landing but of some subsequent catastrophic event.

3. The only clear signs of human activity are the removal of some rectangular pieces of skin from the nose and the splitting and peeling open of the inboard leading edge on the starboard side. It is difficult to imagine how these failures might occur from natural forces.

6. The only impact damage apparent is low on the right-hand side of the nose section. Here, computer enhancement of the image reveals that the skin has been pushed inward, but the underlying structure remains intact. This suggests the impact of a strong fluid force against the relatively stationary object (i.e. wave damage).

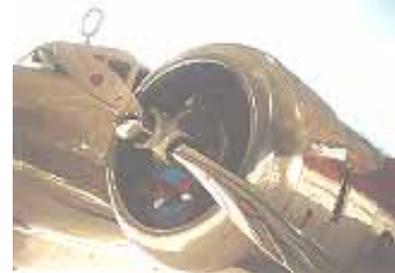
World Flight 1997's Electra. Right engine. Wrong cowling.

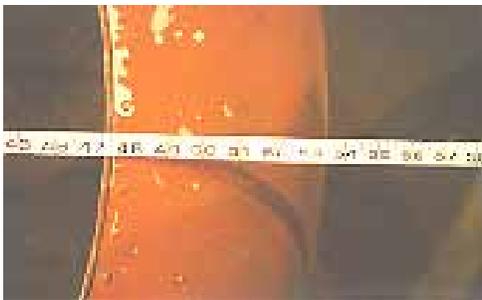
The answer came, quite unexpectedly, during a visit to the National Museum of Naval Aviation in Pensacola, Florida to examine a sextant in their collection (see "The Pensacola Ludolph," page 11). In storage at the museum is yet another NR16020 wannabe. C/N 1130 is a late production 10A which was approaching completion of an extensive rebuild as an Earhart look-alike when the project, funded by a private foundation, ground to a stop. Until the problems were resolved, the Navy agreed to provide storage space. Invited to inspect the project, we noticed some old, used cowlings lying on the floor. Upon closer inspection we noted markings that read "Lockheed 10E cowl, P&W 1340." Where they came from is anybody's guess, but we didn't much care. We measured the diameter of the assembled cowling and got 53.5"—easily within the 1.34" error band for the 54" cowl in the wreck photo.

Whatever the identity of the plane in the wreck photo, its prop and engine cowling have the same proportions as a Lockheed 10E: this thing is just like this thing and they are probably, therefore, the same sort of thing.

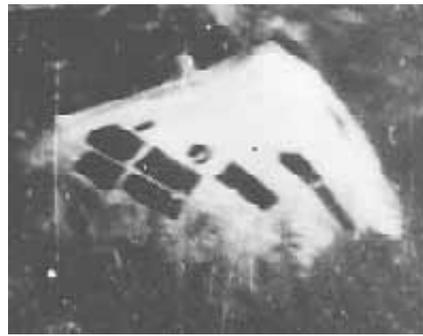
But what about the nose section? At least two researchers have pointed out that while the nose in the wreck photo has the correct number of bulkheads for the Lockheed Model 10, there seems to be a problem with the spacing between them. The nose of the Electra has a cone at the tip which opens as a door. Immediately behind that is a bulkhead at Station 8 (that is, eight inches from the tip of the nose). There is another bulkhead at Station 16, followed by a bulkhead at Station 31 and another at Station 47½. Starting from Station 8, the spacing between bulkheads in the nose of the Lockheed 10

is, therefore, 8", 15", and 16.5". The spacing between bulkheads in the wreck photo nose, on the other hand, appears to be quite even.

Is this apparent discrepancy a disqualifier? Maybe, maybe not. Simply laying a ruler on the photo doesn't correct for viewing angle and possible distortion, either photographic or physical. More computer time and calculations are called for.

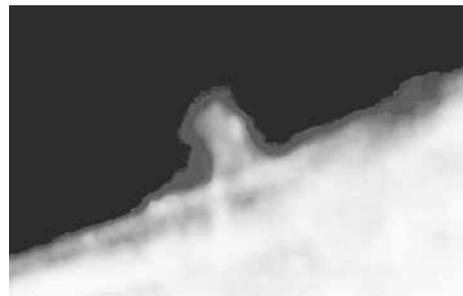
Wreck photo centerpost

One of the most interesting details to come out of the forensic analysis of the wreck photo is the shape of the base of the windshield centerpost. Rather than the straight bar featured in many aircraft types, this centerpost has a sweeping curve at its base which appears to be more stylistic than strictly functional. The feel is almost art deco. A close look at the base of the broken-off centerpost in the wreck photo reveals that same shape.

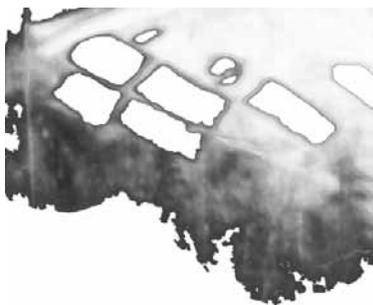
Right side of nose section, vegetation digitally removed.

The possibility that the aircraft in the photo was beaten by large waves or surf may account for other aspects of its appearance. Tons of moving water might well have carried off the upper portion of the cabin, and an airplane driven backward might leave behind an engine that snagged on something immovable. The force of water might also explain the puzzle of the ring cowl.

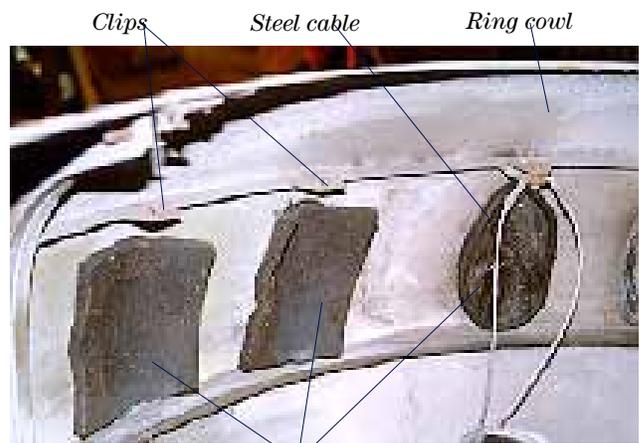
The cowlings of most Lockheed 10s, including Earhart's, came off in three equal 120° sections. Their normal removal would not result in the ring cowl being left behind as is seen in the wreck photo. Some aircraft do use a fixed ring cowl, but none fit the other requirements of the plane in the photo. (We don't yet know about the Tachikawa Ki-54.) The Lockheed 10E cowl is affixed to the airframe by means of a steel cable which passes through metal clips on the inside of the cowl and encircles the engine just forward of the valve covers (see photo below). When secured, the cable attaches the forward part of the cowl (the ring cowl) very firmly to the

Felt pads for valve covers.

engine. The after portions of the cowl, not being subject to direct air pressure, are very lightly attached. Should the engine compartment be engulfed with water, as in the airplane being struck from behind by a big wave, it's not hard to imagine that the only portion of the cowl that would remain intact might be the firmly attached ring cowl.
