# DADOS GALORE

TIGHAR'S first expedition to Nikumaroro in 1989 brought back an artifact we thought at the time might be a cover to some sort of aluminum box. It was originally assigned artifact number 2-18 and later, under an expanded cataloging system, became Artifact 2-1-V-18. The materials and the nature of the construction suggested an aviation origin but nobody we talked to recognized it as any known part of an airplane.

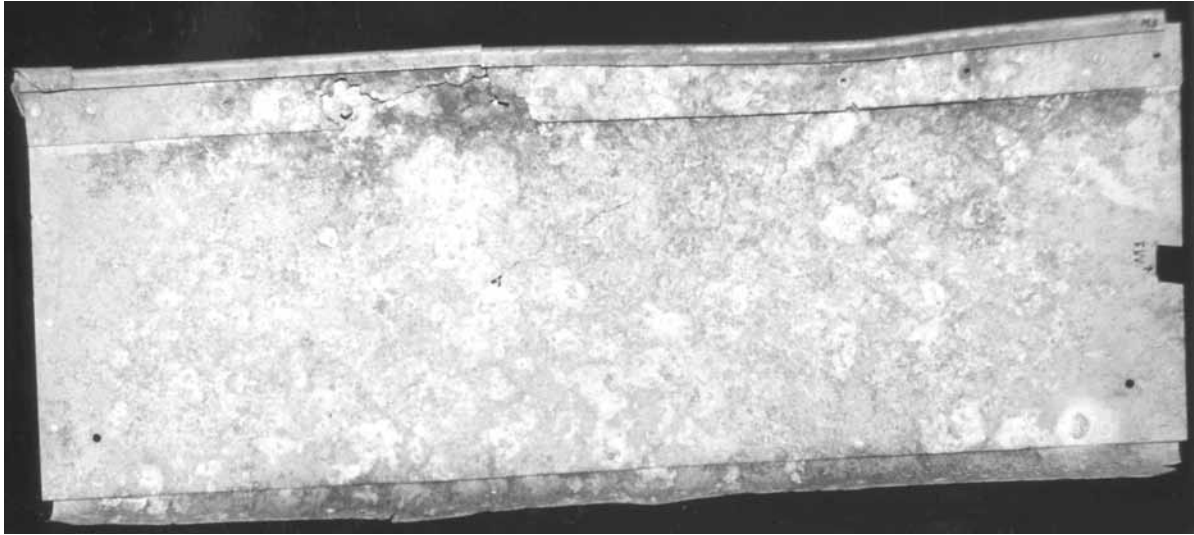
*Artifact 2-1-V-18, the dado recovered from Nikumaroro in 1989. The small rectangular cut-out on the extreme right was made in 1992 by the National Transportation Safety Board laboratory for materials analysis. TIGHAR photo by Frank C. Lombardo.*

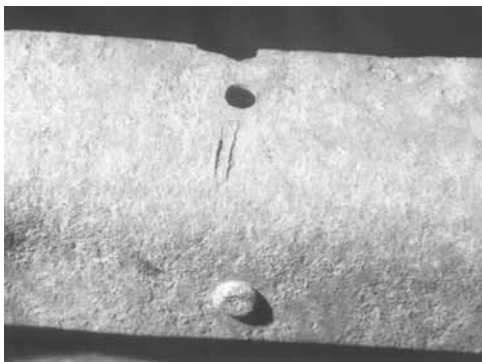
*Apparent pry marks on bottom of right angle flange. TIGHAR photo by F. Lombardo*

Aside from corrosion, all of the damage seen on the artifacts seems to have been caused by adaptive local use rather than by the force of an accident. The dados were disassembled, rather than forcibly removed, from the original structure by unscrewing the mounting screws and prying

up the nails from the “back” side of the 90° flange. That is not possible unless the removal of the mounting screws enabled the outer structure to which it was attached to be discarded thus permitting access to the back of the dado. This would seem to suggest that the dados were removed from a section of wreckage rather than from an intact aircraft.

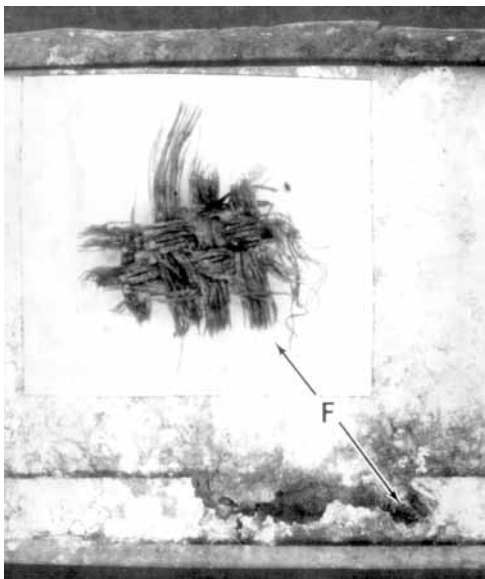
Along the top edge of Artifact 2-1-V-18 was an elongated rivet at the base of which was a small surviving fragment of the original insulation and woven fabric that once covered the entire surface that faced the interior of the cabin. The mottled appearance of the surface may have been caused by residue from the adhesive used

*Arrow "F" denotes the long rivet tail where the fabric remnants were found. Insert is magnified x20. Photo courtesy NTSB Materials Laboratory.*

to attach the insulation. The fragment of insulation was 1/4 inch thick. The woven fabric was blue. Unfortunately, we cannot perform tests to conclusively identify these materials because the fragments were lost by the National Transportation Safety Board (NTSB) laboratory while they were performing a materials identification analysis of TIGHAR artifacts in 1992. We do know, however, that Lockheed Electras were soundproofed with 1/4 inch "kapok felt" and a material called "Seapak." Further research should provide more details.

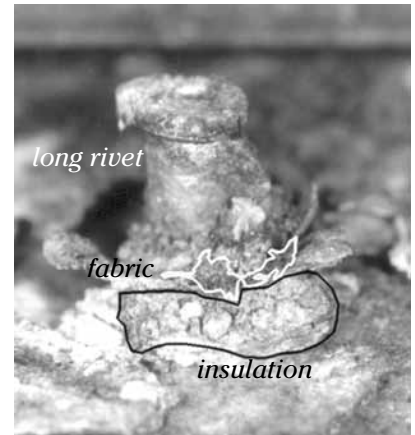
*This micro-photo clearly shows the remnants of blue fabric and insulation when seen in color; highlighting is provided to compensate for monochrome photo. TIGHAR photo by P. Thrasher*

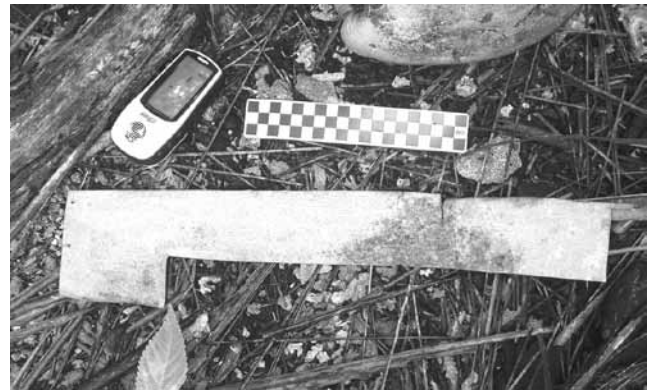
*Artifact 2-7-V-1, Dado. TIGHAR photo by V. Hunn.*

The “new” dados are in much poorer condition than the 1989 find. 2-7-V-1 has been disassembled, pieces cut out, and one edge folded over several times. Because we’re missing one finished edge we can’t be sure how long it originally was. 2-7-V-2 was mostly buried and is in several pieces. Luckily, it had not been cut up and the finished edges were intact. Through expert recovery technique and good in situ photos, we were able to establish its original dimensions.
