TIGHAR artifact 2-2-V-1  
A report as to the purported fit to Lockheed Electra NR16020

Jeffrey Neville  
January 28, 2015

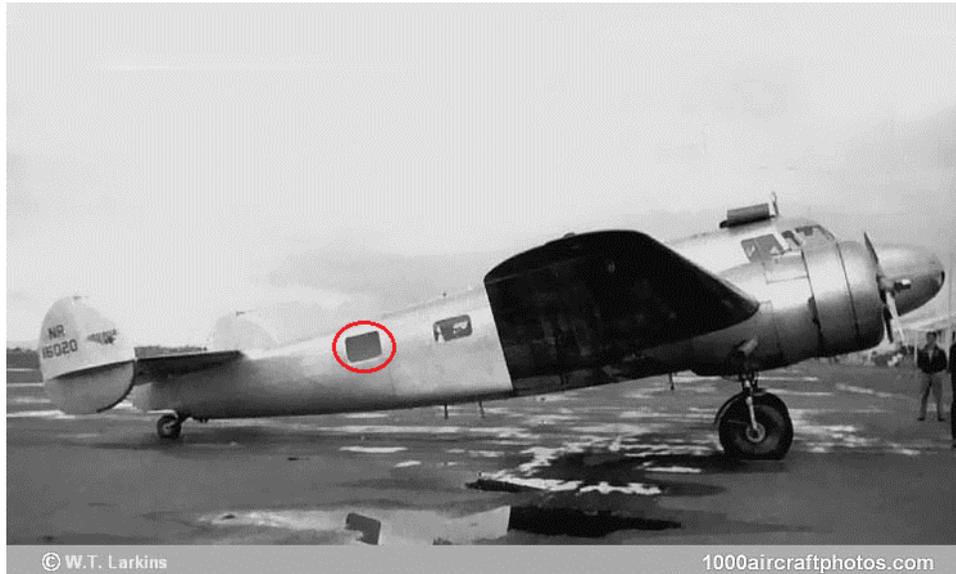
Among the modifications made to Amelia Earhart's airplane was a large, apparently dedicated navigation window which was cut into the right hand skins and roughly centered between fuselage stations 293 5/8 and 320. Reference: Figures 1 & 2.

Figure 1  
Electra NR16020 with large navigation window in lavatory right-hand skin.

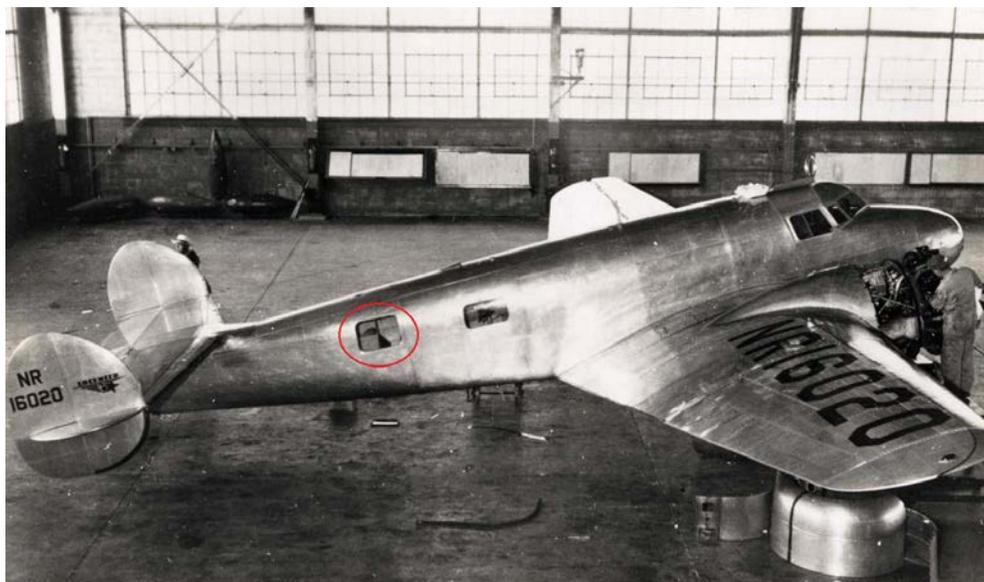
Figure 2  
Large Navigation window

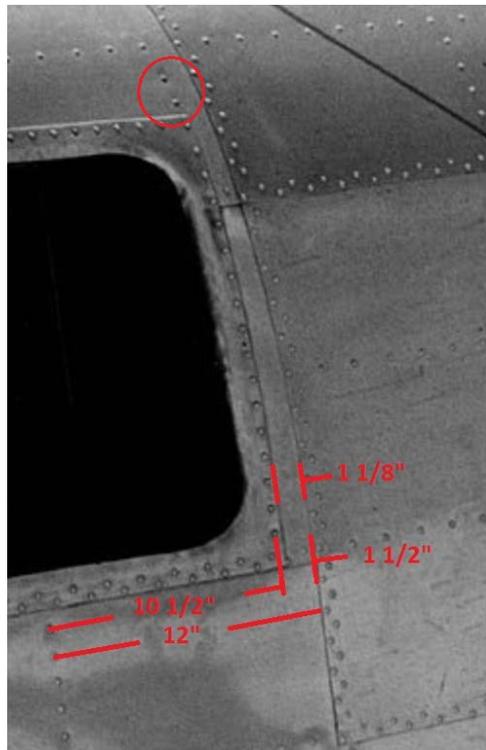
Figure 3

Cropped from Nilla Putnam / Earhart at Miami photo.

The 'Nilla-Amelia' picture taken in Miami (Figure 3) does contain visible and reasonably scalable detail as to the placement of the window coaming forward edge and rivet line.

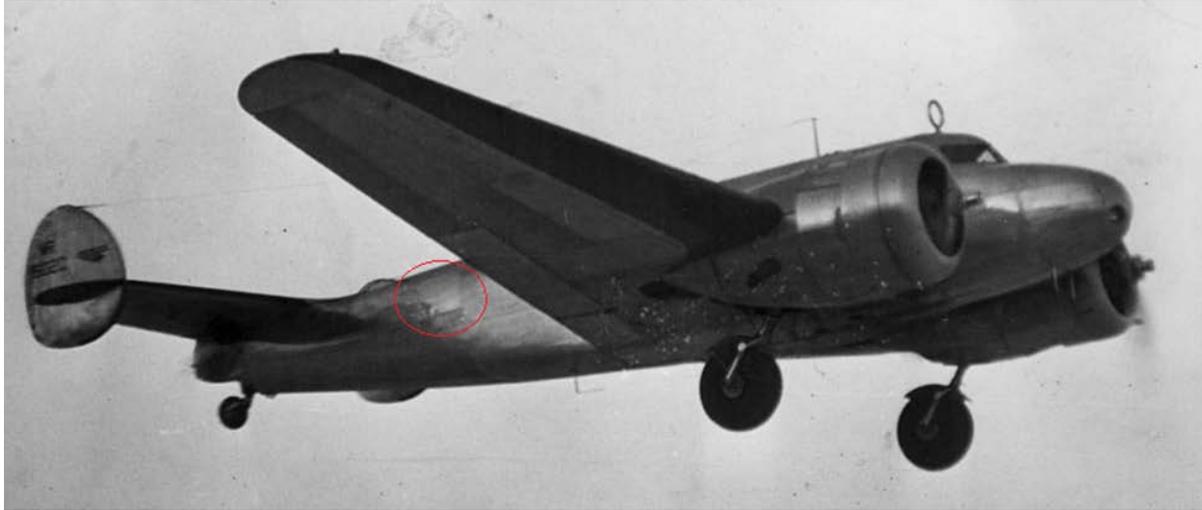
Figure 4  
NR16020 on take-off in Miami – Miami Herald / TIGHAR

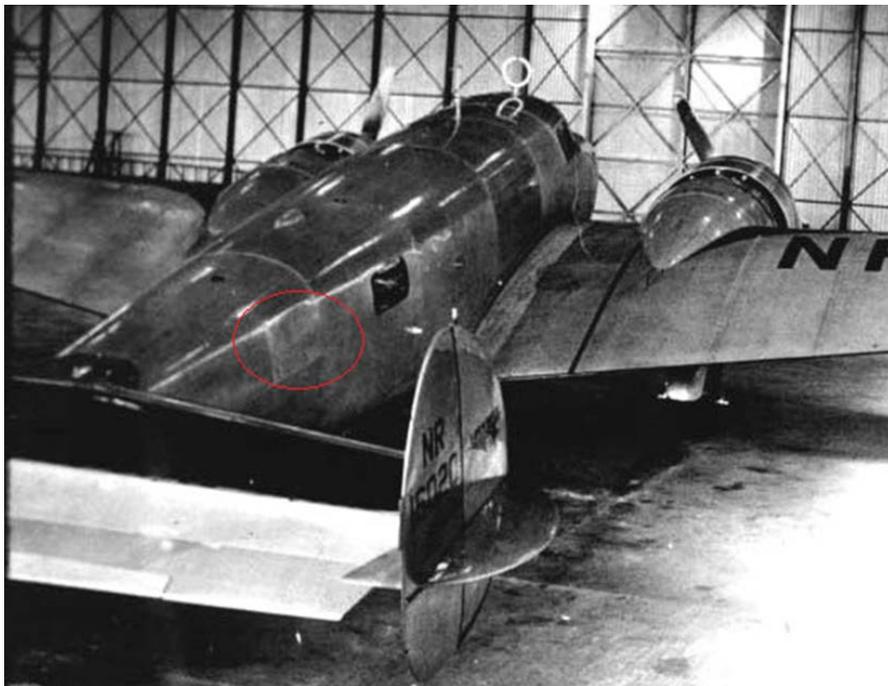
Figure 5  
In hangar in Darwin – courtesy Elgen Long (this is not the highest resolution version).

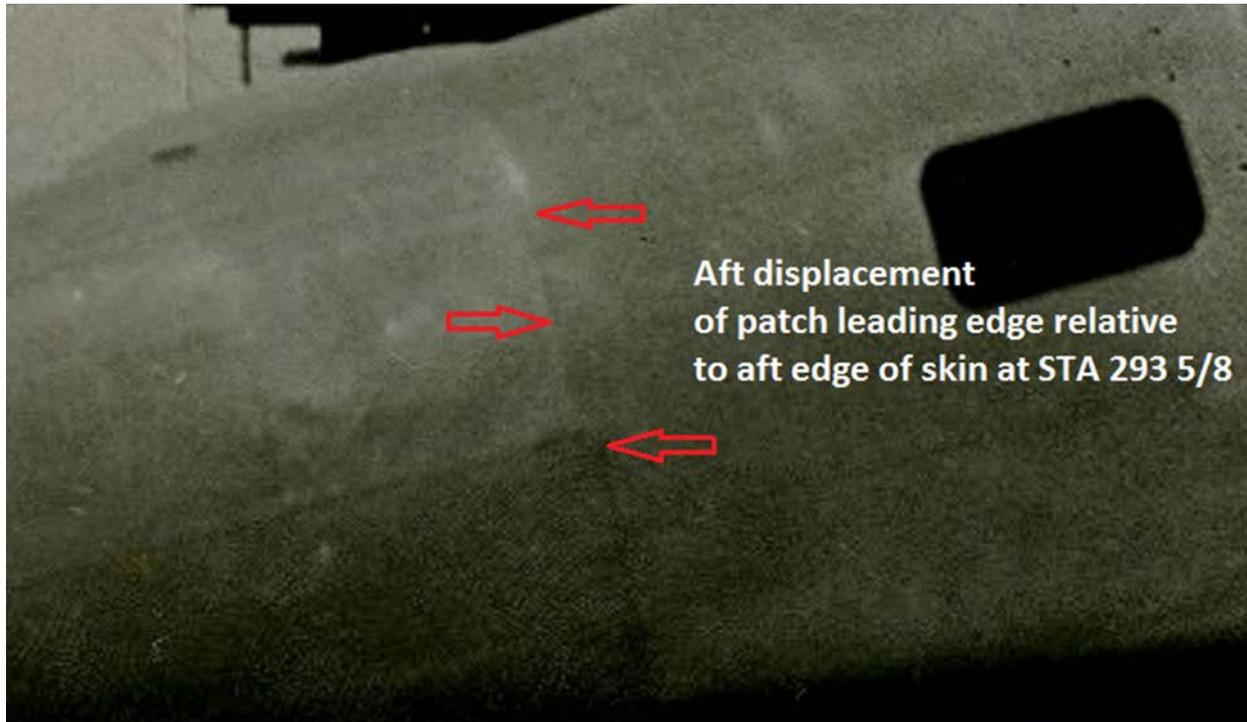
Darwin Ramp - window covering.

Relationship of forward edge to STA 293 5/8 skin edge with offset visibly similar to coaming as in Figure 3.

The Darwin ramp photo (Figure 6) is valuable for visually validating the offset of the cover from STA 293 5/8 as similar to that of the coaming forward edge offset. This was done and applied for the study. The assumption is that the forward edge of the cover in Figure 6 is coincident to the placement of the forward edge of the coaming in Figure 3.

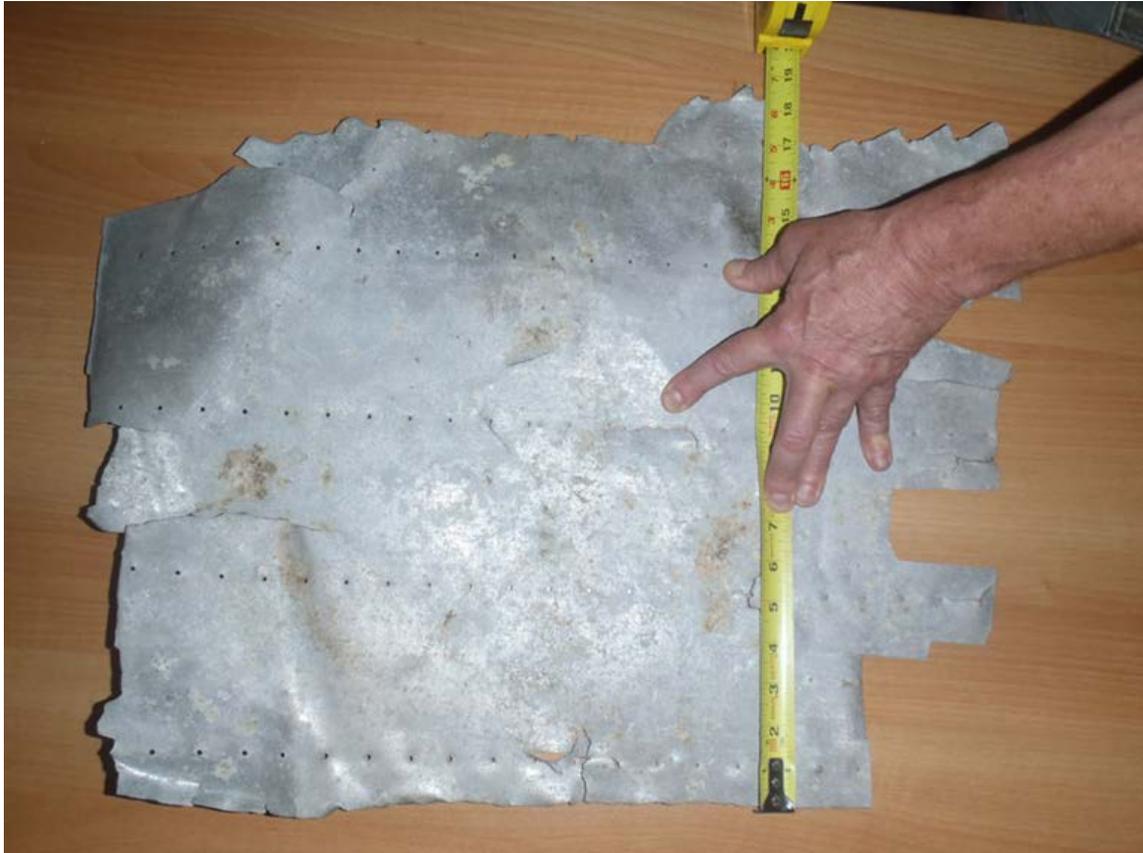
Artifact 2-2-V-1 is a roughly 24 5/8" wide by 18 1/2" high .032" thick sheet of weathered and mechanically distorted aircraft Alclad (reference Figure 7). It bears four rows of neatly spaced number 3 sized rivet holes (pitch equaling 1" apart – verified by Aris Scarla in Dayton, Ohio). These straight rows are themselves somewhat more irregularly spaced from each other with some convergence and divergence apparent in the aggregate arrangement, and spacing varies by some fractions of an inch around +/- 4" apart. The artifact bears evidence of fire or heat exposure and is considerably deformed.

Figure 7  
Artifact laid flat, compliments TIGHAR.

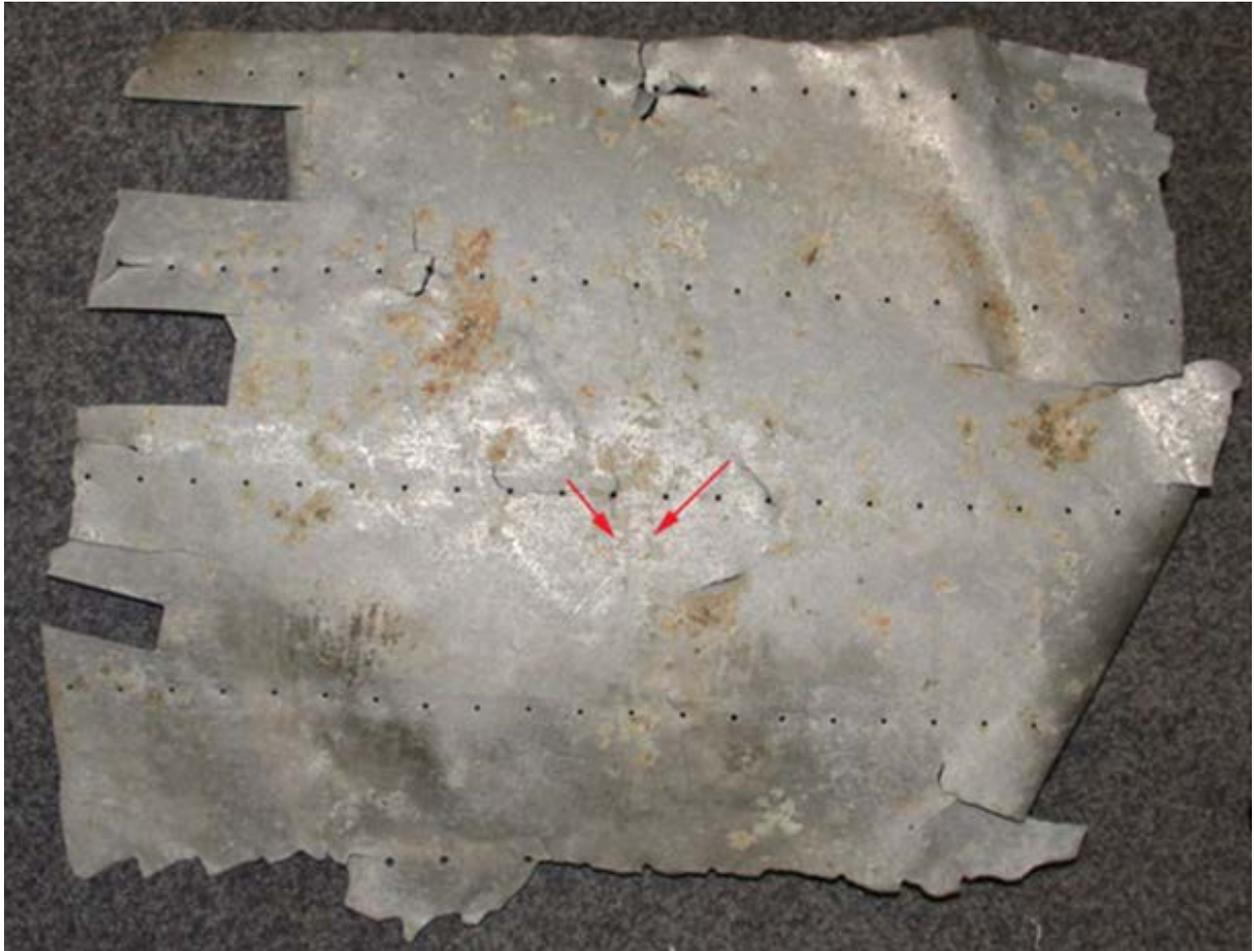
Figure 8

Evidence of a 'crossing member', i.e. a vertical member 'footprint' as outlined between red arrows; TIGHAR suggested this may coincide with the formerly removed member at STA 307, perhaps partly restored during the window covering effort. Red arrows by TIGHAR. Photo: TIGHAR.

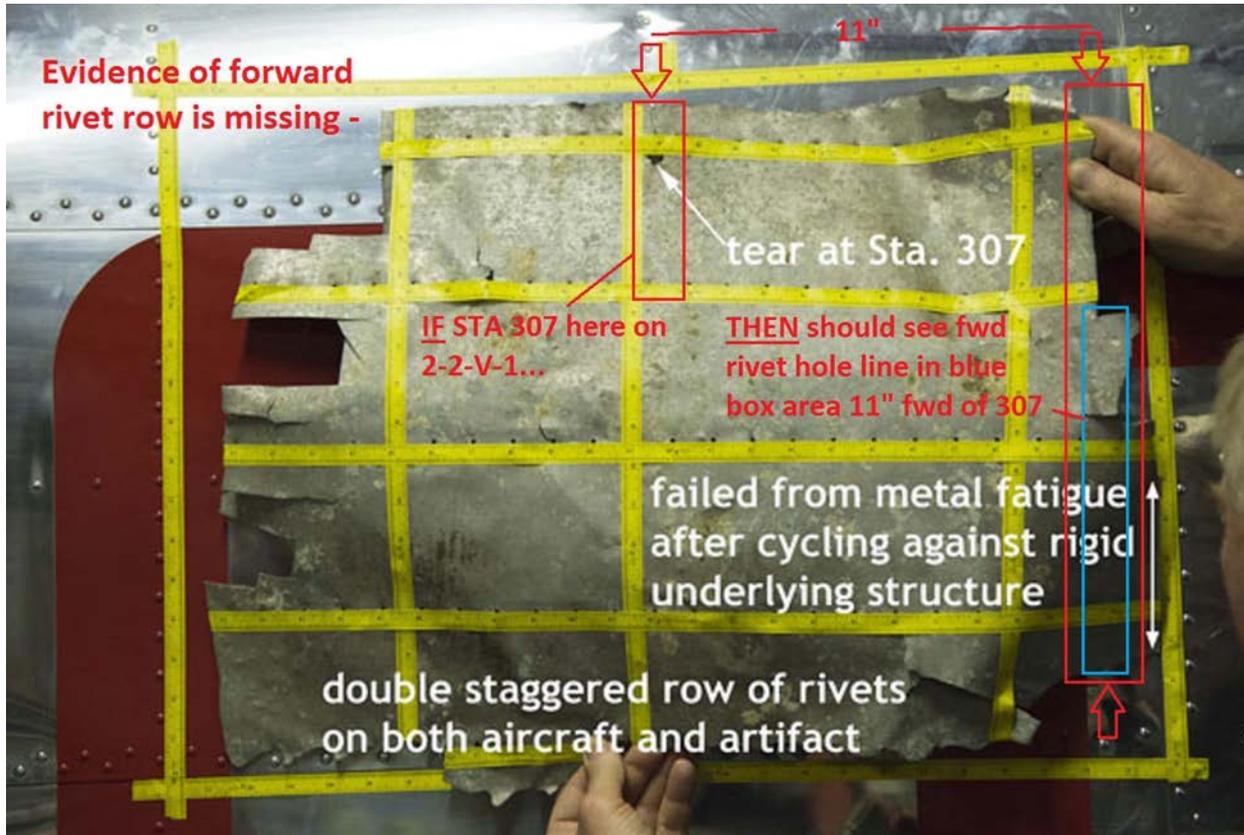
Figure 9

The Wichita photo and match of the STA 307 feature (Figure 9) was impressive when published as the odds of finding a 'matching' STA 307 vertical frame footprint seemed remarkably small. This is considered because it was demonstrated as supportive fit in the Wichita effort: if valid, it would lend weight to the possibility of artifact provenance to Earhart's airplane.

During the Wichita effort, Gillespie held the artifact as near to the fuselage of the Wichita Electra as possible (limited by contours) such that a 'tear' at the 'STA 307 line' was aligned with that station's rivet line on the airplane (reference Figure 9, upper center area of artifact as marked). This provided an excellent visual check for fit of that recently realized feature. It might have also supportive as to fit on the host ship by providing an additional datum point by which to validate alignment.

TIGHAR photo – Wichita Electra metrics study

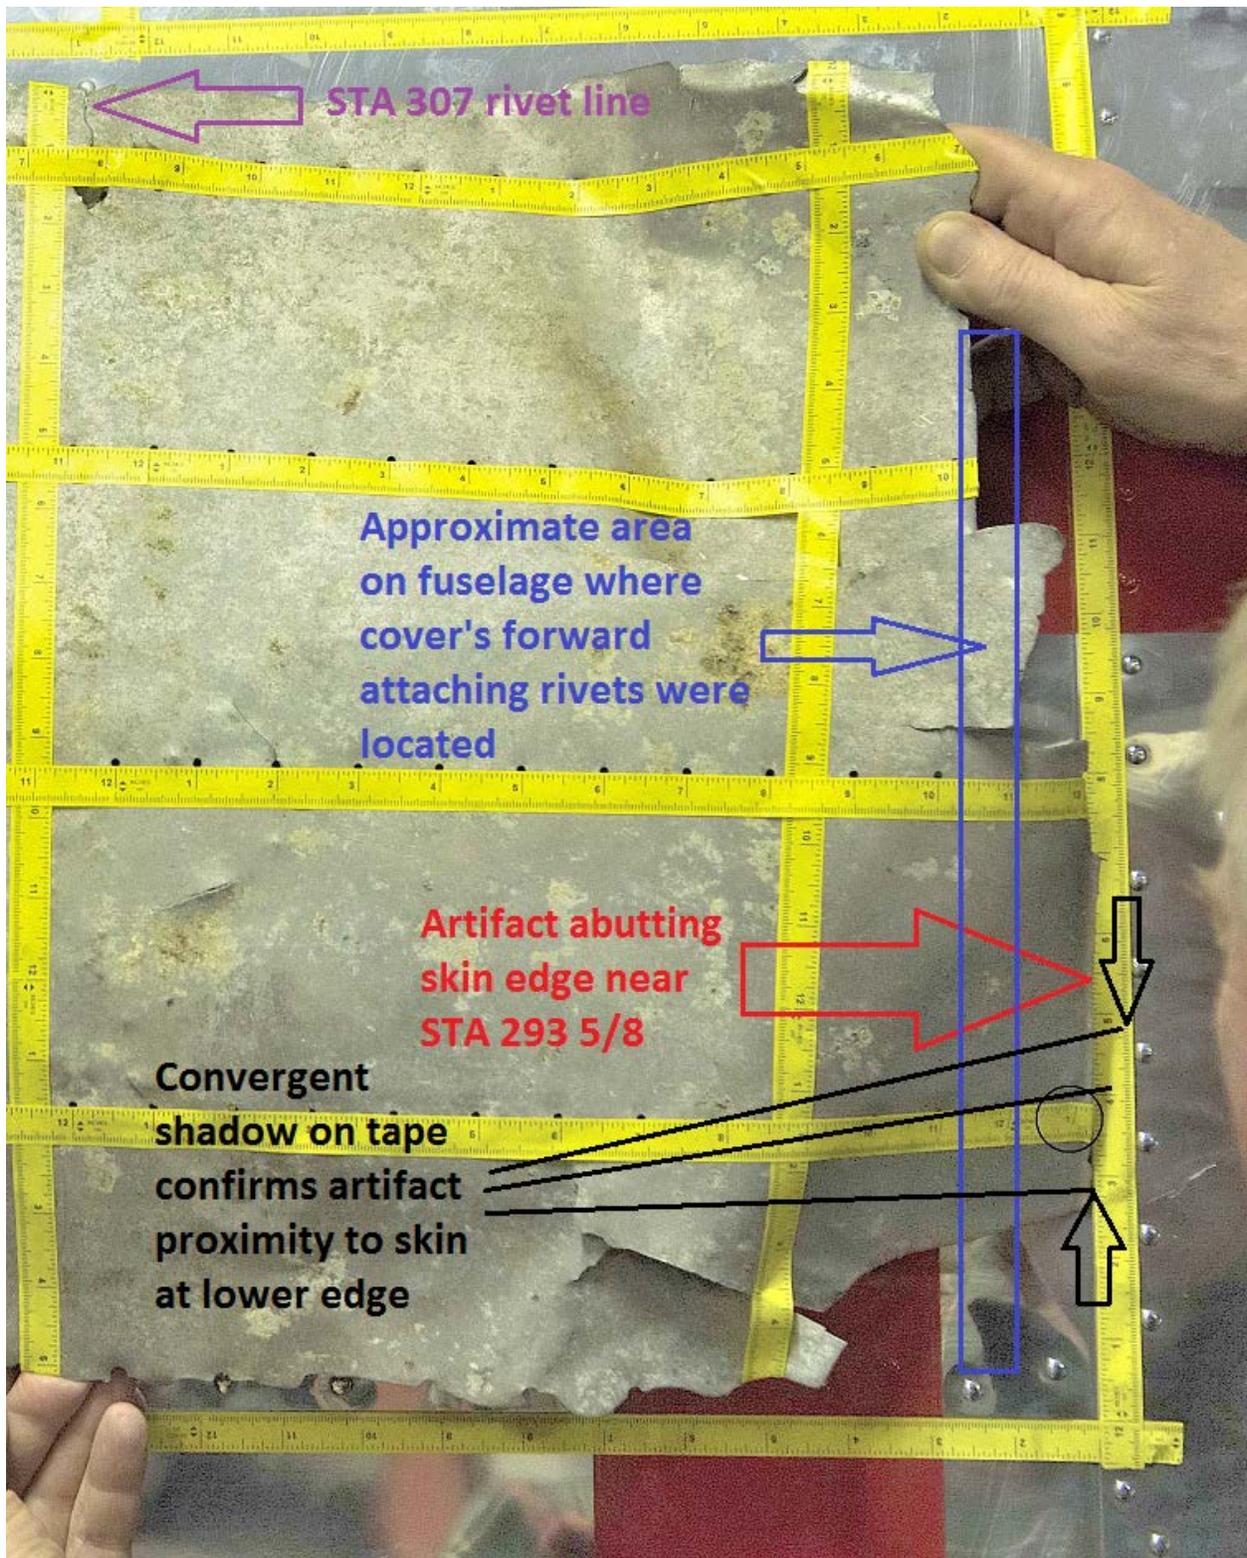
The placement of the forward edge of the artifact therefore would have to approximate that of a ‘remnant edge’ at a location that is consistent with having been broken away short of the attachment point. What we see instead is that the artifact’s failed forward edge is at or near the skin edge at STA 293 5/8 (see Figure 10).

The artifact overruns the expected attach point by approximately 1 ½”. Further considered, with the STA 307 features aligned at that station on the airplane and reconsidering the overrun, we can see no evidence of the rivet holes that would be expected in that forward attachment zone (within blue box, Figure 10). This means the alignment of the failure edge station and that of the STA 307 feature are not in agreement with a fit on the airplane. Also, as can be derived from Figures 3 and 6, we can see that the cover did not extend so far forward as to impinge on the skin edge at STA 293 5/8.

Figure 10  
2-2-V-1 extreme forward edge abutting skin edge near STA 293 5/8

*The STA 307 brace feature cannot align with that corresponding station on the airplane unless the forward edge of the artifact is placed approximately 1 ½" too far forward. This is a disqualifying fit issue for the STA 307 'vertical brace' feature on 2-2-V-1. The STA 307 vertical member trace is irrelevant to the STA 307 vertical bracing on the Lockheed Electra.*

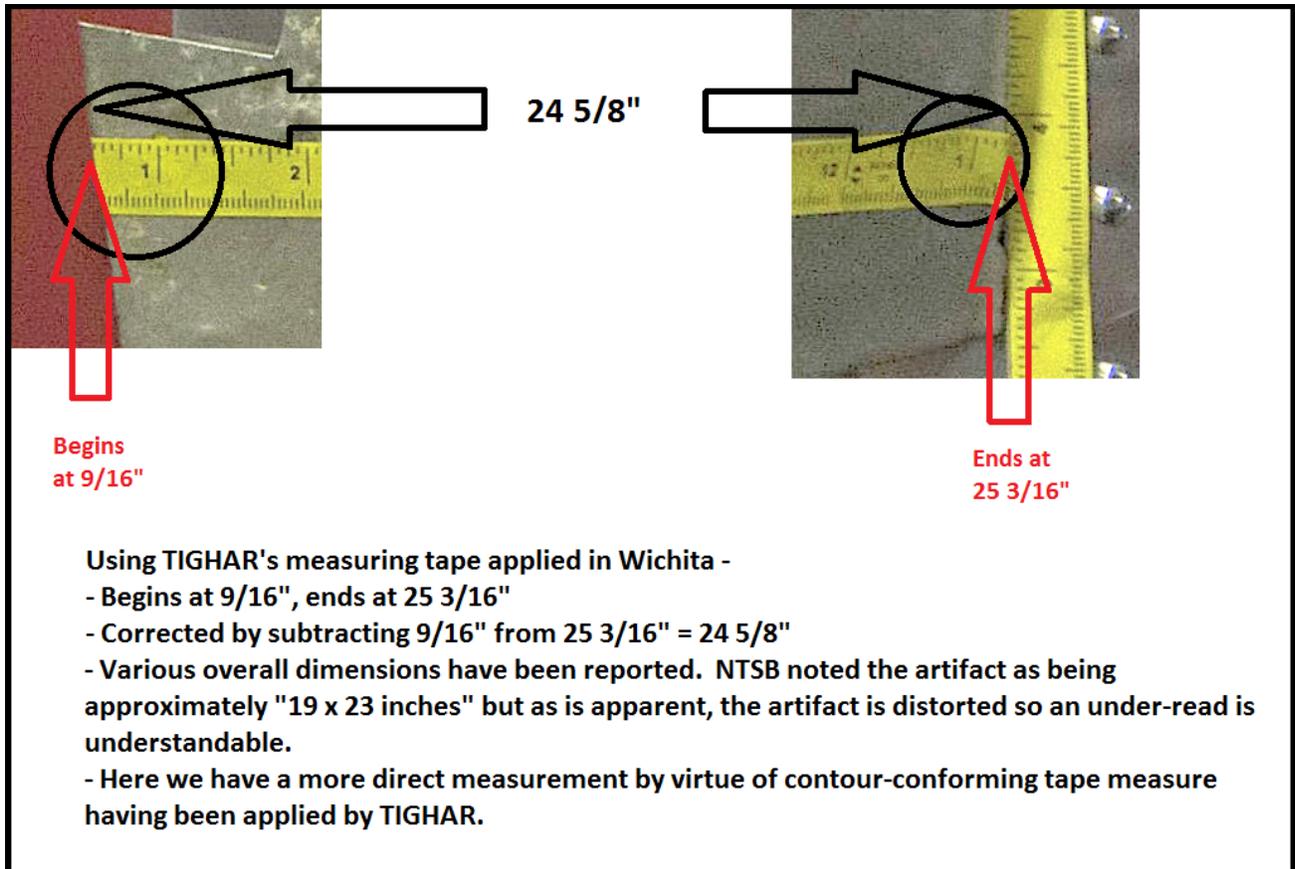
Figure 11

The artifact itself was considered as to width. According to direct measurement by use of TIGHAR's Wichita exterior photo, the artifact is approximately 24 5/8" wide at its extreme width (see breakout of TIGHAR's Wichita photo with contour-adhering measuring tape in Figure 11).

Extreme edges of 2-2-V-1 as measured by applied tape in Wichita. Photo: TIGHAR

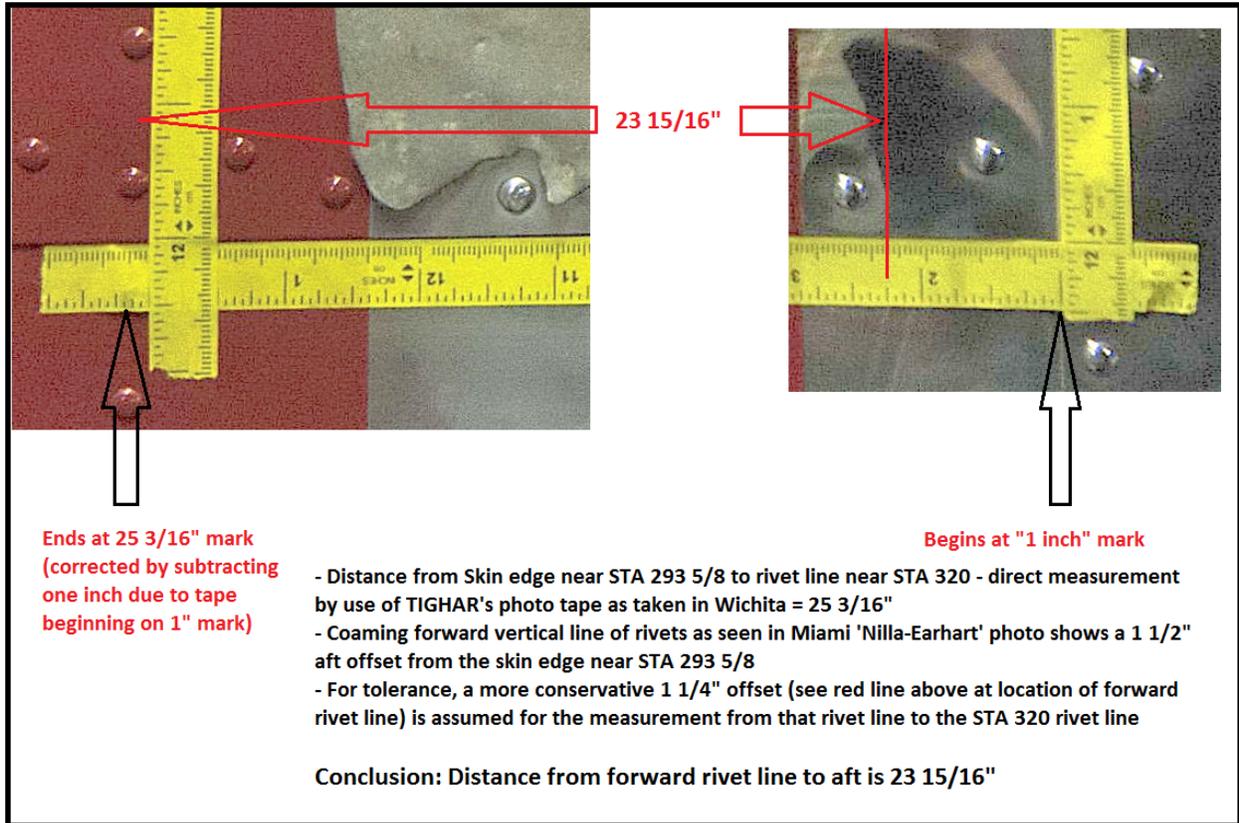
Figure 12

Distance from STA 320 rivet row to forward window cover attachment row as measured by TIGHAR photo with measuring tape applied in Wichita. Images excerpted from TIGHAR photo.

As can be seen in Figure 12, the distance from the aft edge of skin at STA 293 5/8 to the rivet row at STA 320 is 25 3/16". As observed in Figure 3, the forward vertical rivet row in the coaming was offset from the skin edge near 293 5/8 by approximately 1 1/2", and the covering forward row is assumed to have the same offset since there is indication of that in the Darwin ramp photo (Figure 6) and no contrary indication. To provide some liberal tolerance, 1 1/4" was applied in this case (see again Figure 12) – also allowing a wider tolerance for fit of 2-2-V-1.

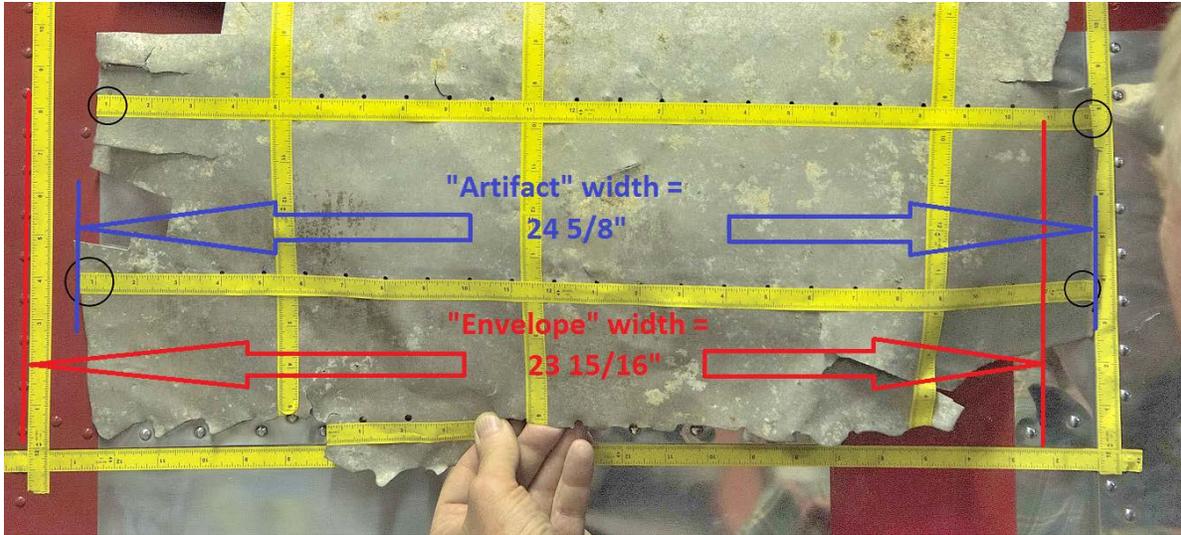
This method yields a measured distance between vertical rivet rows on the window covering of 23 15/16". See Figure 14 for a comparison. In doing so, please note that scale is not reliable - artifact distortion renders visual comparisons moot; the artifact appears shorter than the true measurement due to significant bending. The dimension was derived from a study of the contour-adhering tape measure per Figure 11.

Given the envelope size of 23 15/16" and the artifact's width of 24 5/8" as established, an artifact overhang margin of some 11/16" of an inch can be seen to exist.

Artifact width vs. Envelope width: 2-2-V-1 is wider than the distance between the two vertical rivet rows where the window covering attached. Note that the artifact visually appears narrower than its actual width due to bending.

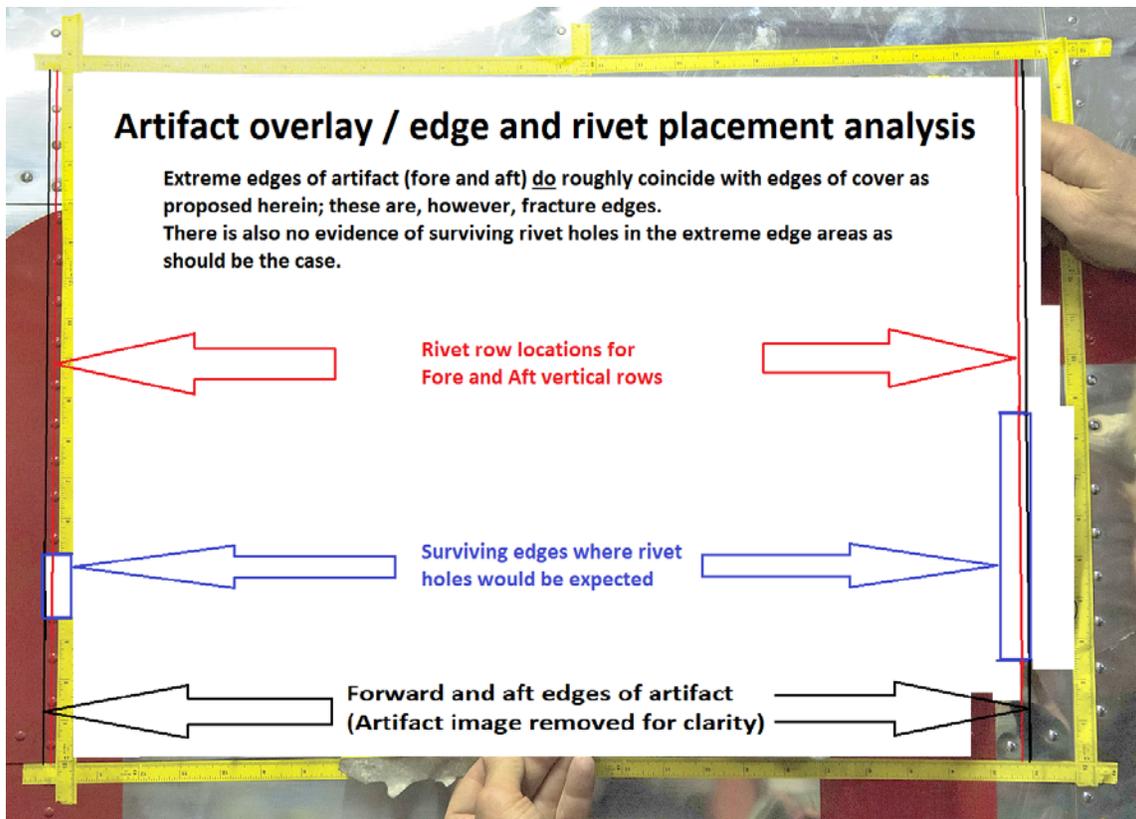
Figure 15

Artifact overlay

The artifact is 24 5/8" wide as measured with some 6" of vertical surviving margin at the RH extreme (see Figure 15, blue box at RH side). The envelope (distance between fore and aft vertical rivet lines for covering attachment) is 23 15/16" wide as measured (red lines in Figure 15), considering the more liberal 1 ¼" aft offset from the skin edge near STA 293 5/8 than is observed in Figure 3.

Were 2-2-V-1 the window covering remnant at 24 5/8" wide, and given a vertical rivet row spacing of 23 15/16" apart (fore and aft), the artifact overshadows the envelope by 11/32" in the fore and aft directions (see red and black lines in Figure 15). The artifact therefore exhibits ample material for a rivet edge distance at the forward and aft rows (11/32" divided equally) of 11/64" per side (as represented by the separation of the red and black lines, Figure 15).

Considering that we see #3 (3/32") rivets in the coaming forward vertical row (Figure 3), we may consider a normal edge distance of 2 ½ diameters to apply (observable in Figure 3 herein and true by the airworthiness guidance of Earhart's day and still so, reference AC 43.13). That would equal 2.5 x .094" = .235", or approximately 5/16" (again, as represented by the red and black lines, Figure 15).

*At its extreme width, the artifact could fit as the covering with a reasonable degree of excessive edge distance as to the left and right vertical rivet rows. However, this must be discounted because there is a lack of finished edges which should be evident at this full-width article at least at the forward (RH) edge (see RH blue box, Figure 15). Instead we see a fracture zone.*

*This is disqualifying in the author's opinion: given the fracture boundaries and considering its full width – which might otherwise coincide handily with the actual covering width, the artifact is physically too wide to be Earhart's Navigation Window Covering. Any edges surviving at the extremes should be finished edges.*

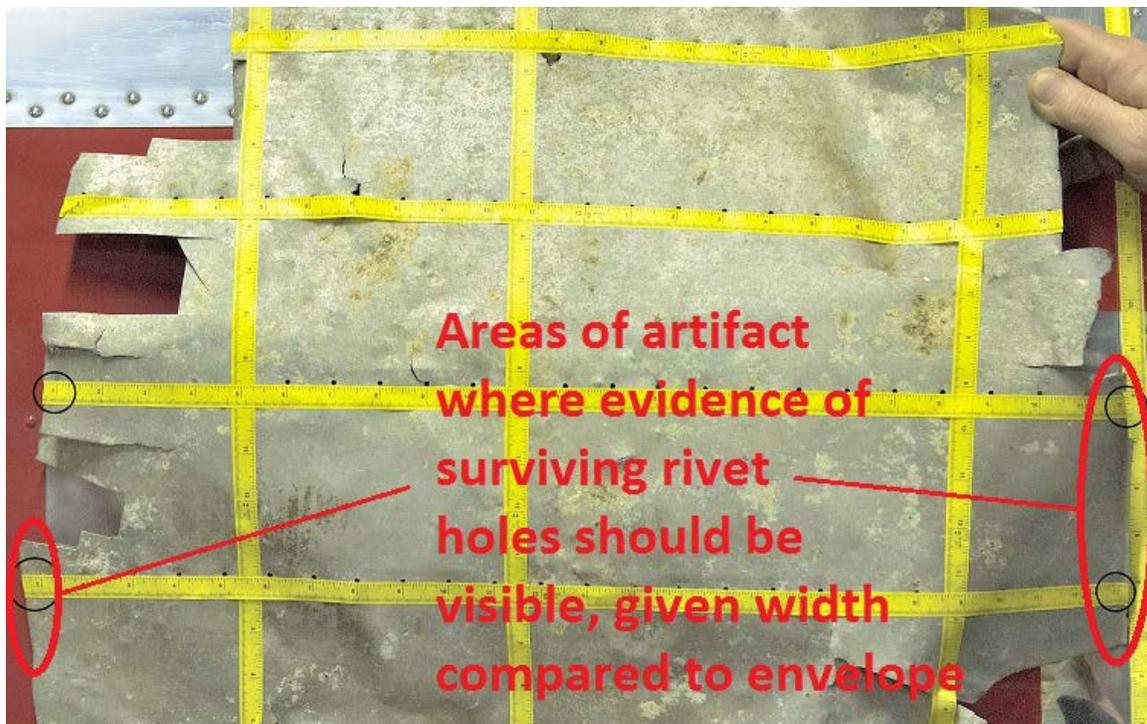
Figure 16

Given that the aft edge has less margin area – being trimmed to more of a point, the odds of finding rivet hole evidence in that area are notably slimmer. However, the forward extreme edge bears a straight fracture edge that is approximately 6” high. Discounting the more pointed aft (LH) edge, ignoring the fracture edge at the forward (RH) end and considering that at 24 5/8” wide the artifact would be ‘full width’, i.e. ‘undamaged width’, there should be observable evidence of rivet holes well within the forward edge area (reference Figure 15). None is observed.

Most probable areas for surviving rivet holes as remnants from forward and aft edge attachment were 2-2-V-1 the navigator’s window covering.

*As established, ample margins exist such that surviving rivet holes should be visible in or near the extreme lateral margins of the artifact, were it a remnant of the navigation window covering for NR16020. Given the liberal tolerances applied in the analysis and resulting adequacy of margins for surviving rivet holes and the absence of same, the artifact does not bear evidence of attachment to the Earhart Electra in the Navigation Window area. The author considers this disqualifying.*
