**TIGHAR**

# **Fractographic Analysis of Artifact 2-2-V-1**

**MMR Project No. 128927**

August 27, 2019

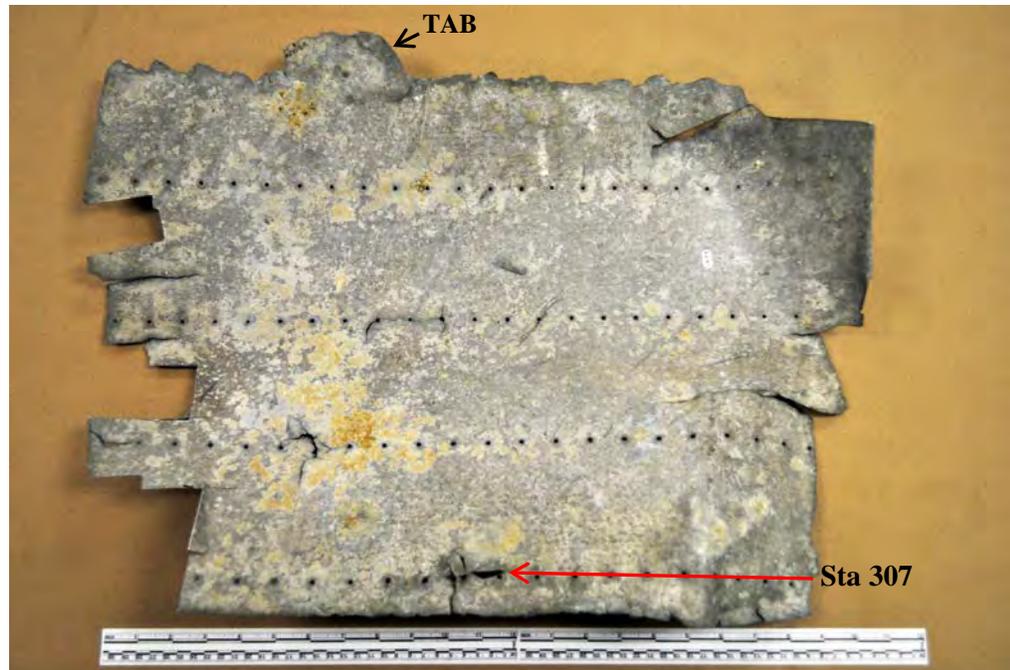
Figure 1: Overall view of 2-2-V-1 with the Tab and Sta. 307 features labelled.

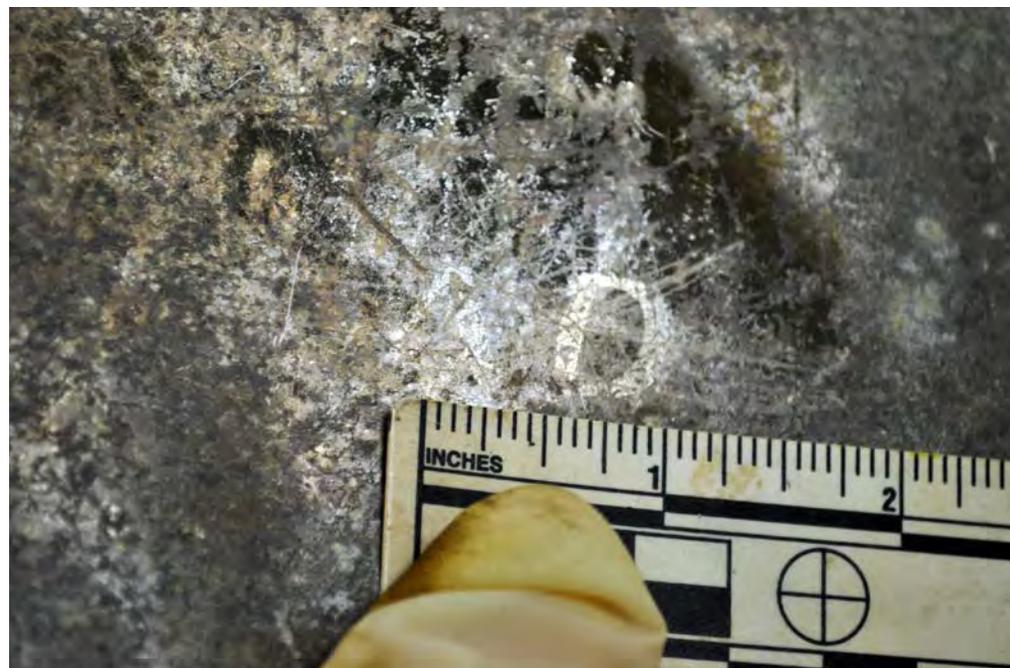
The outer radius of the artifact possessed the letters “AD” near the tab, a “6-” or “-9” mark (depending upon which way is properly “up”) near Sta. 307, and a possible small P or D over a 9 near the tab. No such discernable markings were present on the inner radius surface.

Figure 2: The "AD" logo near the tab. Two other instances of this logo were also present. This was the best defined.

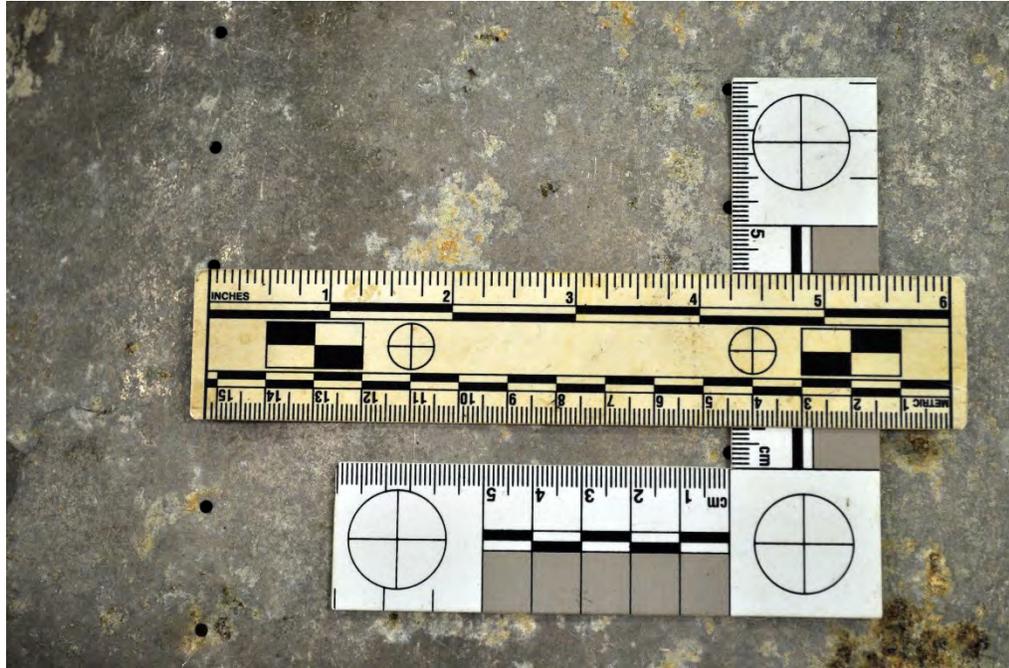
The lines of smaller rivet holes were 4 ¼-inch apart, although that was not exact for all the row spacings. These rivet holes were located 1-inch apart. An intact rivet was present in line with the Sta. 307 feature and has been the subject of previous examinations. The partial line of larger rivet holes exhibited irregular spacing and linear misalignment. The features discussed are shown in Figures 2 through 11.

Figure 3: Smaller rivet hole rows were spaced 4.25-inches apart.

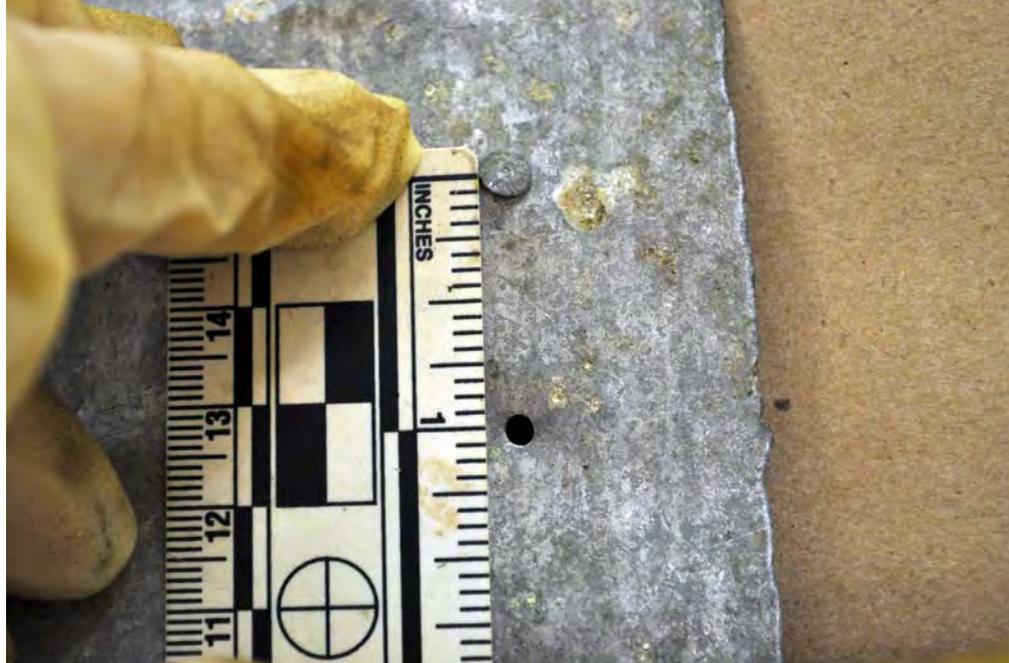
Figure 4: Smaller rivet holes were 1-inch apart. The intact rivet is shown.

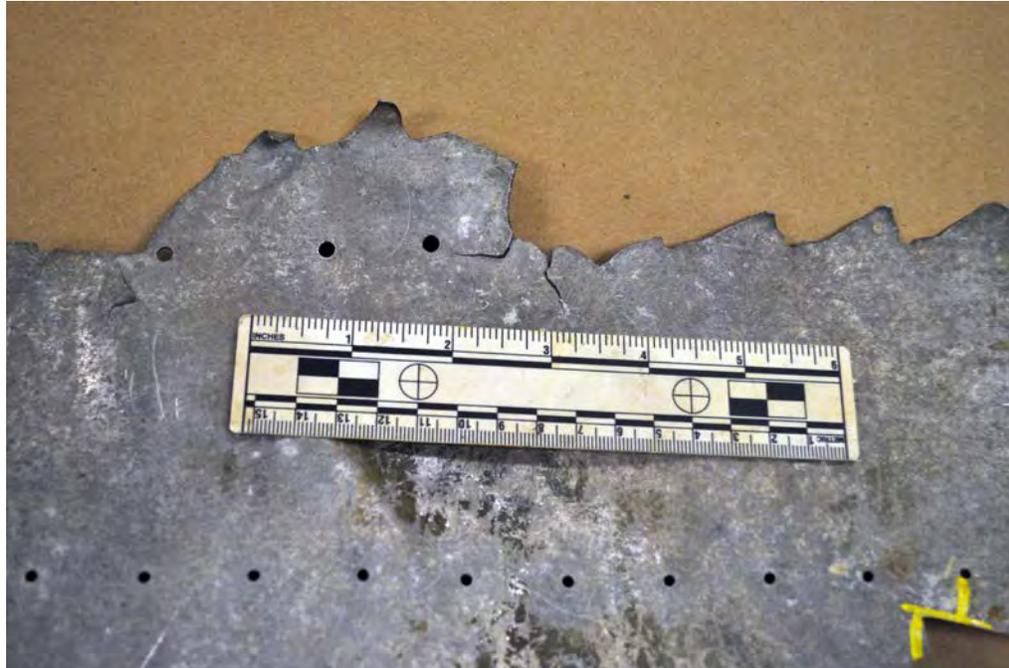
Figure 5: The larger rivet holes remaining on the artifact at the tab feature.

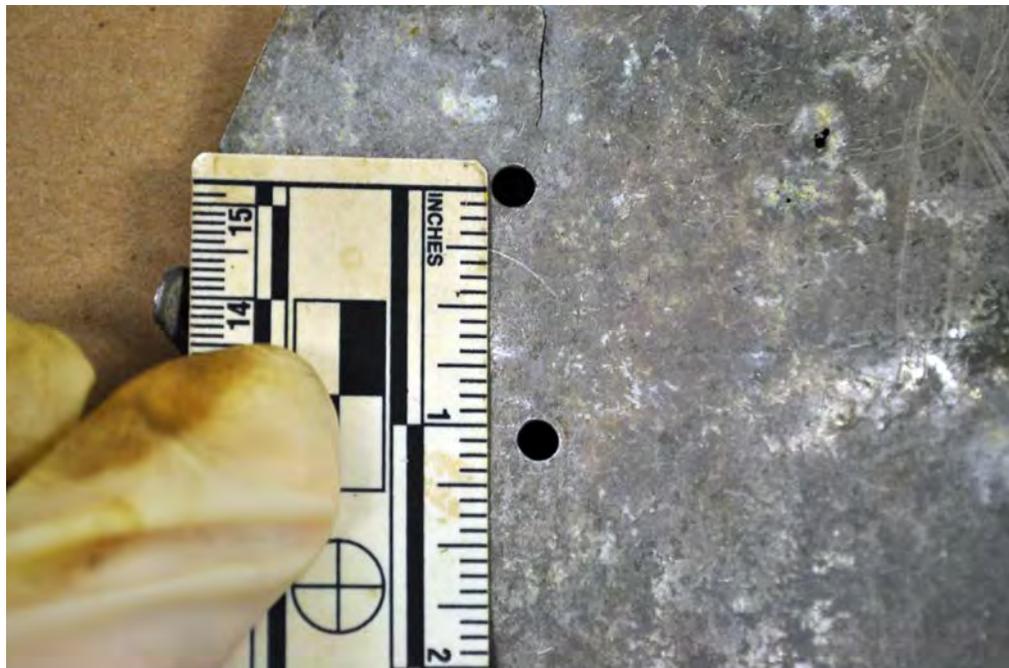
Figure 6: Two of the larger rivet holes were 1 1/6-inch apart.

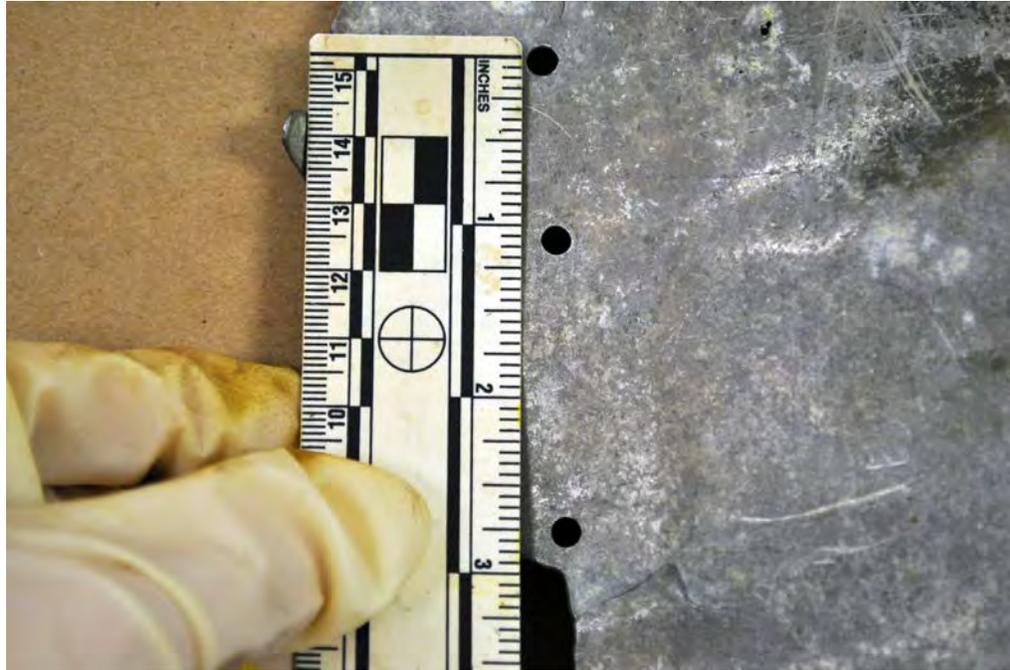
Figure 7: The irregular spacing and linear misalignment of the larger tab rivet holes.

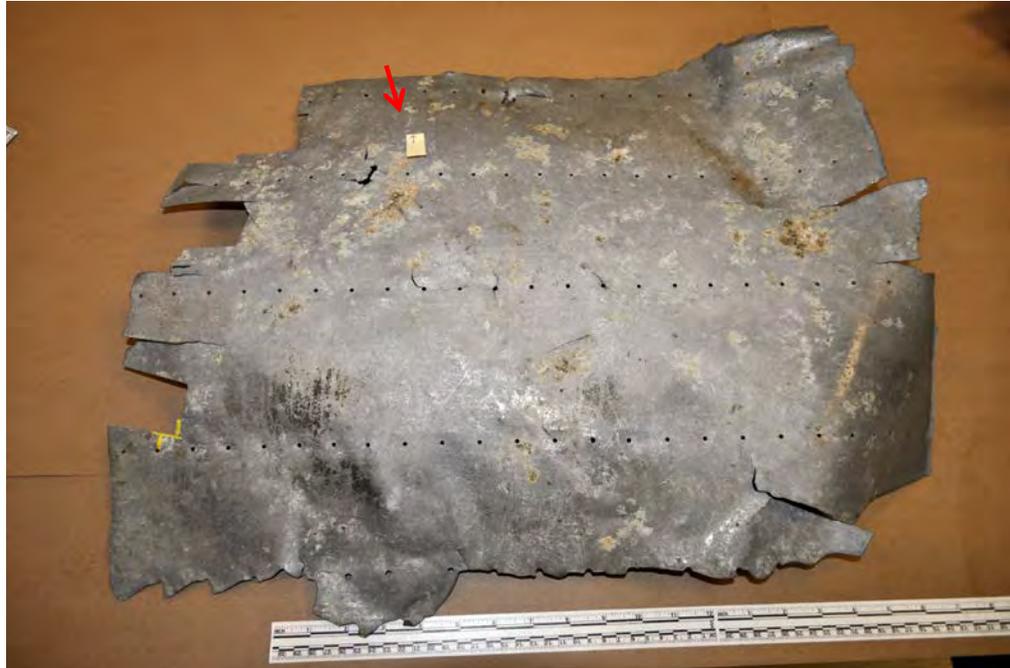
Figure 8: Overall view of the -9 numerical marking location, arrow.

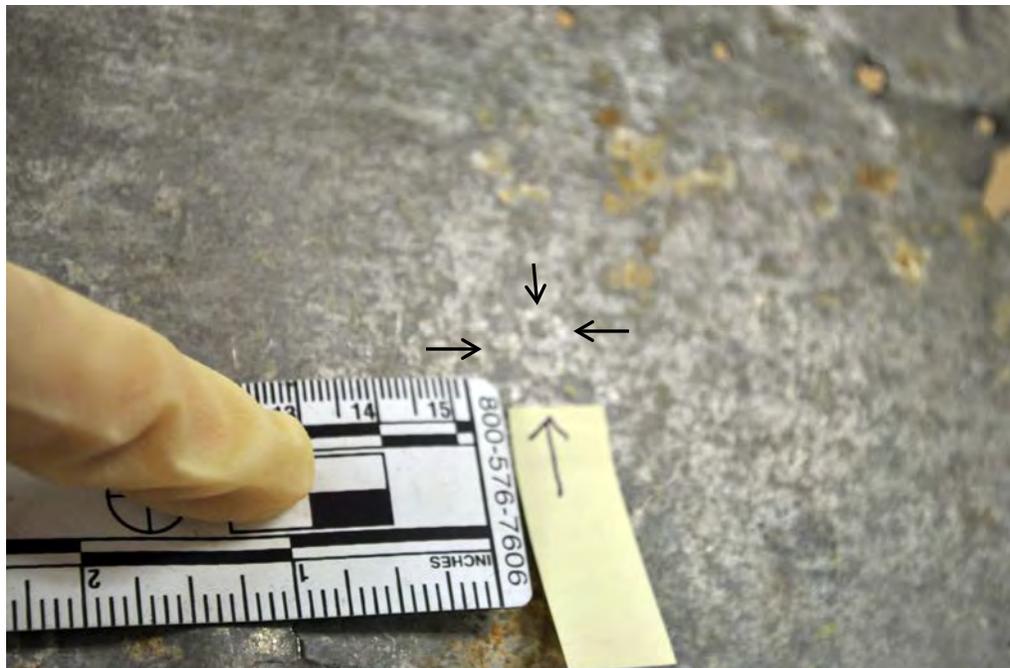
Figure 9: An apparent “-9” near the Sta. 307 feature, arrows.

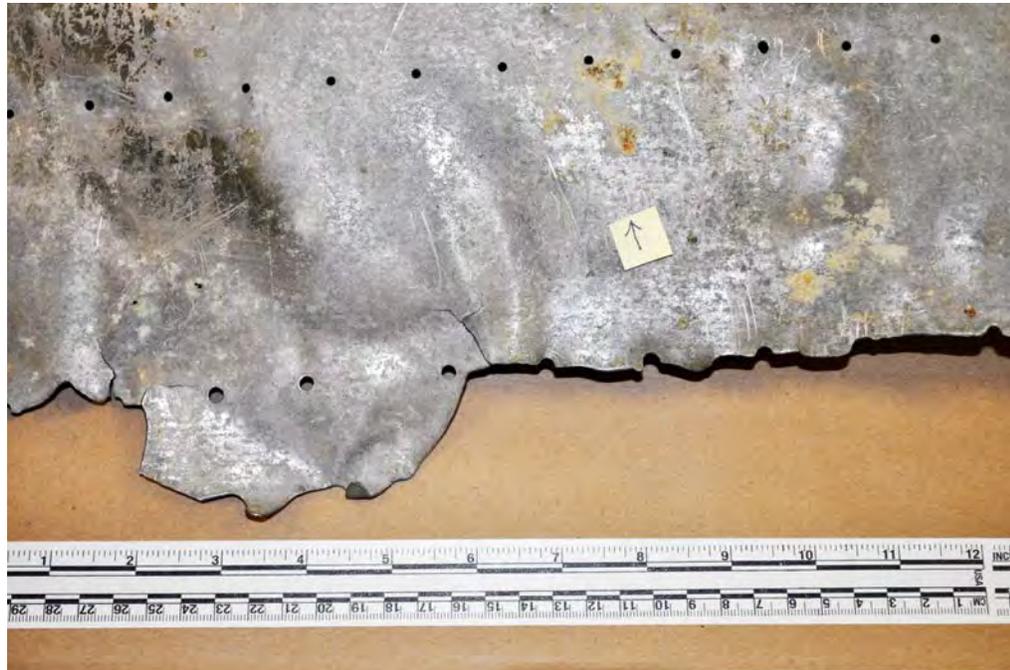
Figure 10: Location of the D over 9 mark, arrow.

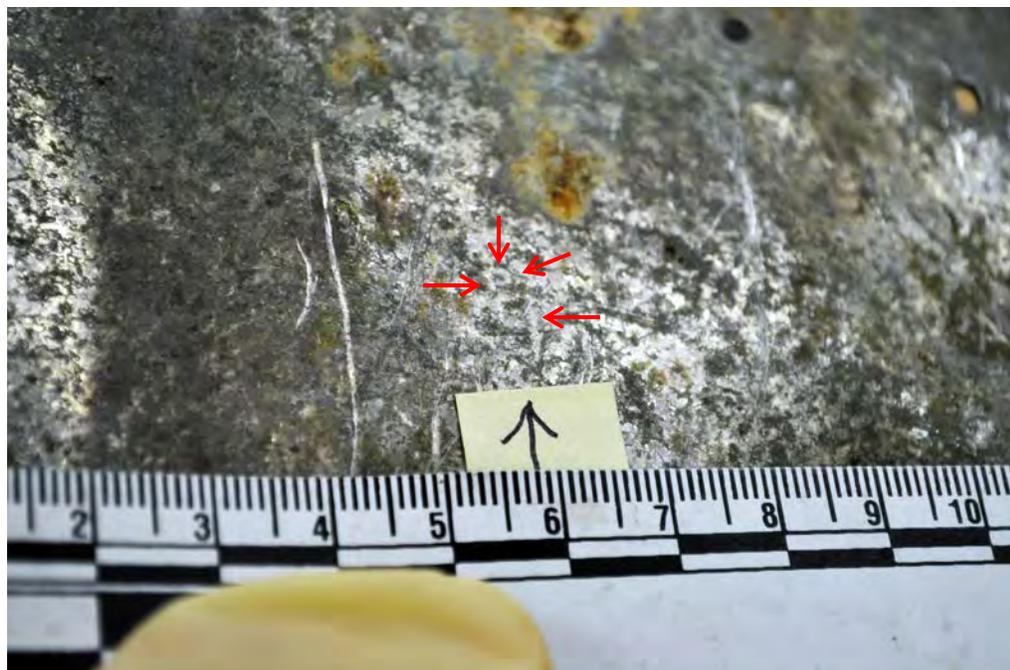
Figure 11: An apparent D (or possible P) over a 9 near the tab, arrows.

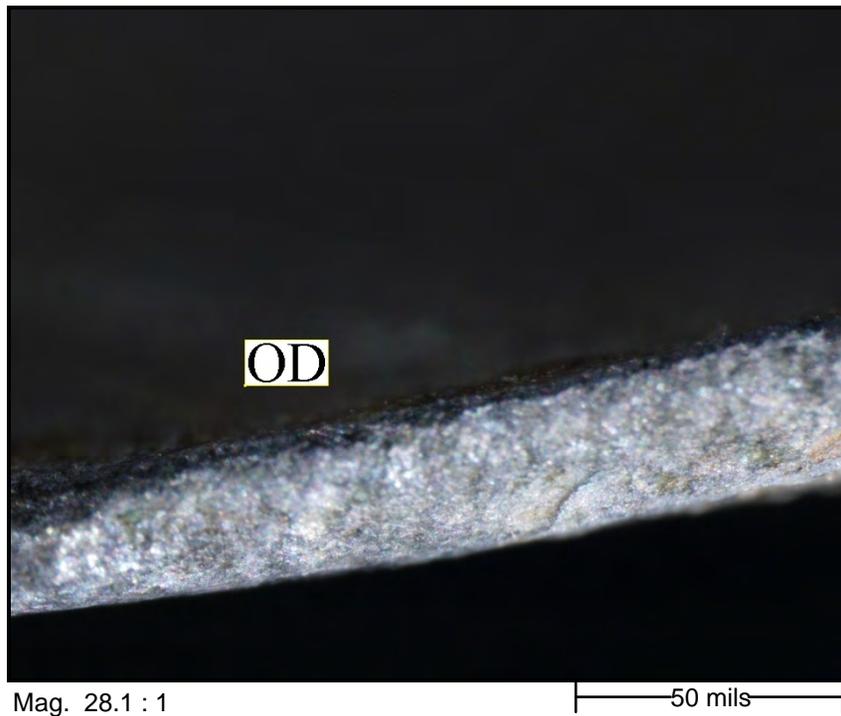
To determine whether any radial markings, beach marks, or any other larger fracture features were present to indicate the location of fracture origins or direction of fracture progression, the artifact and its small separated piece were examined with a stereomicroscope. This examination was generally unrevealing, as all fracture surfaces examined exhibited post-fracture damage and corrosion, Figures 12 and 13.

Figure 12: A typical fracture surface on 2-2-V-1, representative of all fractures examined. No fracture features were discernable.

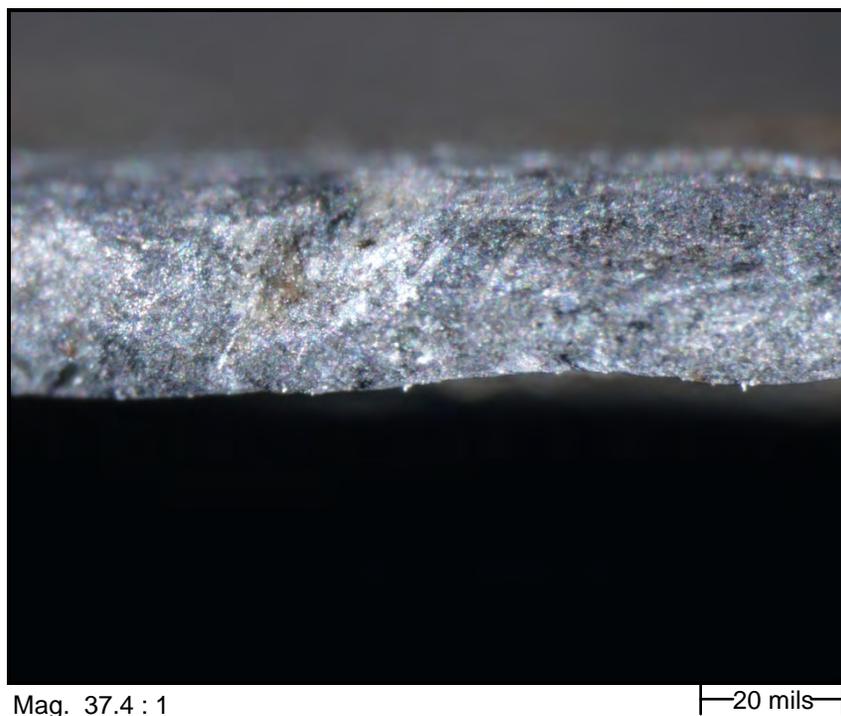
Figure 13: A higher magnification view of a typical fracture showing post-fracture rubbing damage.

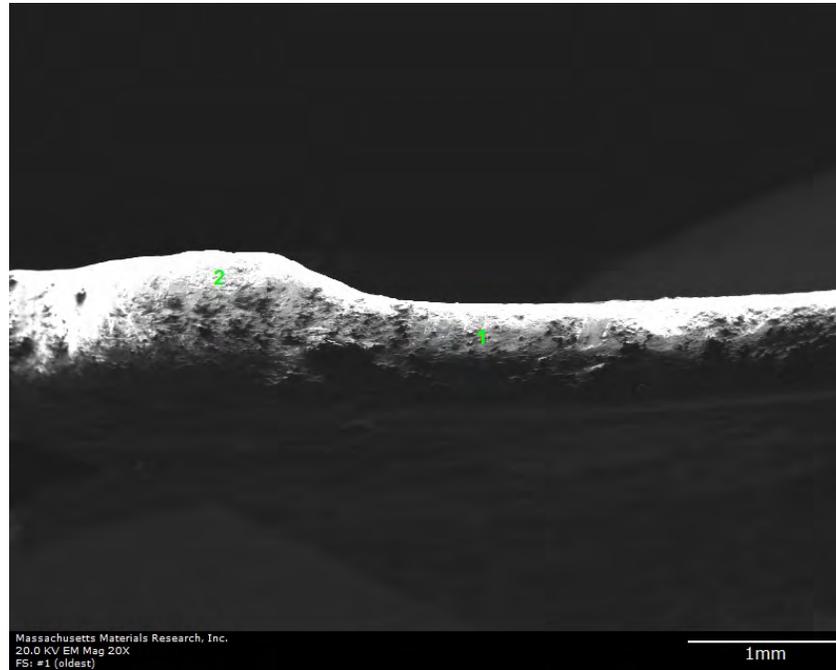
Figure 14: Fracture 1 overall with areas 1 and 2 marked.

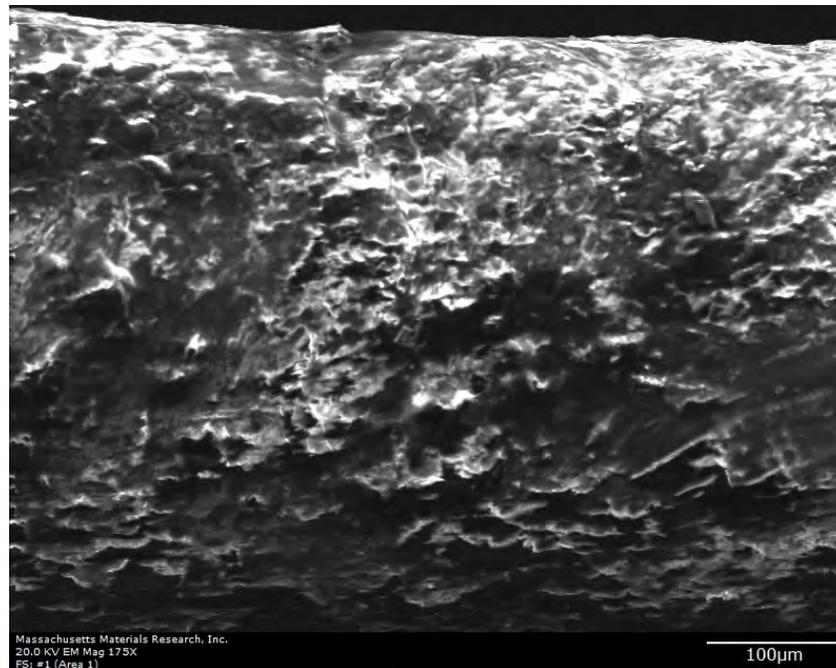
Figure 15: Fracture 1 area 1 detail showing mechanical rubbing and no fracture features.

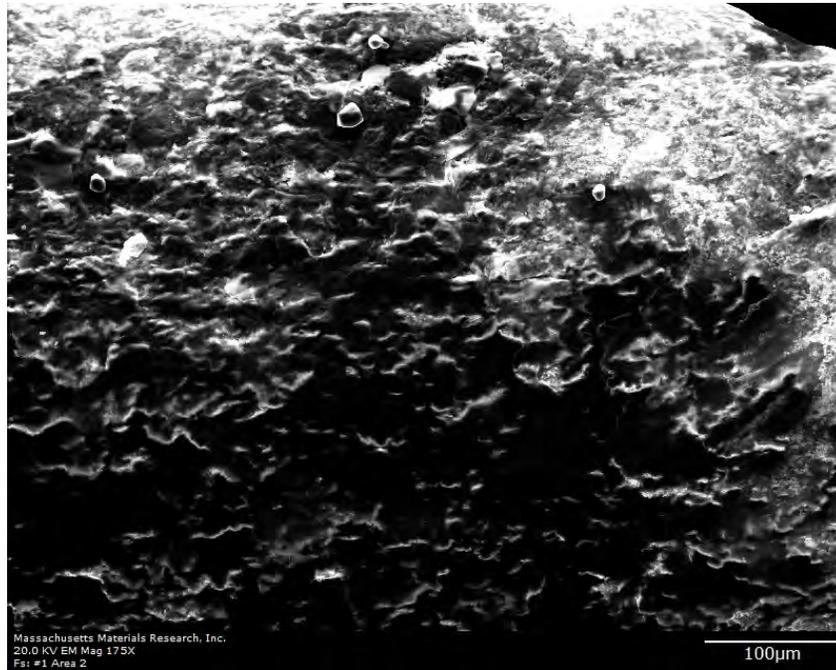
Figure 16: Fracture 1 area 2 detail showing mechanical rubbing and no fracture features.

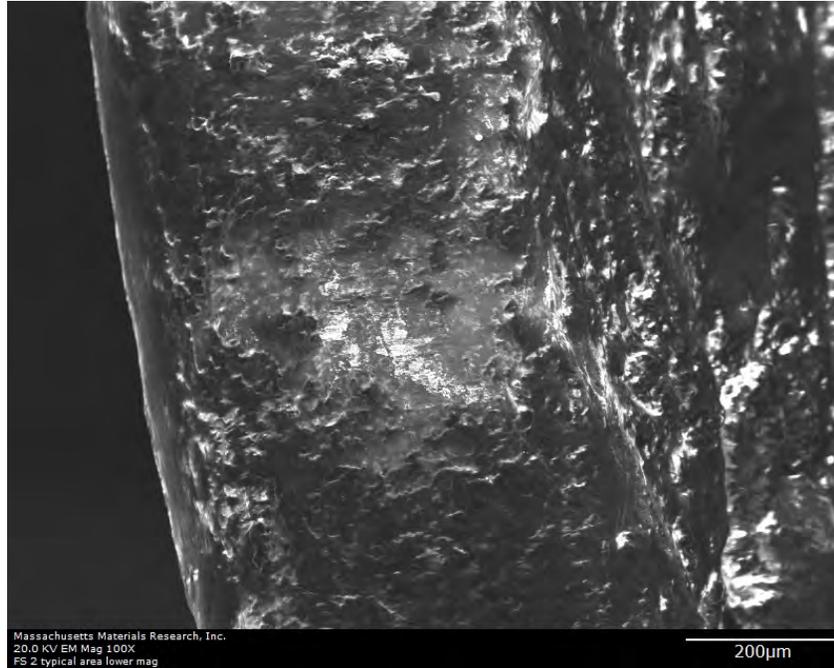
Figure 17: Fracture 2 at a typical area, overall view. No larger fracture features present.

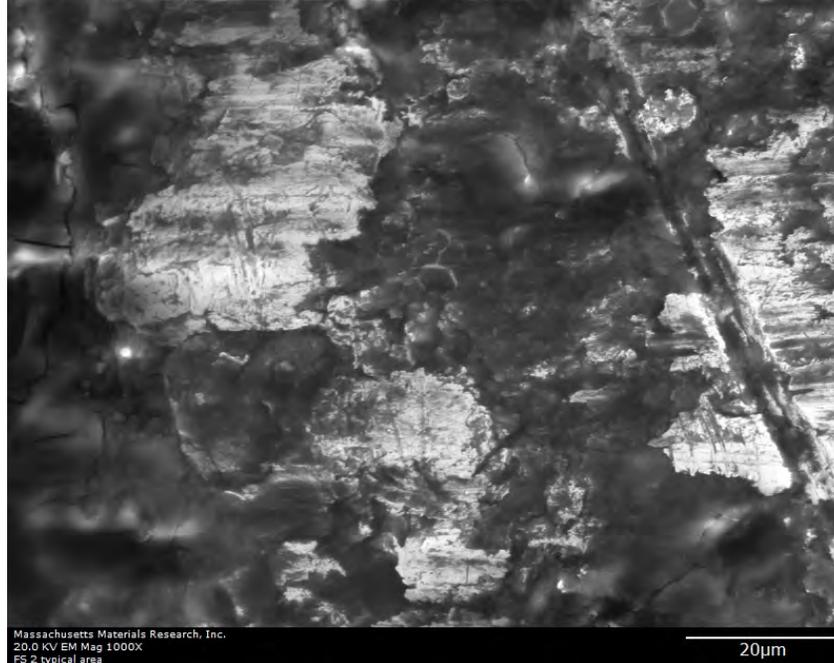
Figure 18: Fracture 2 typical area detail showing no fracture features.

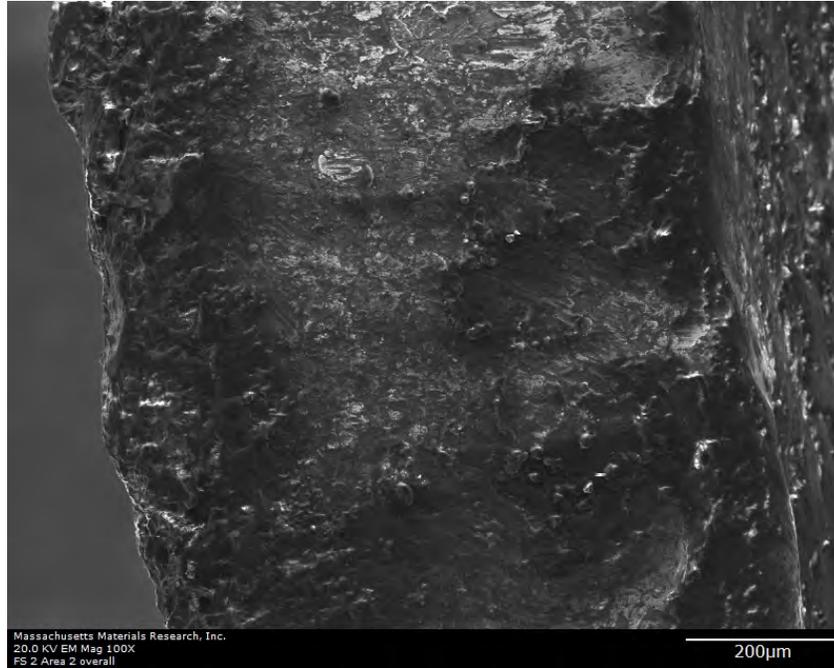
Figure 19: Fracture 2 area 2 overall. Same general appearance of mechanical damage as the typical region.

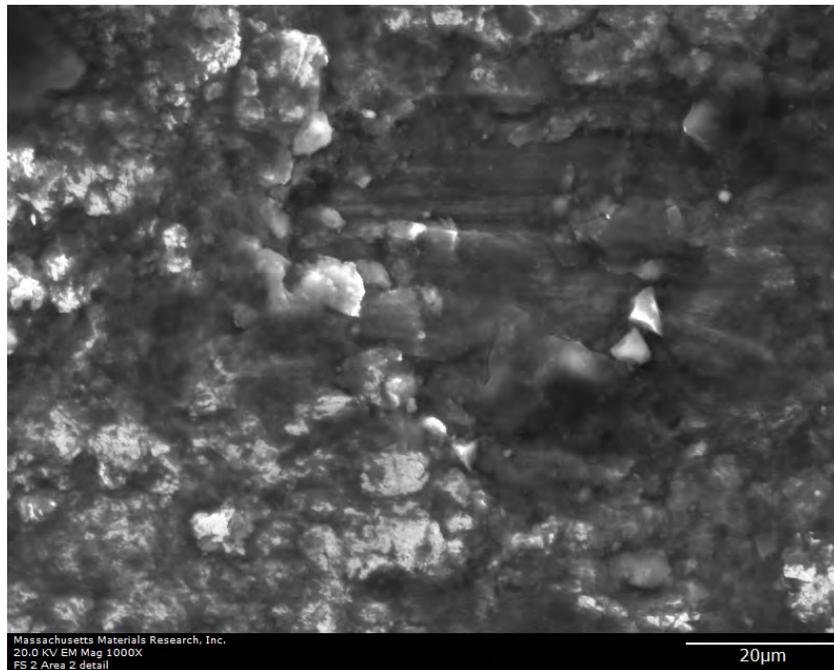
Figure 20: Fracture 2 area 2 detail showing no fracture features.

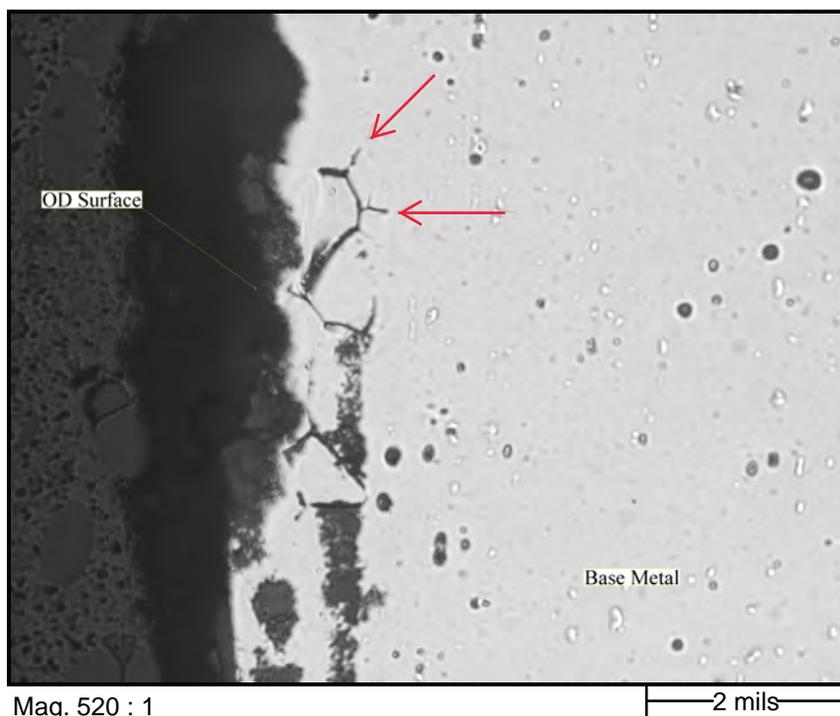
This examination confirmed that extensive corrosion was present on the artifact surfaces and fractures. The corrosion was general, pitting, and intergranular attack forms, all of which would be expected from an aluminum alloy fragment submerged in seawater, Figures 27 through 31.

Figure 27: Separated fragment outer radius corrosive attack with intergranular attack at arrows. As-polished.

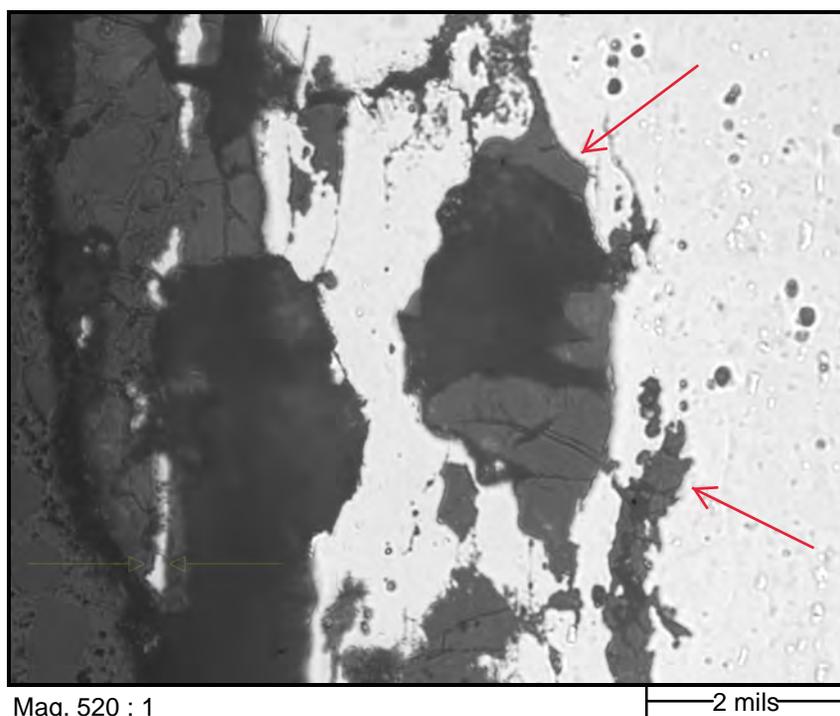
Figure 28: Detail of Figure 27 showing remnants of surface cladding, yellow arrows, and corrosion along second phases in base metal, red arrows. As-polished.

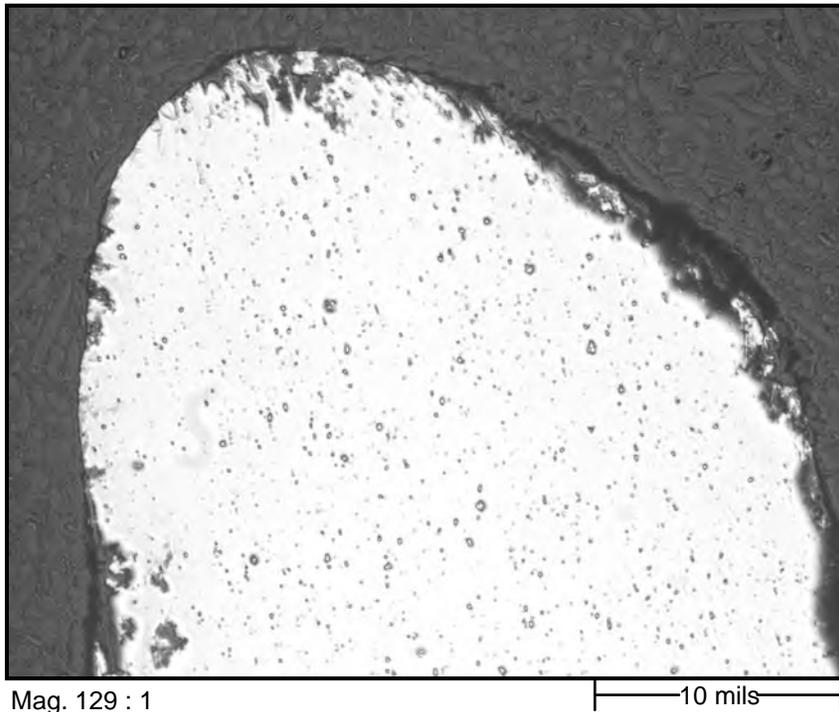
Figure 29: Separated fragment original artifact fracture surface showing extensive corrosion and rounded fracture surface region. As-polished.

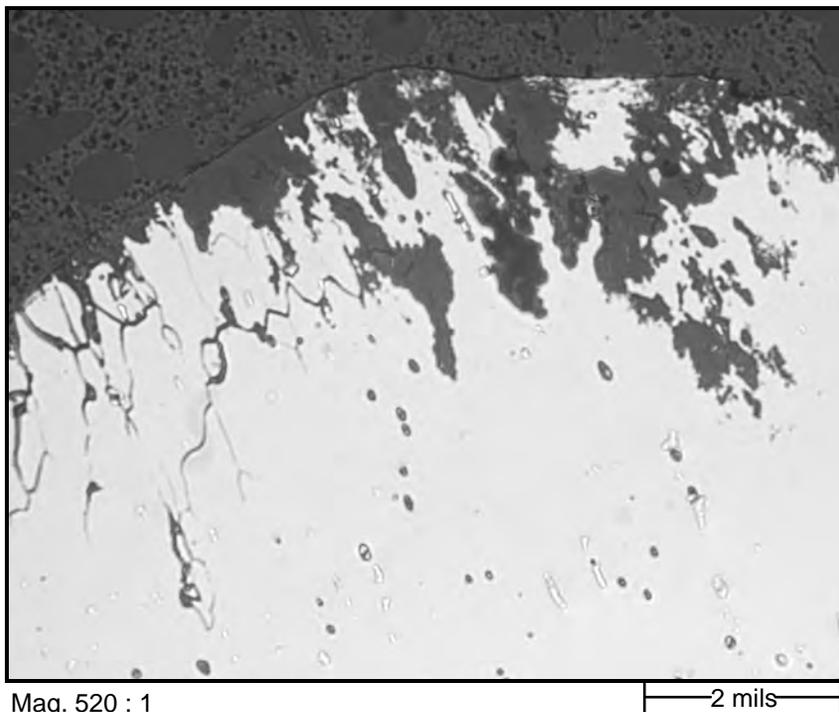
Figure 30: Detail of fracture surface corrosion from Figure 29.

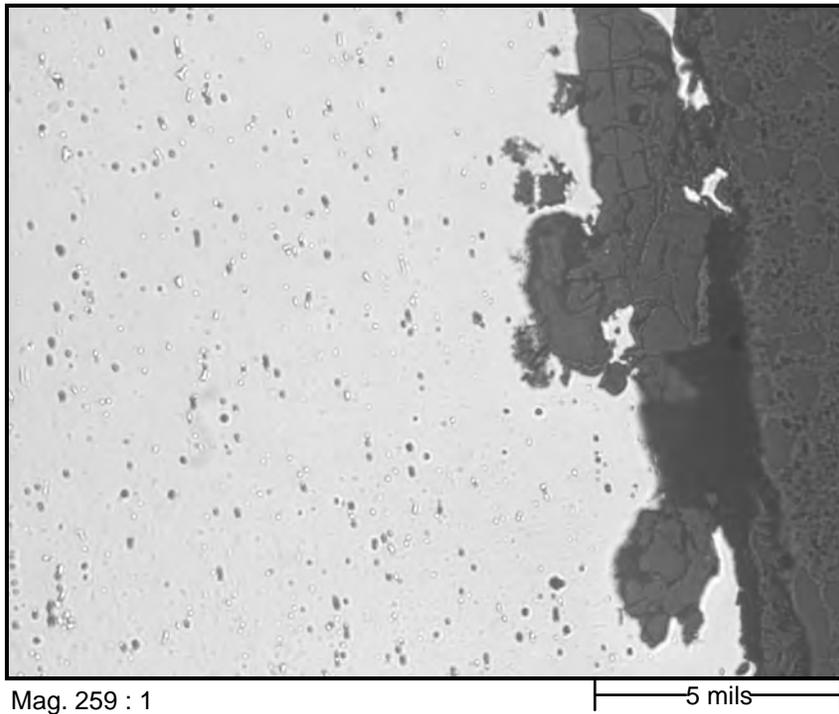
Figure 31: Typical pitting on the possible heat affected region surface. As-polished.

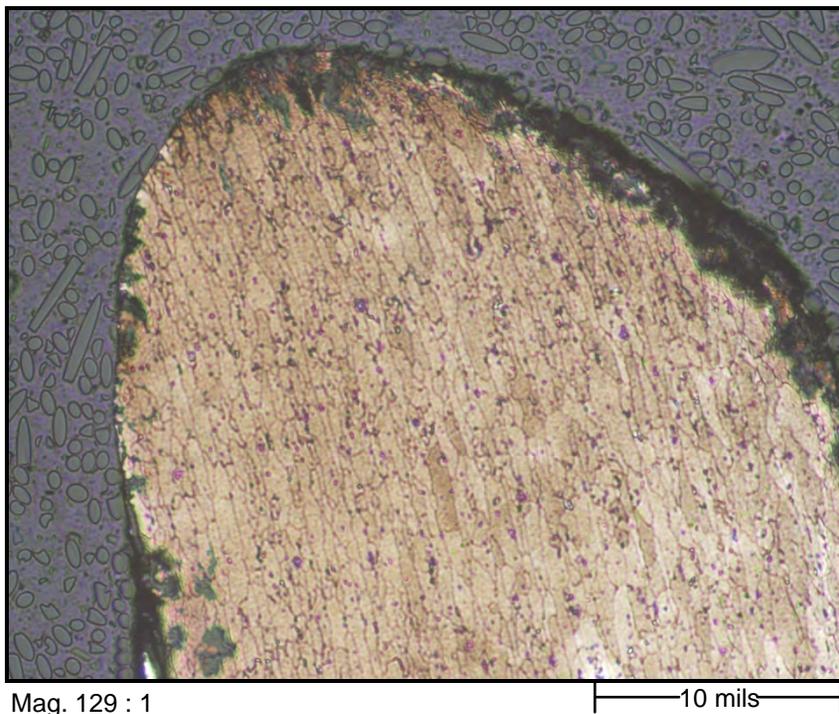
The original edge fracture present at one end of the separated fragment mount did not possess enough base metal grain deformation to have fractured via tearing (i.e. overload), Figure 32. While the extensive corrosion prevented observation of the actual fracture mode, metallurgical analysis ruled out overload in this region. Examination of the base metal grain structure of the separated fragment and possible heat affected region revealed no evidence of grain growth, recrystallization, second phase form or size alteration, grain boundary melting, etc. Cold work was present at the possible heat affected region, Figures 33 and 34. This indicates that the more brittle behavior of the possible heat affected region was not due to heat, but instead due to the effects of cold work. The microstructure of both mounted cross-sections was typical of solution treated 2024 aluminum.

Figure 32: Etching revealed not enough grain deformation for overload fracture at separated piece original 2-2-V-1 fracture. Etchant: Keller's.

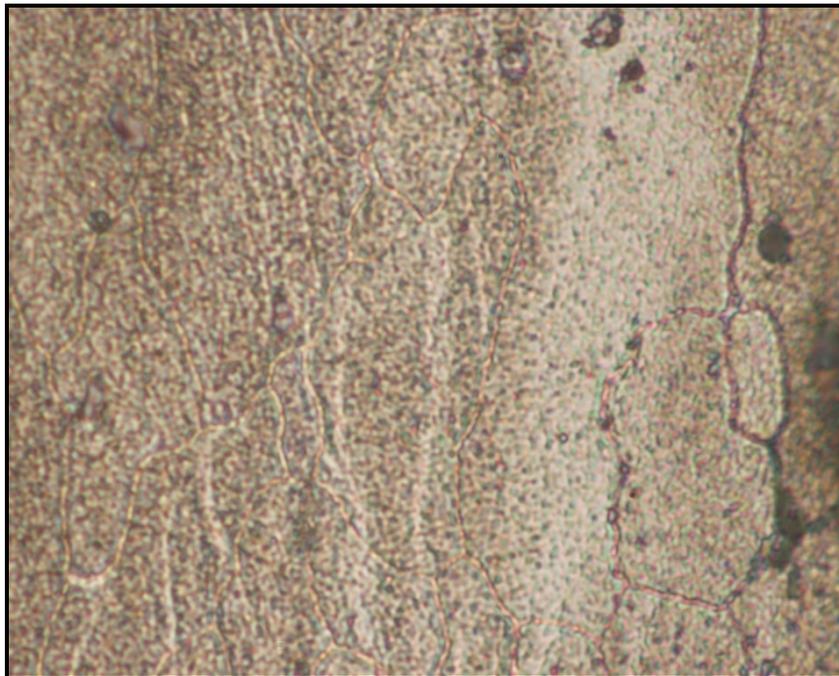
Figure 33: Detail, separated fragment grain structure. Etchant: Keller's.

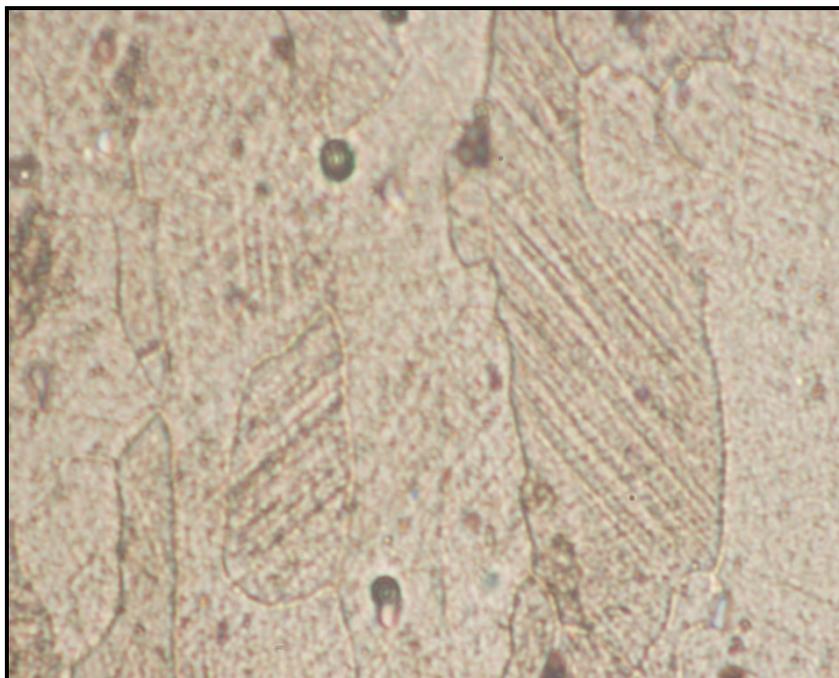
Metallurgical examination revealed that more brittle behavior of the artifact material in a possibly heat affected region was actually due to cold work effects. This examination also revealed that the artifact fracture surface grain structure along that same edge was not deformed enough to have occurred as the result of overload fracture in the region examined. The microstructure of the artifact material was typical of solution treated 2024 aluminum alloy.

Figure 34: Detail, cold work and no heat effects in possible heat affected region grain structure. Etchant: Keller's.
