Back To Square One for 2-2-V-1

Artifact 2-2-V-1.

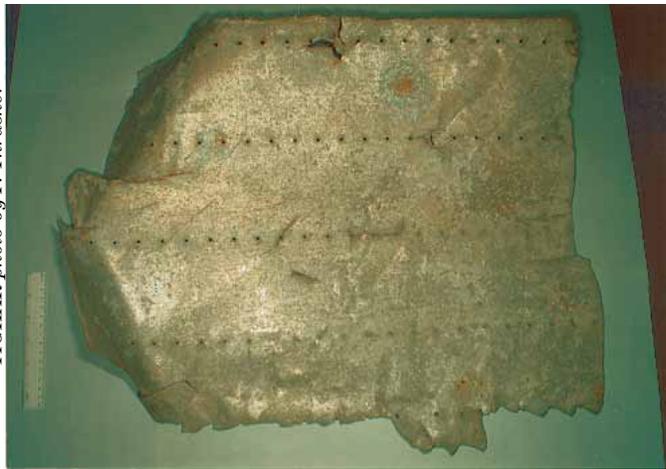
Recently analyzed photographic evidence indicates that the section of aluminum aircraft skin we found on Nikumaroro in 1991 (Artifact 2-2-V-1) does not come from the part of the Earhart aircraft where we had suspected it did.

The aluminum sheet, while undoubtedly a section of airplane skin, does not seem to fit any known aircraft type, including the Lockheed Electra. However, the general construction of the piece (type of aluminum, thickness, rivet type, rivet size, space between rivets, rate of taper between rivet lines, etc.) seems to be more typical of the Lockheed 10 than of the WWII types used in the Central Pacific. There is no doubt that, following the extensive repairs necessitated by the Hawaii wreck which ended the first world flight attempt, Earhart's airplane differed in some respects from standard Electra's. It was, and still is, our hypothesis that Artifact 2-2-V-1 is from one of those repaired, non-standard areas. But, like trying to fit an errant piece into a jigsaw puzzle, we haven't yet found just where and how it fits.

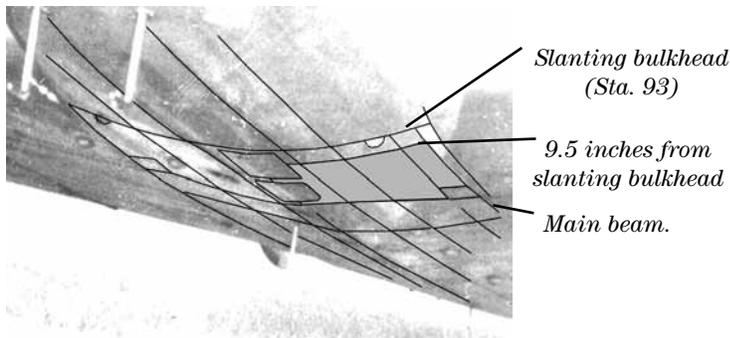
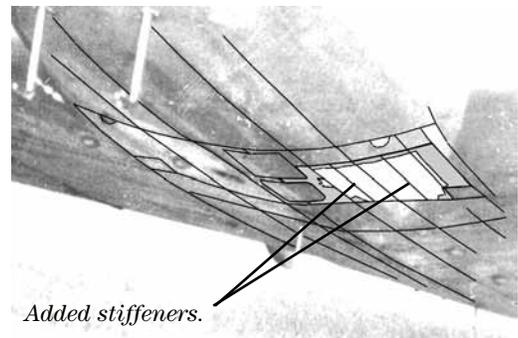
This is what the belly should look like if the patch was installed as theorized by TIGHAR. (2-2-V-1 is shown in white against gray patch.)

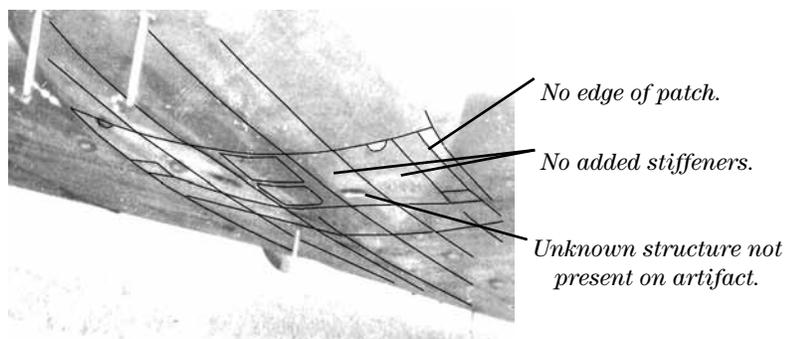
either. There should be "a double row of rivets similar to joint in slanting bulkhead" 9½ inches aft of the slanting bulkhead and there is quite obviously no such seam present. It would appear that whatever repairs were made to NR16020 following the wreck at Luke Field, they did not conform entirely to the repair orders issued by Lockheed. That presents something of a quandary in trying to assess whether Artifact 2-2-V-1 could reasonably be part of the Earhart aircraft. In the absence of photos taken by someone lying on their back under the airplane, no one can say with any certainty just what the rest of the belly looked like, regardless of what the repair orders call for. So where did this battered bit of aluminum come from? Further research may or may not provide a conclusive answer, but we'll keep at it.

This is what the belly actually looked like as determined from the San Juan photos.
