Ferrous Metal Artifacts at the Seven Site, Nikumaroro

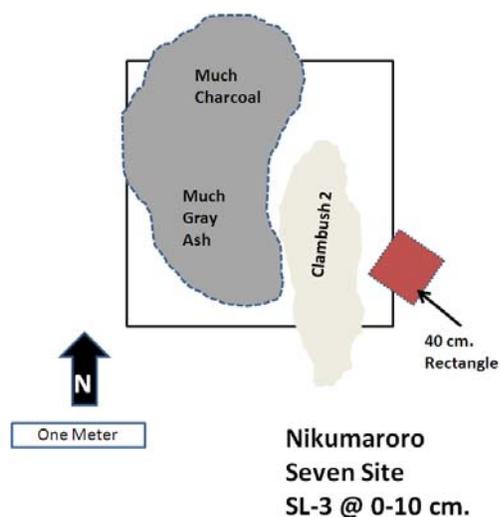
Fig. 1A: Schematic of SL-3

Just west of Clambush 2, a deposit of highly oxidized ferrous metal was recorded in 2001, and recovered in 2007 (See Figures 1A, B). The deposit was rectangular, and 40 cm. across along its northwest side. The northeast side terminated indistinctly at a length of about 30 cm., the southwest side at about 25 cm. The southeast side could not be distinguished, but no fragments were found beyond about 40 cm. from the clearly defined northeast side, so we interpret the object as having been square, 40 cm. across on all sides.

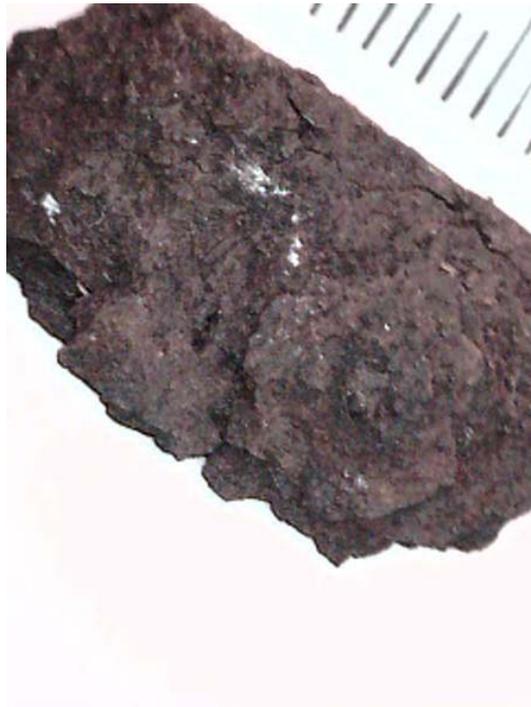
At least one edge of the object was straight. This is reflected in the overall distribution of fragments along the edges of the deposit, and the specific shape of five pieces (e.g. Fig. 2).

Fig. 2: Straight Edge with rivet-like device (mm. scale)

The object was held together by, or perhaps decorated with, some kind of rivet-like device (See Fig. 2). At least eight examples of such devices were found in the 40 cm. rectangle², and many more (discussed below) elsewhere in SL-3.

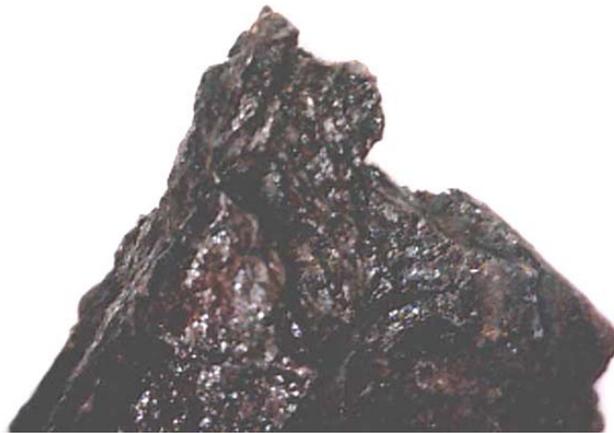
Three fragments exhibit thin wires or rods embedded on the edge of (Fig. 3), between (Fig. 4), or wrapped around by (Fig. 5) the layers of thin metal. The wires/rods appear to be rectangular in cross-section, and are about 2 mm. thick.

Fig. 3: Microphotograph of wire or rod embedded in edge of metal piece; note also rivet-like device in lower right-hand corner.

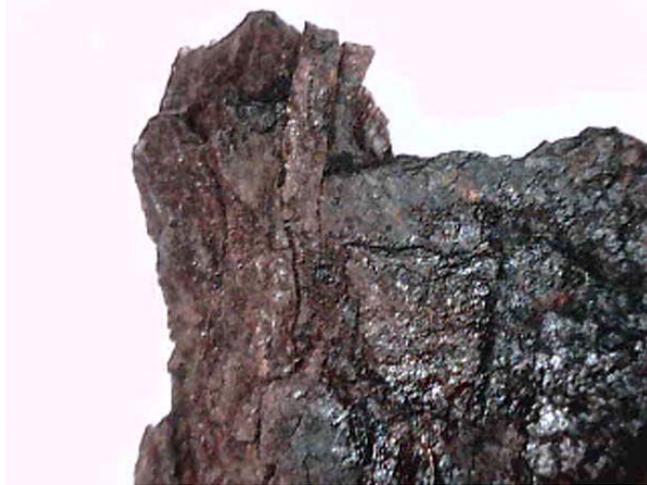
Fig. 4: Microphotograph of wire or rod (possibly two) embedded within/between sheets of metal.

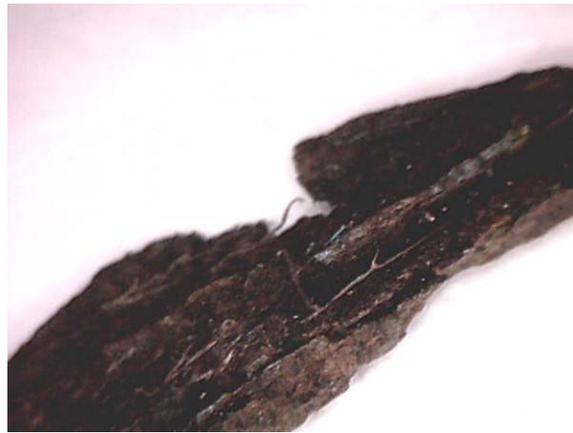
Fig. 5: Microphotograph of wire or rod with thin ferrous sheet(s) apparently wrapped around it.
