**Archaeological Test Excavations at
the Sites of
Hangars One and Two,
College Park Airport
Maryland
October 2005
by
The International Group for Historic Aircraft Recovery
October, 2007**

**Archaeological Test Excavations at the Sites of
Hangars One and Two,
College Park Airport, Maryland
October 2005
by
The International Group for Historic Aircraft Recovery¹**

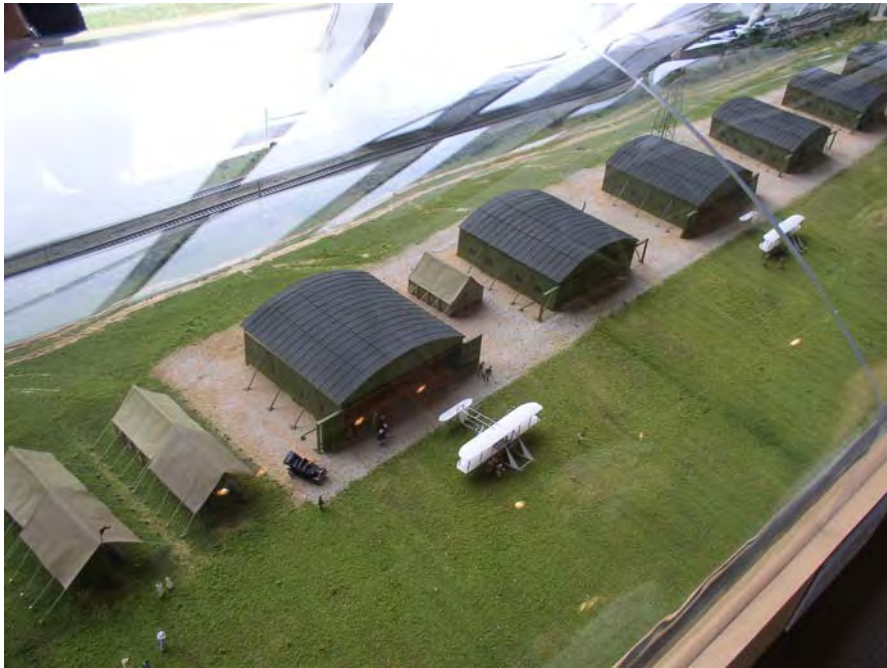
Figure 3: Model of Hangars and Associated Tents, 1911, In College Park Aviation Museum, Based on Period Photos (Hangar One and Medical Tents in Foreground)

The Museum has extensive files of historical photographs, which have been used to create a small three-dimensional model of the hangars as they would have looked in their heyday, and which were very helpful in guiding our work. Many of these photographs show structures other than hangars on the site. Early in the life of the hangars these other structures are military-style tents said to have housed messing and medical facilities. Later, the tents were replaced with small wood frame structures. One goal of the TIGHAR project was to test one or more

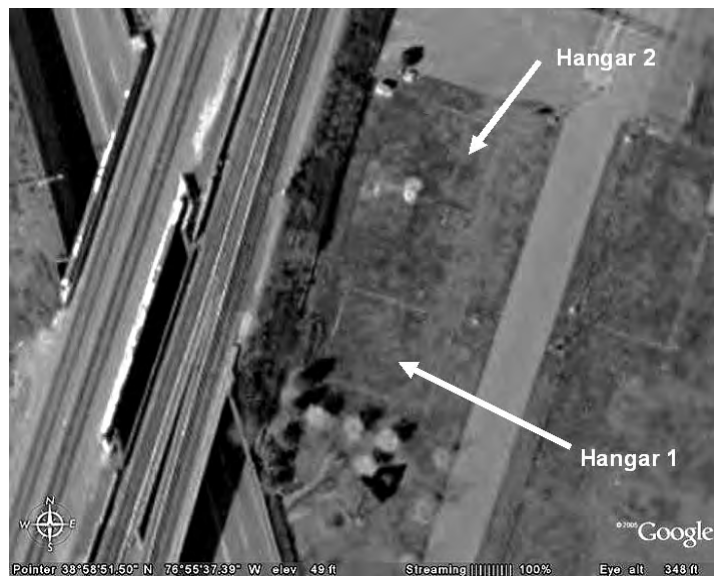
**Figure 4: Satellite Image of Hangar One/Two Site
(Source: Google Earth)**

Figure 4 is a satellite image of the site. Figure 5 is a schematic site map showing the locations of test pits (sizes exaggerated to make them visible on an 8½ x11” page).

The Hangar One/Two site – which of course is only a remnant of the overall 1911 airfield – is a long, narrow, semi-rectangular area some 60 meters on its northeast-southwest dimension and 25 meters northwest-southeast. The northwest edge of the site is transited by underground utility lines, and a mounded concrete platform occupies the northwest corner of Hangar Two. This platform was associated with one of several small structures without foundations that occupied parts of the site between 1940 and the 1970s.

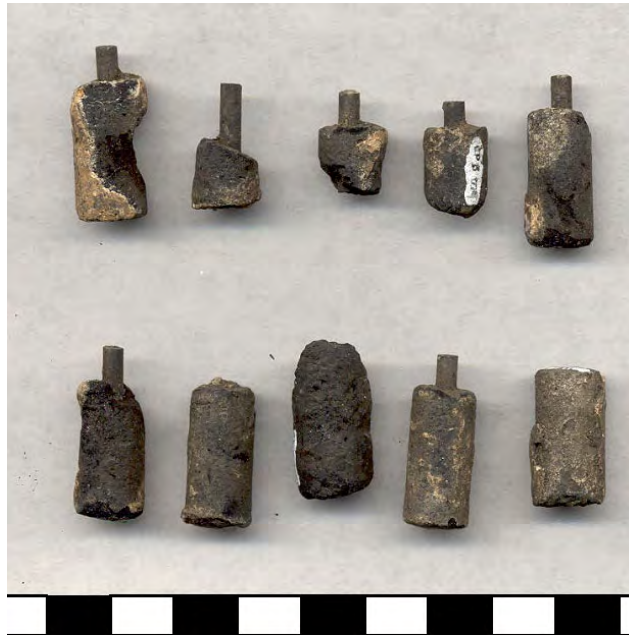
Figure 11: Examples, Fuses/plugs/insulators from Unit B, 10-20 cm. level

The most intriguing “machine parts” (though their identity remains uncertain) are thought to be *fuses* of some kind or early *spark plugs* perhaps used in airplane engines. These are small cylindrical objects made of a light-colored ceramic with a dark gray core. Although few are complete and even the complete examples show signs of erosion that makes their original sizes somewhat uncertain, they appear to range in size from about 2.0 to 2.5 cm. long and from .8 to 1 cm. in diameter. The core in all cases is about 2.7 mm. in diameter.

Opinions are mixed as to the identity of the cylindrical objects. Specialists at the College Park Aviation Museum's restoration shop thought them most likely to be fuses, and were quite certain they were not sparkplugs⁸. TIGHAR members familiar with antique aircraft engines tended to think they were elements of such an engine's electrical system⁹. Posting a description and photograph on internet discussion fora used by airplane, ship, and automobile scale modelers brought in no opinions from ship or automobile modelers but several from aircraft modelers. The most detailed was the following by Jeff Herne, former Director of the New Jersey Aviation Hall of Fame and Museum.

Very early combustion engines didn't have spark plugs as we know them today. These plugs would be inserted into the engine block opening and the spark would result when the piston itself got close enough to the core of wires to arc across. Usually, it was just a hole, and a metal forked clip held the plug down, hence the term "plug". They were generally connected to a crude magneto usually driven by gear or friction drive directly from the crank.

Typically, these plugs didn't last long, which is why you'll find them all over the place and in large quantities. As the compressions in engines rose, neither the "plug" method nor the materials used could withstand the pressures, so the spark plug as we know it today, a threaded metal rod encased in ceramic, came along. We have early Curtiss examples dating back to 1909.

I'd place the time frame sometime between 1905 and 1910. We have an example of an early Boland engine dated 1908 that has missing plugs. I actually fabricated a pair that look very similar to this, from turned acrylic rod, to fit the engine. The openings are not threaded¹⁰.

All but one of the cylinders (24 of 25) were found in Unit B, half (12) of these in a cluster some 25 cm. across in the southeast quarter of the 10-20 cm. level and almost all the rest (10 of 12) elsewhere in the same level. This might suggest that they had been kept together in a container (e.g., a bag or box) that has deteriorated. Since most of the specimens appear to have been used, however, and it is difficult to imagine a re-use for them, it is hard to imagine why anyone would have retained them. It may be that the Unit B specimens were lost or otherwise disposed of in the course of a single event. An alternative might be that they reached their resting place simultaneously or at different times via a single route. Hangar One almost certainly had a wood floor¹¹. If the objects were plugs of the kind described by Jeff Herne, and had to be changed out

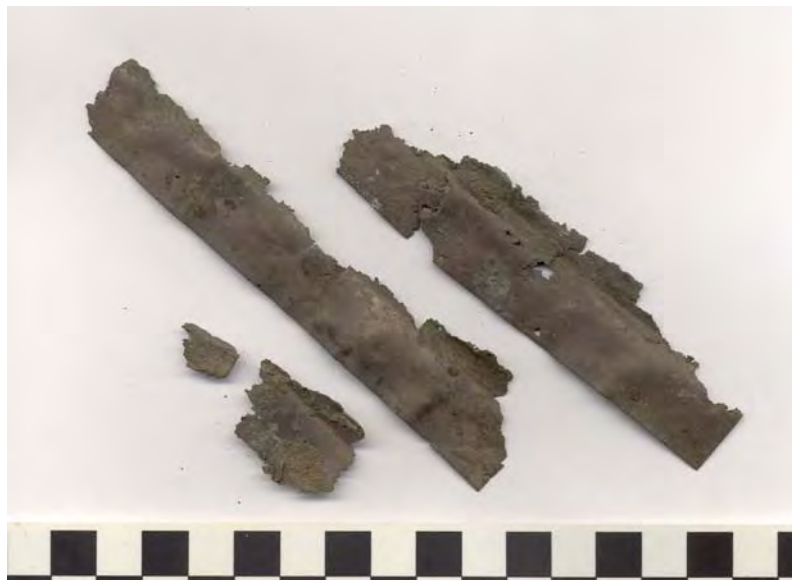
Figure 13: Sheet Metal Fragments

Five fragments of non-ferrous (probably brass) *sheet metal* are classified as machine parts though they could have been used for a variety of purposes. All appear to be from the edge of the same piece; they exhibit one cleanly finished edge with the rest badly deteriorated as though the remainder of the piece had corroded away. All pieces measure 1-3 cm. wide and four are less than 1 mm thick; the fifth is slightly thicker. There are small holes resembling tack holes along the finished edges of the longer pieces, and some evidence of a sort of corrugation parallel to the edge. They resemble some kind of covering for a small machine or instrument.

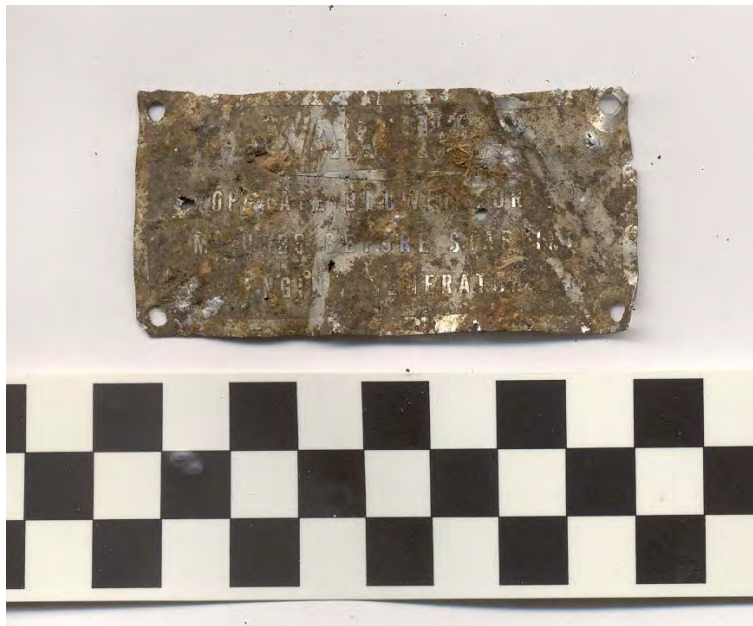
Figure 15: Warning Plate

A *generator warning plate* was found in the same unit. It is made of a non-magnetic metal, 7.5 by 3.3 cm. and less than 1 mm. thick, and bears the words:

WARNING
Operate Blower for ____
Minutes before starting
Engin(e) (G)enerator (Op)eration

Letters shown in brackets are inferred, though obscured.

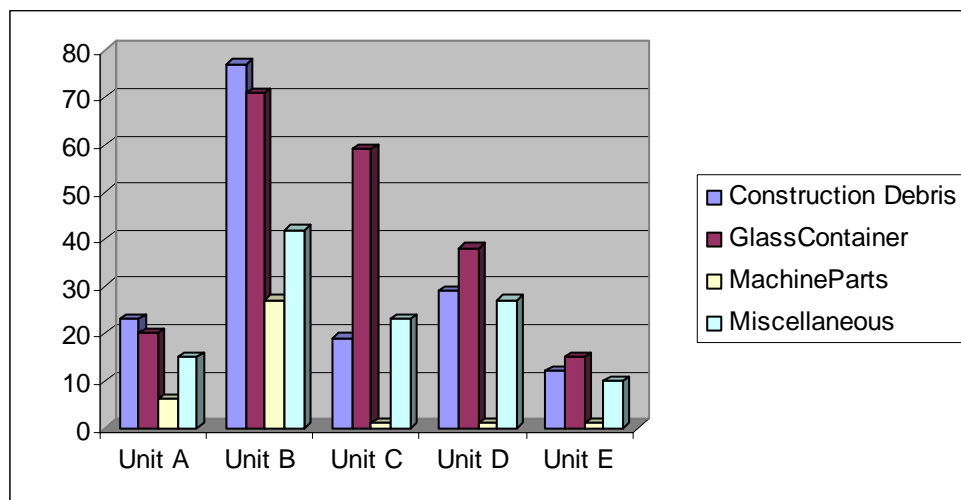
Figure 16: Distribution of Artifact Classes Among Test Units

Unit B, inside Hangar One, obviously produced the most of all classes of artifact, but was particularly rich in structural debris and glass container fragments. The presence of abundant structural debris is consistent with the documented burning and presumed subsequent clean-up of the building in late 1944. The reason for numerous glass containers is less obvious, but they presumably represent domestic use of the hangar at some point in its long life.

The fact that machine parts are common in Unit B is consistent with the storage and maintenance of aircraft and other machinery in the hangar. The near absence of such parts in Unit D – inside Hangar Two – is not consistent with the
