ARTIFACT 2-2-V-1 *

Found October 18, 1991.

Submitted to National Transportation Board (NTSB), Washington, D.C. for laboratory examination December 19, 1991.

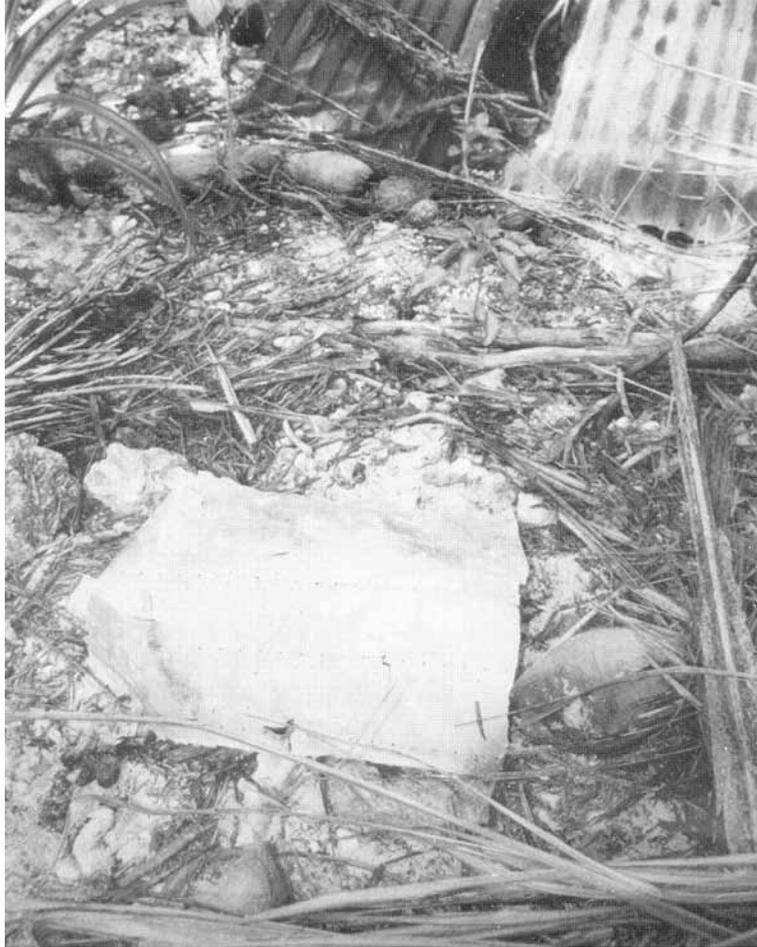
TIGHAR Photo by P. Thrasher

The photograph below shows the artifact in situ on Niku's western beach. It is a section of aluminum aircraft skin approximately 25 inches long by 18 inches wide and .032" in thickness. Four parallel rows of rivet holes of one inch pitch (space between individual rivets) evidence 92

rivets with a shaft diameter of $\frac{3}{32}$ ", one of which is still in place. The skin has failed along a fifth line of 14 rivets of $1\frac{1}{4}$ " pitch, $\frac{5}{32}$ " in diameter, except for one section about three inches long where there is an anomaly in the pitch. A detour in the tear at this point (visible in the photo as a "tab" along the top edge) suggests that there was once an external structure which served to reinforce the sheet at this point. Nearby, the letters "AD" are visible; traces of the word ALCLAD in the original manufacturer's labeling.

Tangled on one corner of the skin (the upper left in this photo) was a 30 inch length of 22 gauge, single filament copper wire with remnants of rubber insulation surviving in several places (visible only on the original color slide – it's pretty small).

The aircraft skin was lying amid the debris of beachfront vegetation torn out and washed up by huge waves which had hit the island's western shoreline sometime between our visit in 1989 and our return two years later. The corrugated metal visible in the upper right of the photo is the collapsed roof of a wooden frame building with "Gardner Co-Op Store 1940" painted over what was once the doorway. In 1989 the building stood intact, surrounded by a jungle of coconut and pandanus trees which extended westward (toward the bottom of the photo) about 50 feet. Beyond, open beach continued another 100 feet to the high tide line. The seaward side wall of the structure was pushed inward by the storm surge and most of the vegetation between the building and the beach was obliterated by the same force. On the first expedition we had thoroughly searched the old store (empty except for a bed frame, some rats, and a very dead cat) as well as the area around it. There was certainly no big chunk of airplane skin lying about at that time. It appears that the extensive beach erosion caused by the storm (apparently the worst in 52 years) churned the artifact up out of the sand and left it where we found it along the high water line. A further search of the beach and areas inland turned up a few more smaller pieces of wreckage which are still under investigation.

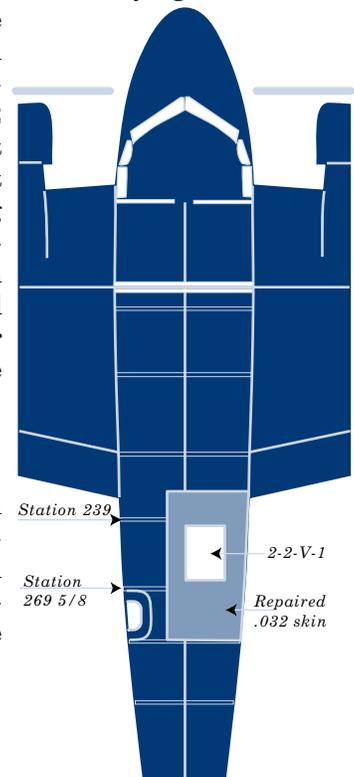
This artifact has been matched in every documentable respect to a section on the belly of Earhart's Lockheed 10E between Fuselage

Stations 239 and 269³/₈s (see diagram). With the help of NTSB, Alcoa Aluminum, and the National Air & Space Museum's Paul E. Garber Facility, TIGHAR has identified, documented and matched 12 separate aspects of the artifact with this specific area on the Earhart aircraft.

- Aluminum alloy: 24ST
- Surface treatment: ALCLAD
- Skin dimensions: Fits within those of Skin #35R on the Electra.
- Skin thickness: Identical to Skin #35R.

- Manufacturer's labeling: Identical to existing Lockheed 10s and unlike that used during World War II.
- Rivet head: AN455 brazier (a pre-war style largely superceded during World War II by the AN470 universal)

- Rivet alloy: A17ST (code AD)
- Rivet shaft diameter: $\frac{3}{32}$ "
- Rivet shaft length: $\frac{3}{16}$ "
- Rivet pattern: Four parallel lines of AN455 AD 3/3 tapering $\frac{1}{4}$ " over the length of the sheet.

- Failure pattern: The "tab" on the artifact, which indicates an external reinforcing structure, matches the position of the aft belly antenna mast on the Earhart aircraft.

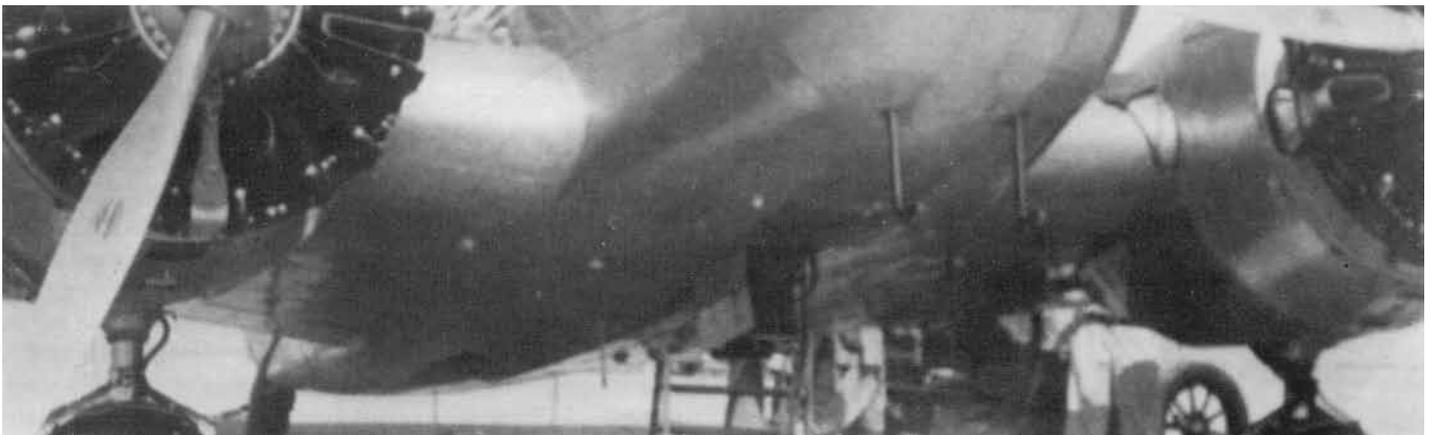
Through laboratory analysis of its physical features, and archival documentation of their significance, Artifact 2-2-V-1 has been shown to be identical, in every knowable aspect, to a particular and unique section of NR16020. At the same time, it has been shown to be unlike any part of any other aircraft known, or even rumored, to have been lost in the region. The conclusion is inescapable. This is a piece of Amelia Earhart's aircraft.
