CORROBORATION

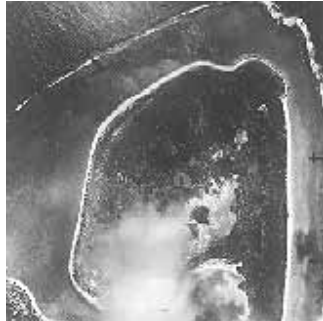
In these two aerial mapping photos taken in 1953, the large land mass is Nutiran district at the island's west end. The photo at left shows the white line of breakers on the fringing reef and the broad reef flat between it and the beach. The photo at right shows Tatiman Passage which leads into the lagoon. The roads and structures of the village can be seen on the land to the south of the passage.

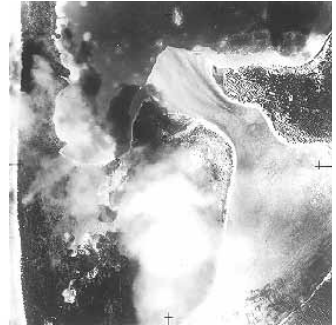
Enhanced enlargements of these photos, as processed by Photek, disclose four small (a few feet across) light colored objects visible down through an estimated three to four feet of water standing on the reef flat. In Photo 2 the fourth object is exhibiting a specular reflection characteristic of shining metal. This is the part of the reef flat where Ms. Taiki says she saw part of an airplane wing in the late 1950s.

identical to the reddish-brown of the coral. A debris field of aluminum wreckage should show up as small light spots distributed in a linear fashion. Any such anomalies would have to appear in at least two photos to insure that they weren’t flecks of dust or flaws in the developing process.

To find out if there was anything there we called on our old friend Jeff Glickman of Photek, Inc. of Hood River, Oregon. Photek’s state-of-the art digital imaging capabilities and Jeff’s forensic skills had already proved their worth in the Earhart investigation (see *TIGHAR Tracks* Vol. 11 No. 3 “The Earhart Electra, Part 2” and Vol. 12 No. 1 “The Niku III Preliminary Expedition”). A careful examination of the reef-flat in the indicated area revealed not only four objects which met the necessary qualifications for aluminum debris (light color, small size, linear orientation, appearing in two photos) but, in one photo, one of the light-colored objects was even exhibiting a specular reflection (the type of glint normally seen only from sunlight shining on metal).
