# The Wreck Photo

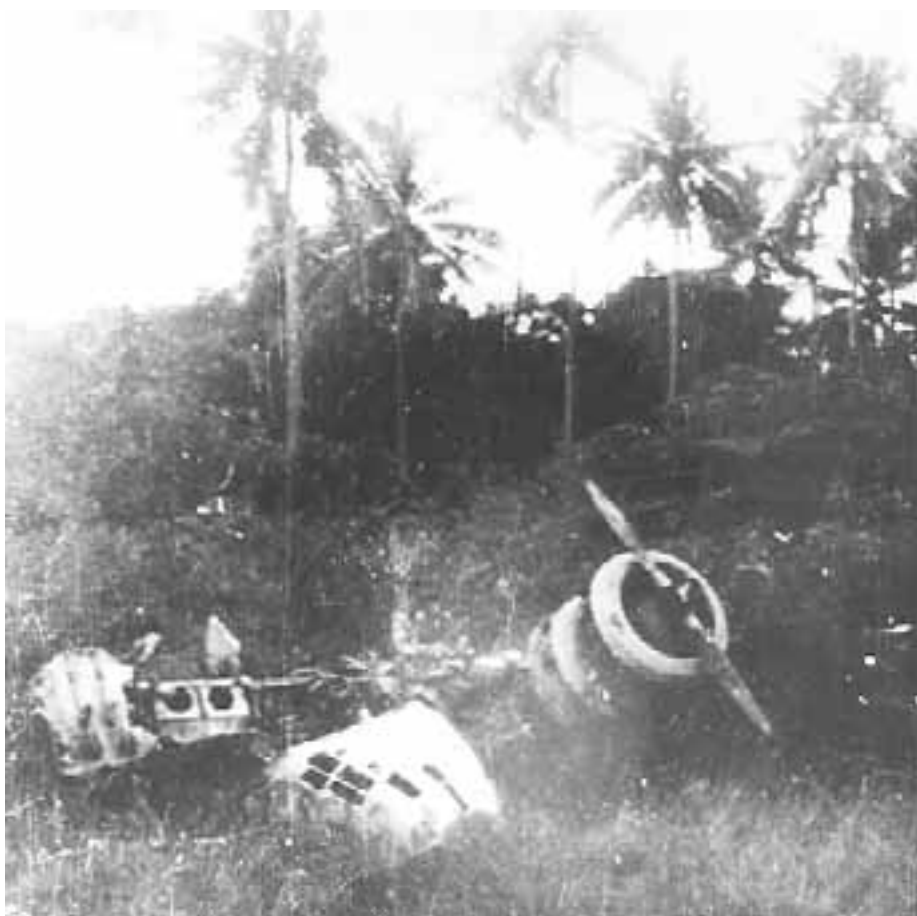
WITH THE HELP OF THE RAAF MUSEUM IN Point Cook, Australia and the Smithsonian's Paul E. Garber Facility in Suitland, Maryland we've been able to eliminate the Tachikawa Ki-54 as a candidate for the aircraft in the photo. The Lockheed Model 10 equipped with the Pratt & Whitney R1340 engine is now left as the only known type which features all of the structural elements visible on the wreck. The type of damage exhibited, details of the environment, and even the existence of a photograph, correspond well with anecdotal accounts of aircraft wreckage seen on Nikumaroro which are corroborated by forensic imaging of aerial photos of the island which appear to indicate the presence

of metal debris in a specific location. Based upon what we know at this time, this could be a picture of NR16020 on Nikumaroro.
