# TIGHAR TRACKS

**September 2003**

# DADOS GALORE

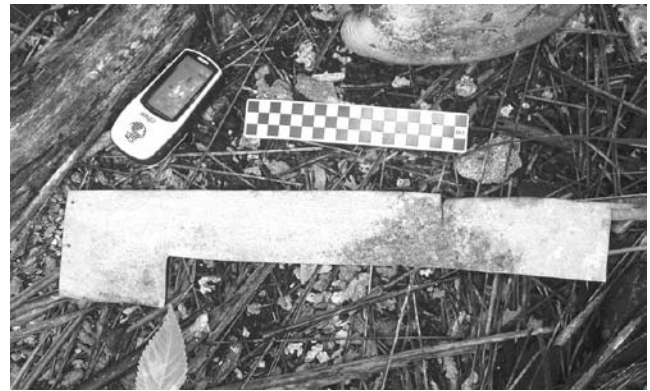
*Artifact 2-7-V-1, Dado. TIGHAR photo by V. Hunn.*

That is where our dado research stood until the Niku Vp expedition team returned with what are, without a doubt, the remains of at least two more dados found very close to where Artifact 2-1-V-18 was found in 1989. That these artifacts – 2-7-V-1 and 2-7-V-2 – are dados is apparent from the identical rivet size and spacing along the edges, the  $3/4$  inch inset of the mounting holes, and the presence of a small surviving section of the veltrim. The identification was confirmed by TIGHAR with the help of x-rays taken by conservators at the Maryland Archaeological Conservation Laboratories at Jefferson Patterson Park in southern Maryland. The lab is also taking appropriate measures to conserve the artifacts. TIGHAR is deeply grateful for the generous assistance of the dedicated scientists

The “new” dados are in much poorer condition than the 1989 find. 2-7-V-1 has been disassembled, pieces cut out, and one edge folded over several times. Because we’re missing one finished edge we can’t be sure how long it originally was. 2-7-V-2 was mostly buried and is in several pieces. Luckily, it had not been cut up and the finished edges were intact. Through expert recovery technique and good in situ photos, we were able to establish its original dimensions.
