2004 EARHART PROJECT EXPEDITIONS

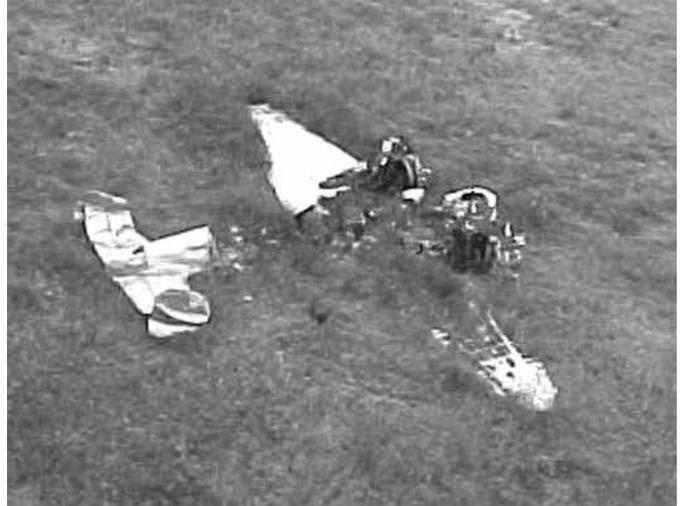
Because the fuel is in the inboard wing sections, post-crash fires often destroyed the cabin area. This is all that is left of c/n 1005 after it nosed over while making an off-airport landing in northern Canada.
