# DETECTIVE STORY

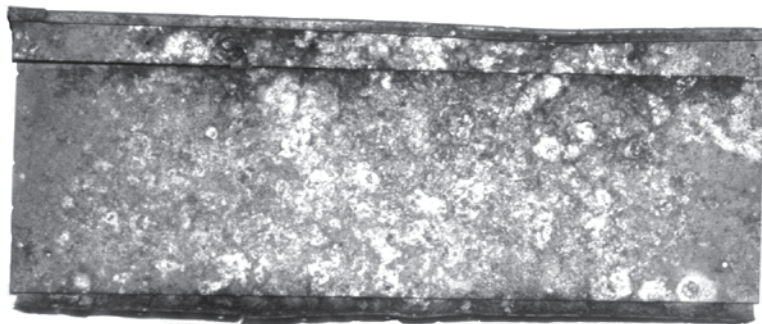
*Artifact 2-1-V-18*

**T**he first, and most complete, example was recovered during our very first expedition to Nikumaroro in 1989. We discovered Artifact 2-1-V-18 lying on the ground near the remains of the village carpenter shop. All we knew at the time was that it was an odd-looking riveted aluminum

structure with a fragment of some kind of insulating material stuck to one side.

Metallurgists at the National Transportation Safety Board (NTSB) laboratories in Washington, DC identified the alloys but couldn't tell us what the structure was used for. They did, however, manage to lose the insulation fragment. Seniors technicians at a shop that installs business aircraft interiors later identified the artifact as a "dado" – a panel, often insulated, which covers and protects the juncture of the aircraft's cabin flooring and the fabric-covered interior wall (see *TIGHAR Tracks*, Vol. 11, No. 3, September 11, 1995). Military aircraft do not normally feature dados. The only civilian aircraft known to have been wrecked on Canton Island was an FAA Constellation that crashed and burned in 1962. By that time, the settlement on Nikumaroro was already in the process of being abandoned.

Whenever we're confronted with an apparently unsolvable puzzle, we back up and re-examine the supposed facts of the case. Reviewing our reconstruction of 2-1-V-18, we found a mistake. Rust marks left by "Tinnerman" fasteners showed that two holes we had previously identified as "mounting holes" were, in fact, used for securing the insulation to the face of the dado. It seems like a small detail, but it changed everything. Without mounting holes, there was no way to attach the dado to the cabin wall. The only way to affix the object to anything was via the right angle flange along the bottom. The holes in the flange were not rivet holes but were, instead, meant to accommodate screws or, more probably, nails (as evidenced by pry marks on the underside of the flange).

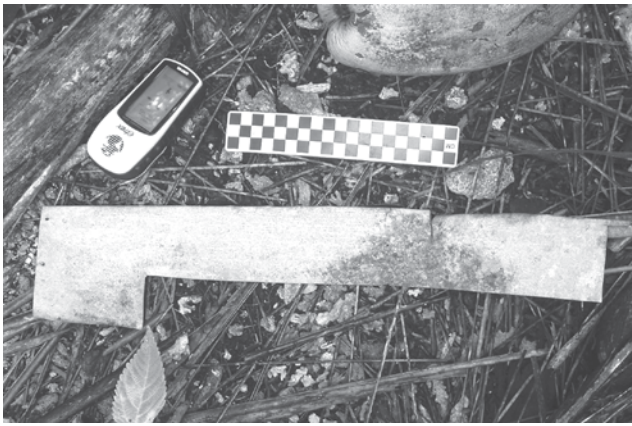
*Artifact 2-7-V-1*

Then, in 2003, TIGHAR's seventh expedition to Nikumaroro found two more "dados" near where we recovered the first one fourteen years before. These were somewhat longer and in much worse condition than 2-1-V-18 but they were, without question, the same type of component.

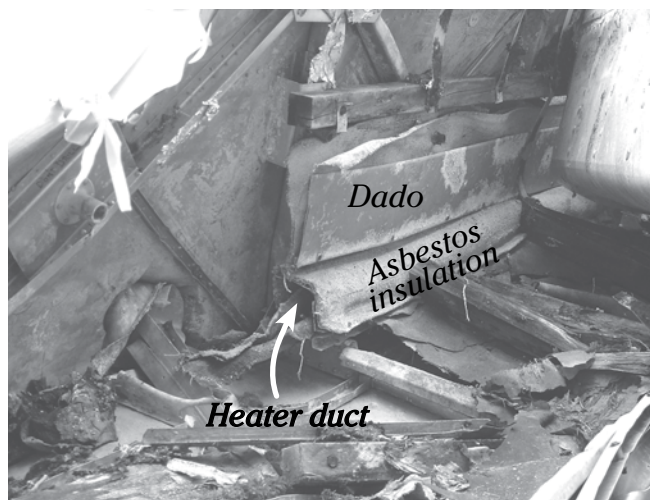
The Electra's cabin did feature dados, but they were nothing like the structures we found on Nikumaroro – much simpler, not insulated, not attached to the flooring,

and fastened to the fuselage with screws. A careful examination of the wreck in Alaska revealed that this particular Electra had been modified to carry a small auxiliary fuel tank in the cabin. Where the tank was close to the cabin wall, and only in that area, the heater duct was wrapped in heavy asbestos matting. This was unexpected, but welcome, confirmation that fuel tanks installed in an Electra cabin had to be insulated from the heater ducts.

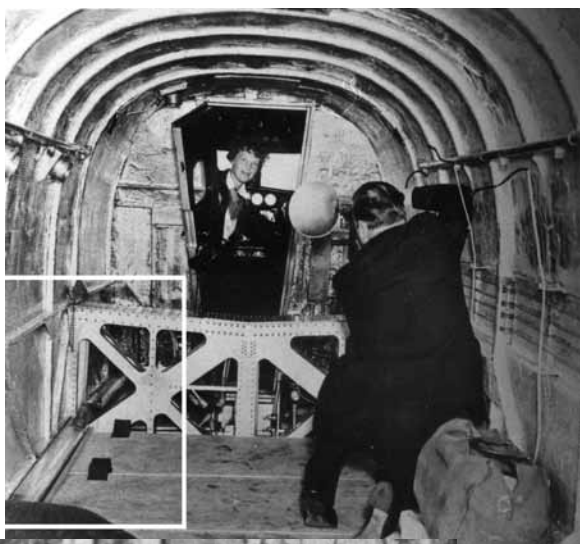
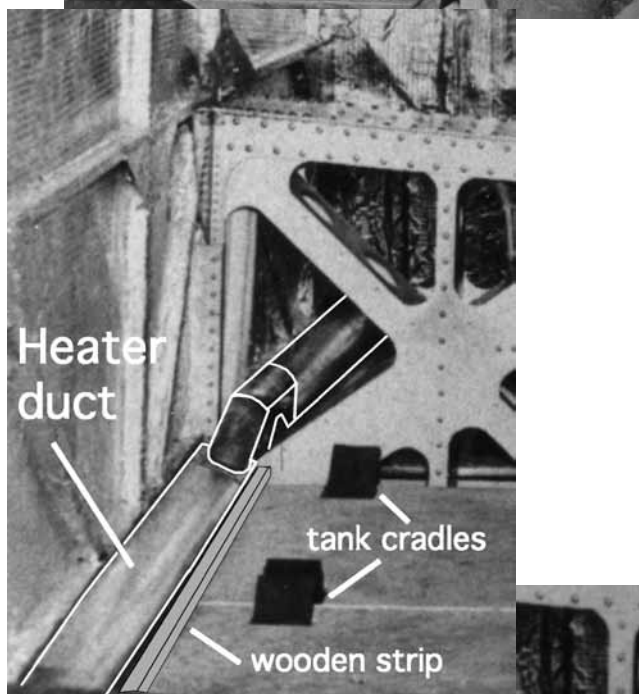
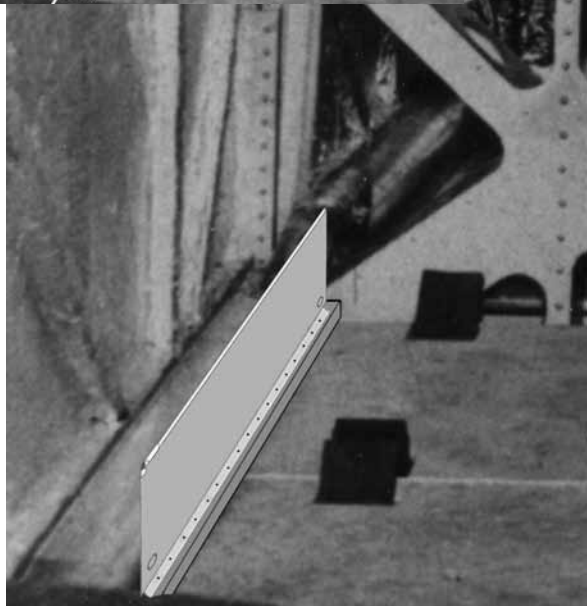
The same photo that shows the heater ducts, but no asbestos, in place just before the fuselage tanks were installed, also shows something on the floor beside the ducts (see next page). Running parallel and immediately adjacent to the heater duct on the left side of the cabin is what appears to be a piece of wooden molding perhaps one inch square in cross-section. Its precise placement suggests that it is installed rather than just tossed down. What is it for? Other Electras don't have anything there.

The tank in the Alaska wreck was mounted on a wooden frame, but Earhart's tanks seem to have rested directly on the floor, held in place by cradles attached to the flooring and padded metal straps anchored to the fuselage structure. The wooden strip could be to brace the fuselage tanks against side-to-side shifting (the heater ducts are easily dented), but the photo shows no provision for insulating the tanks from the heater ducts. Was the photo taken just before heat shields were nailed to the wooden strip? The Electra's flooring was divided into panels that could be removed to permit access to wiring and accessories, such as the flap motor, in the belly. Attaching the insulating barrier to a wooden strip would be better than nailing it directly to the floor. That way the whole assembly could be easily removed as one piece if one or more floor panels needed to be taken up.

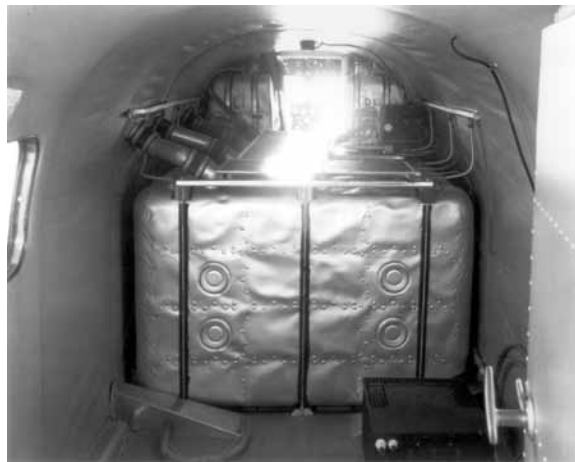
Unfortunately, once the tanks were installed, photos can't show what might be between the tank and the wall. So what's the

next step? After eighteen years of research we feel pretty confident that we have copies of all of the available photos of the Earhart airplane under construction. The same is true of engineering drawings. Lockheed diagram 42681, dated March 12, 1937, is a schematic of the fuel system for Earhart's Electra. It's good documentation of how the plumbing worked but it's of no help in answering this question. If drawings detailing
