# JULY 3 – 29, 2012

**L**ast summer's expedition to Nikumaroro collected new information about the underwater environment in the area we think holds whatever is left of the Earhart Electra but, although analysis continues, the expedition did not return with conclusive imagery of airplane

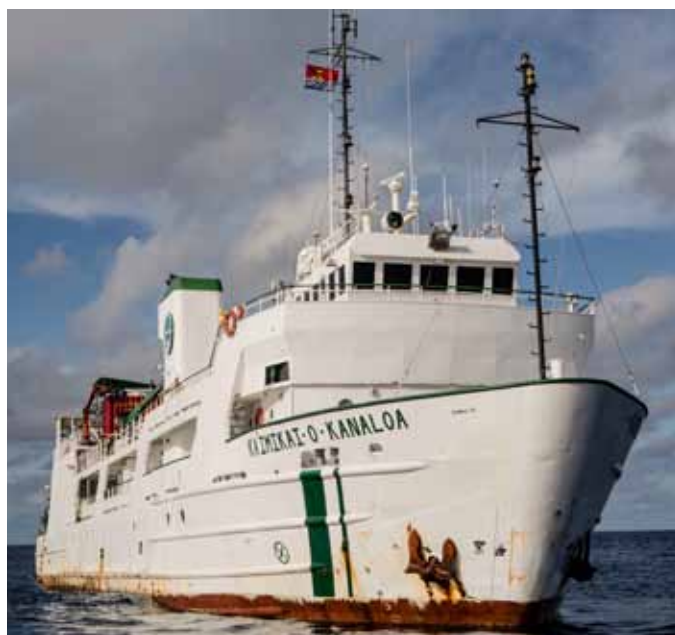
*The expedition vessel was the University of Hawaii oceanographic research vessel R/V Ka'imikai-O-Kanaloa or more commonly "KOK." The ship would map the underwater environment in the search area using its hull-mounted SeaBeam multi-beam sonar. TIGHAR photo by L. Rubin.*

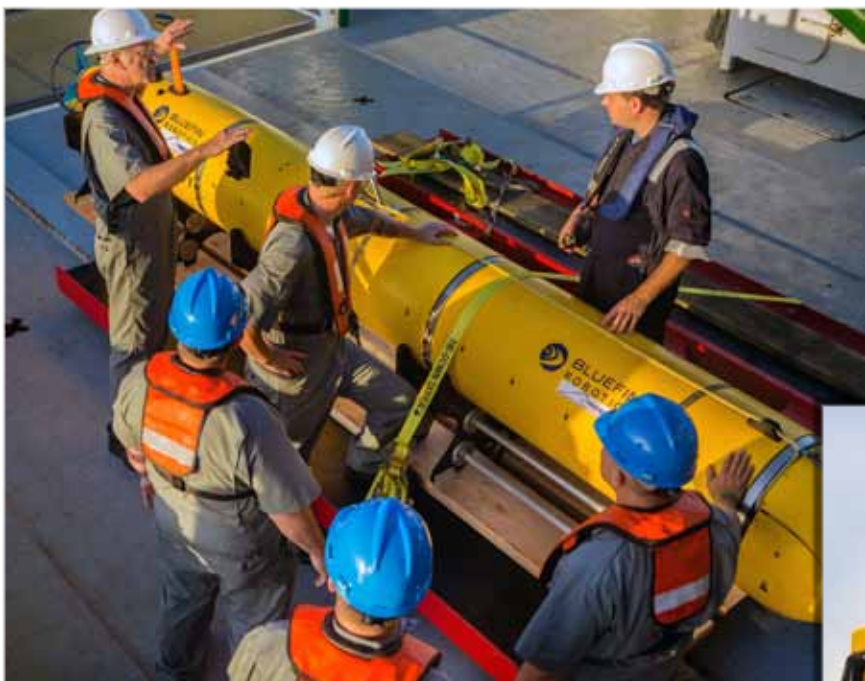
*The primary search contractor for Niku VII was Phoenix International of Largo, MD. Five Phoenix technicians, assisted by two technicians from Bluefin Robotics of Quincy, MA would collect side-scan sonar imagery using a Bluefin 21 autonomous underwater vehicle (AUV). TIGHAR photo by L. Rubin.*

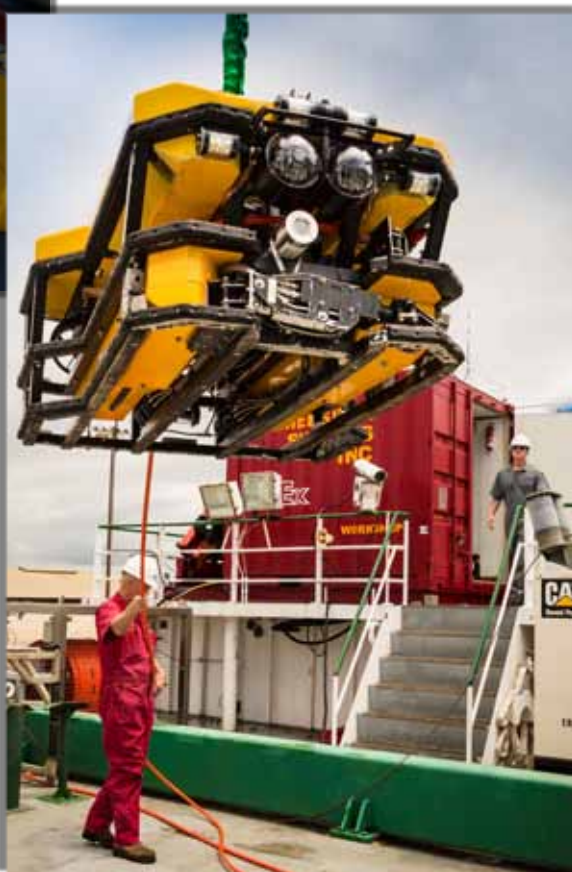
*Targets identified by Phoenix would be investigated by sub-contractor Submersible Systems, Inc. (SSI) using a TRV-M Remote Operated Vehicle (ROV) equipped with a High-Definition video camera provided by Phoenix. TIGHAR photo by L. Rubin.*

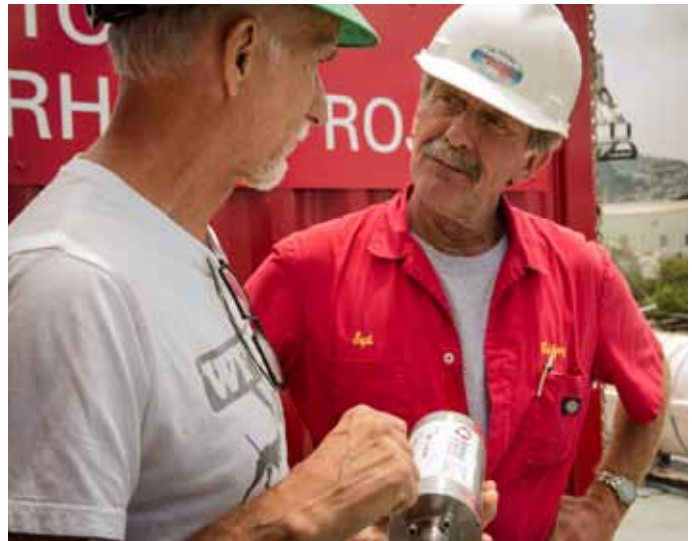
*TIGHAR cameraman Mark Smith and ROV pilot Wolfgang Burnside with the High-Definition video camera. "Somehow we have to get this thing working." TIGHAR photo by L. Rubin.*

The HD camera to be used on the expedition has been rented by Phoenix. Wolfgang has seen the manual but he had never seen the camera until he arrived in Hawaii. From reading the manual, Wolfgang knew he was going to have to splice a connector for the camera into the ROV tether. This will create a potential weak spot in the tether at depth but it's the only way to connect the camera. What Wolfgang didn't know was that there is a fundamental mismatch between the camera's capabilities and the ROV system with which it is to be used. The camera will not be controllable from the surface and it might not be possible to trigger HD recording at all. This is a major crisis. There is no point in conducting the expedition without an operational HD camera system. With departure scheduled for the morning of July 2, we have three days to get it working.

More problems with the HD camera. Even if Mark can get it working, we will not be able to get high resolution still photos as we had expected and the quality of the HD video will be marginal at best. It turns out that the camera is merely a consumer-grade Sony HandiCam in a waterproof housing. Its default resolution is 9 megabits per second – at the bottom end of the HD spectrum and totally inadequate for our purposes. The camera can be manually set to 24 megabits per second – barely broadcast quality – but only after it is running. Maximum recording time at this bit rate is about 6 hours. Since we need to trigger recording before the ROV is launched we'll waste some of our sub-surface record time getting the sub launched and down to the depth we want to operate in.

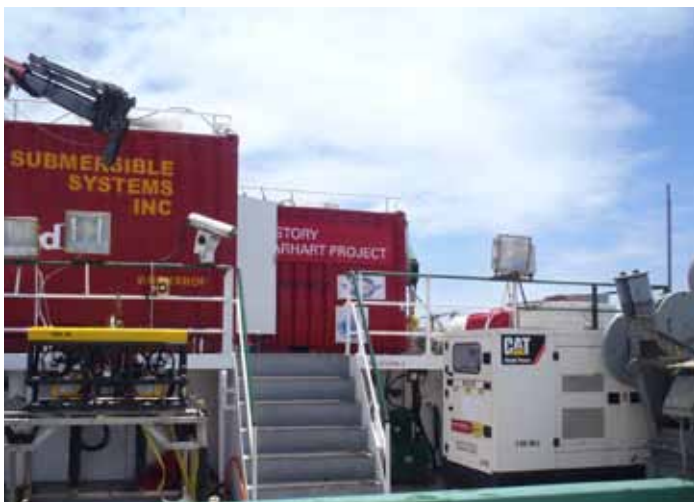
*The addition of a dedicated generator (white unit at right) to the ROV system solved the "dirty power" problem. TIGHAR photo.*

A dedicated generator for the ROV is located, arrives, and is lifted aboard. If it doesn't solve the "dirty power" problem it will mean that there is a flaw within the ROV system, but tests indicate that it does solve the problem and it gets welded to the deck.

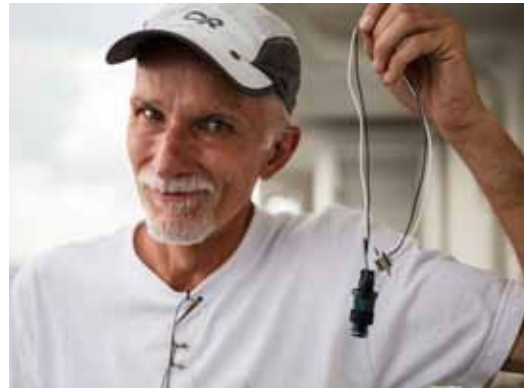
*Mark Smith with the connector that proved to be the key to making the HD underwater video camera at least marginally operational. TIGHAR photo by L. Rubin.*

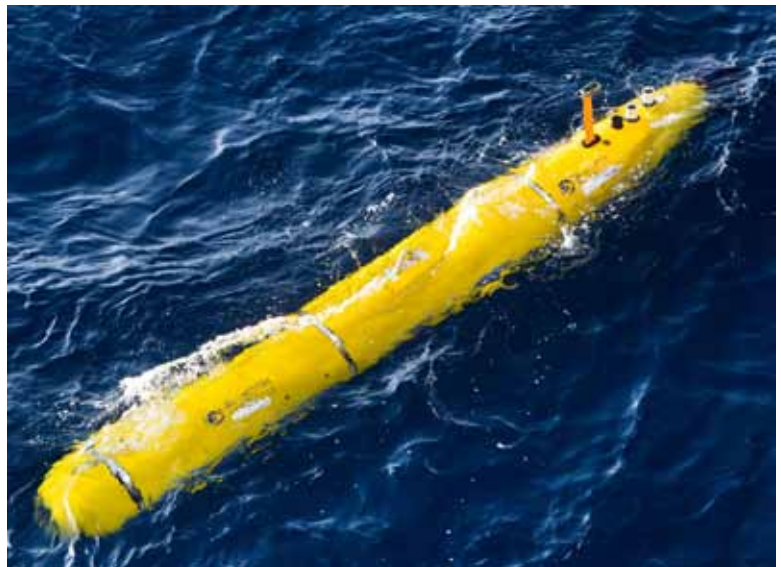
*The AUV must be properly balanced and ballasted. TIGHAR photo by L. Rubin.*

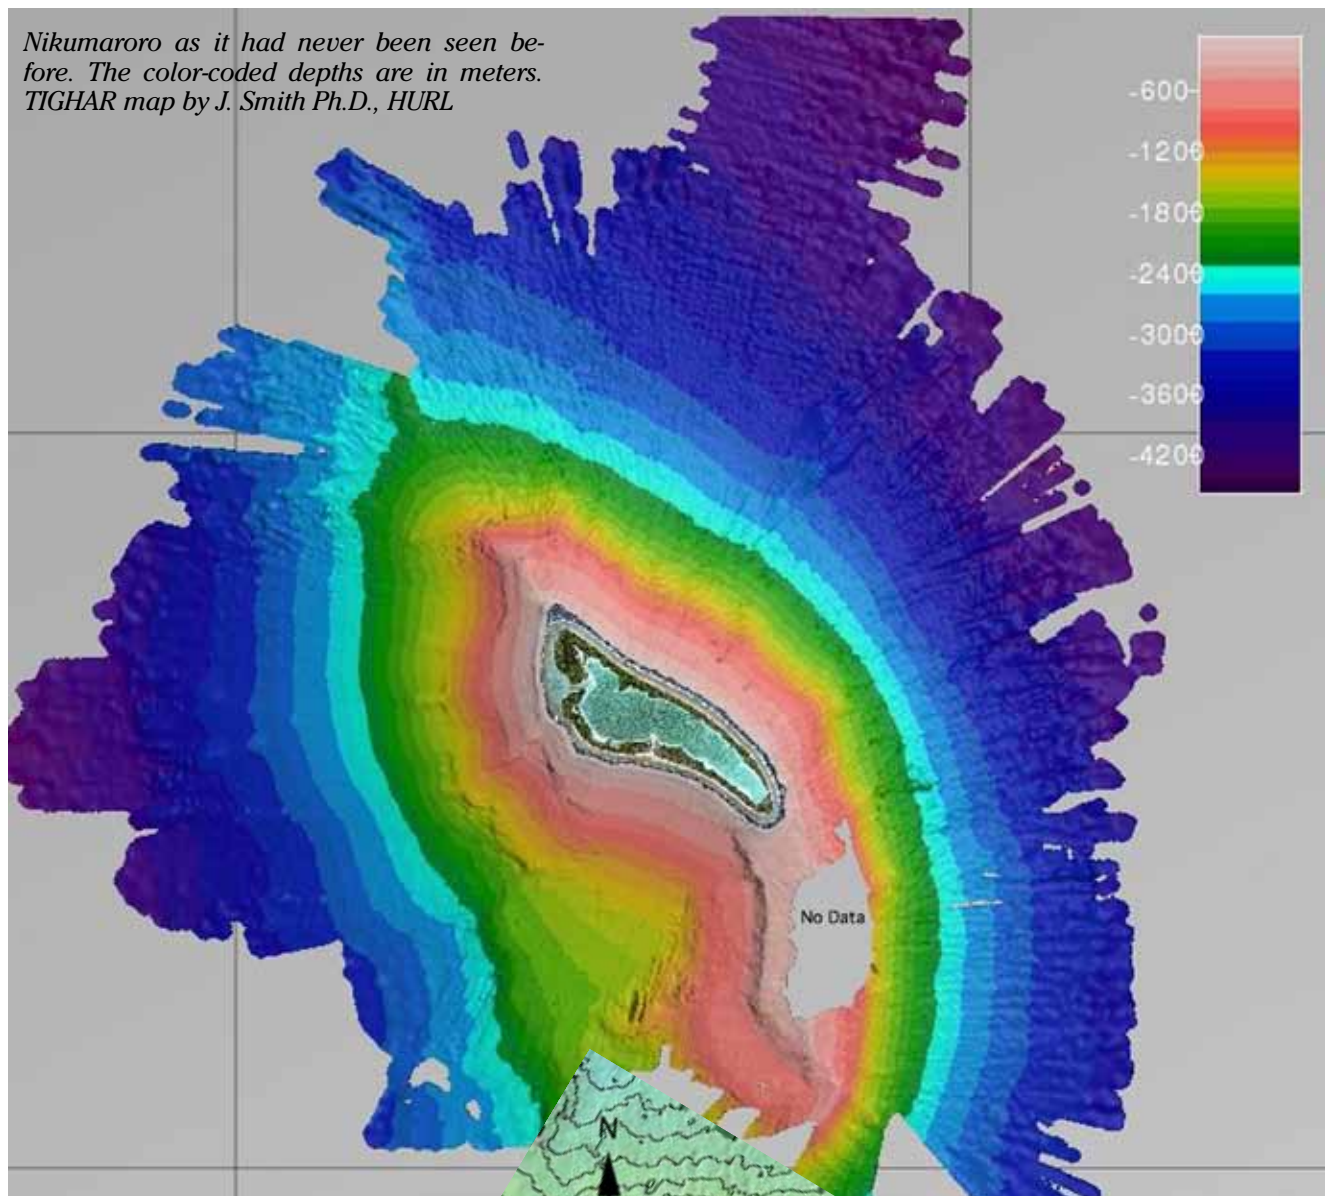
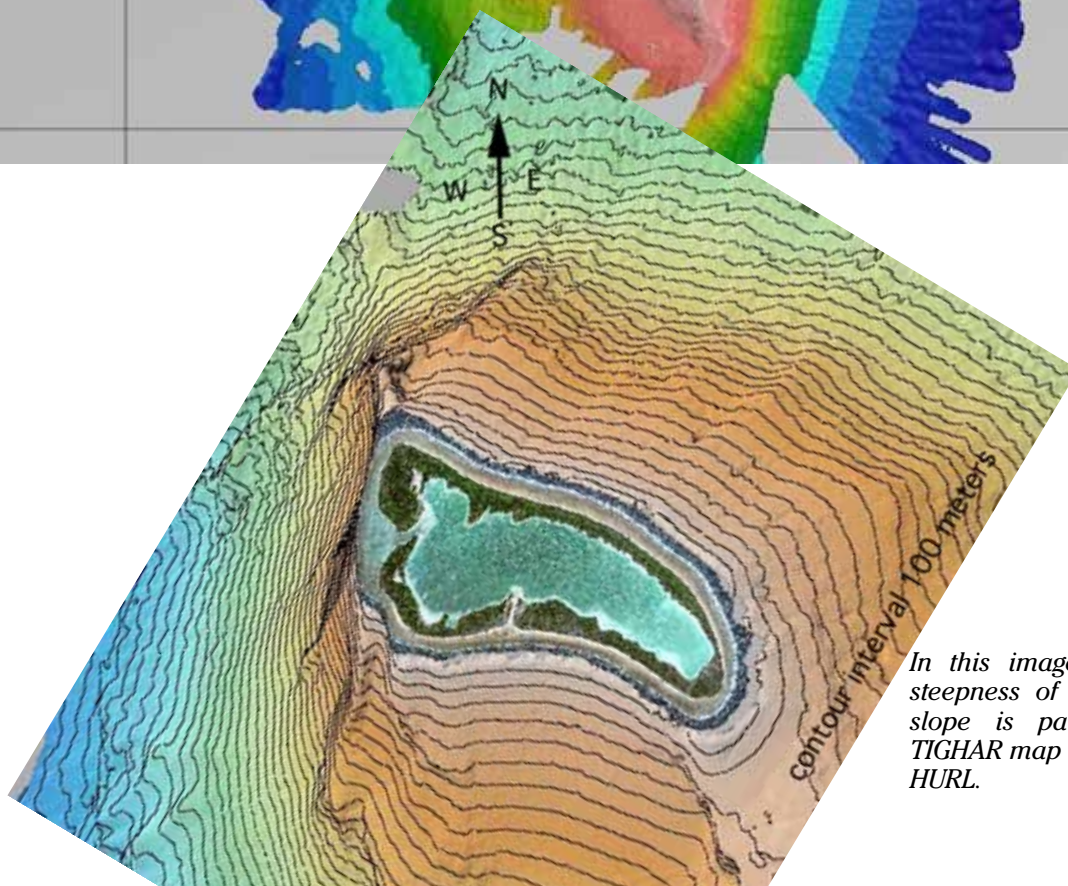
*Nikumaroro as it had never been seen before. The color-coded depths are in meters. TIGHAR map by J. Smith Ph.D., HURL*

*In this image, the staggering steepness of the western reef slope is painfully apparent. TIGHAR map by J. Smith, Ph.D., HURL.*

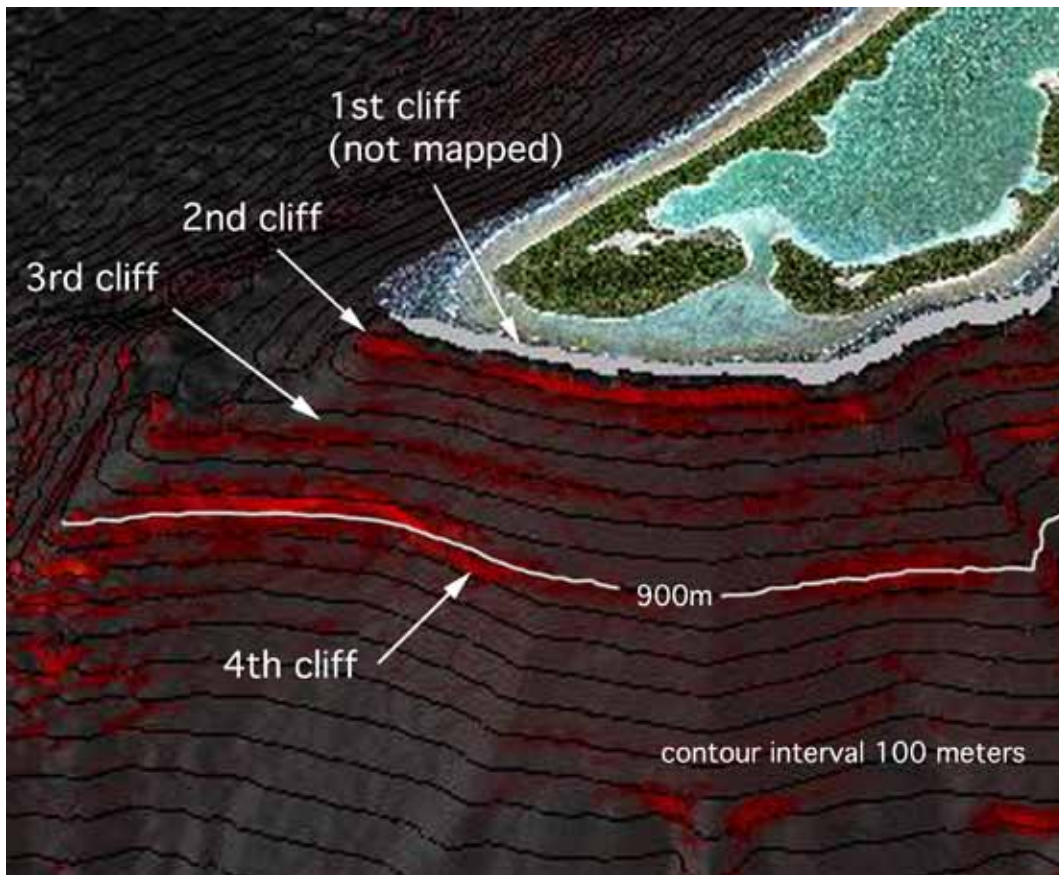
*In this image, the red areas indicate extreme "rugosity." Nikumaroro's western reef slope is a series of four virtually vertical cliffs. The first cliff is close to the reef edge in water too shallow to map. The ROV could investigate down to a maximum depth of roughly 900 meters (2,952 feet). TIGHAR map by J. Smith Ph.D., HURL.*

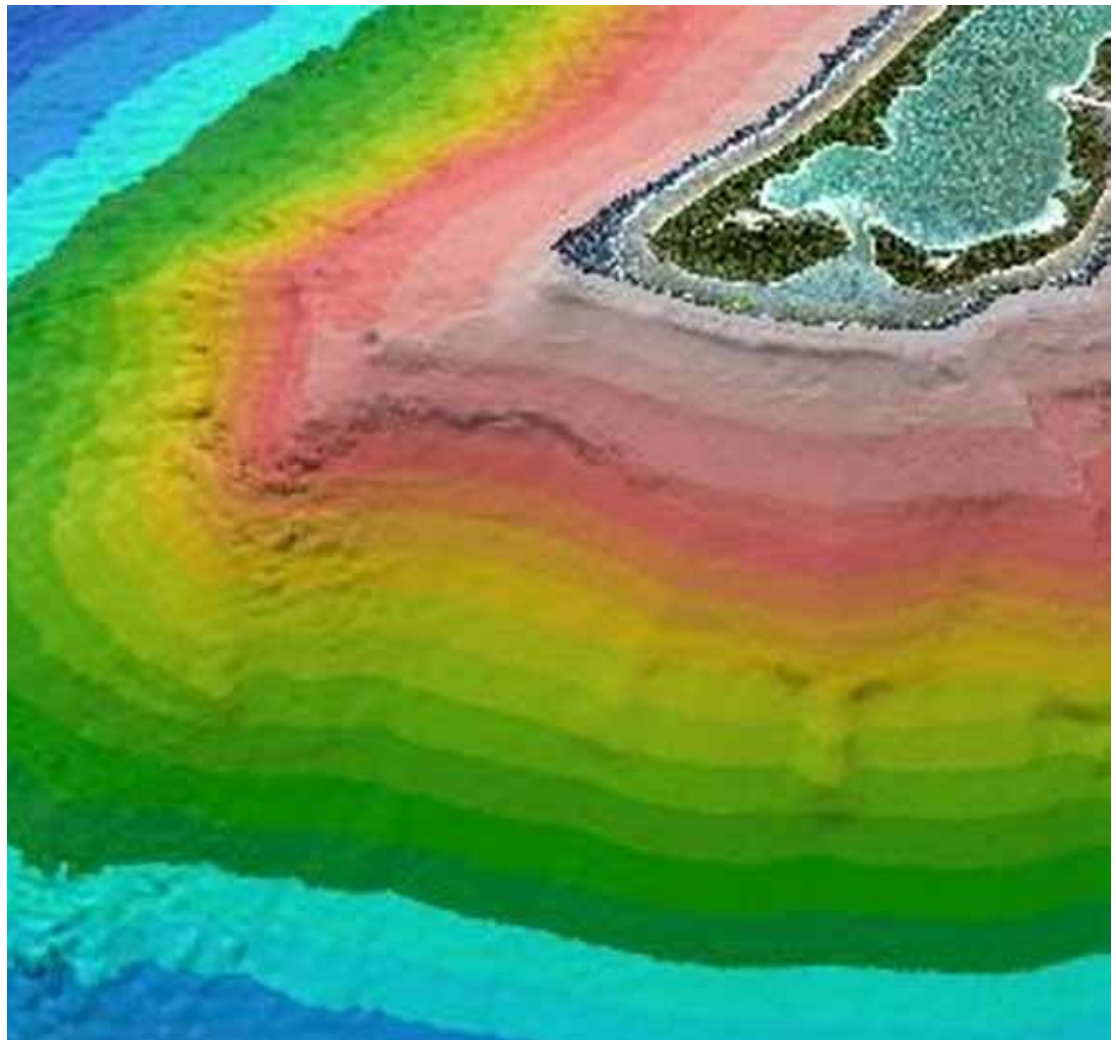
*Although extremely useful for mapping the daunting underwater landscape, the SeaBeam sonar lacks the resolution necessary to see wreckage. TIGHAR map by J. Smith, Ph.D., HURL.*

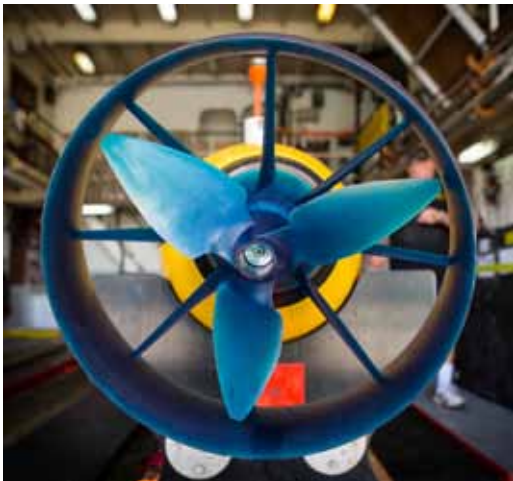
*The AUV's articulated propulsion system. TIGHAR photo by L. Rubin.*

AUV is repaired. Prop was not turning on prop shaft. Ready to deploy on another test as soon as ROV is recovered.

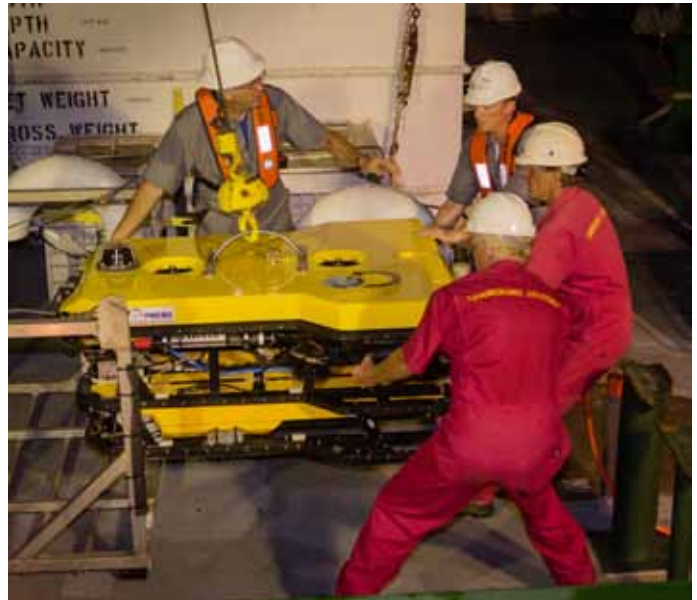
*Launching the ROV. TIGHAR photo by L. Rubin.*

The need to make a deep dive so soon worried Wolfgang Burnside, the ROV pilot. The tether for the ROV had been modified to accommodate the feed for the high-definition video camera and the seal had not had time to properly cure. If the seal failed at depth it would flood and ruin the tether. No tether, no ROV – but with a \$2 million dollar AUV needing immediate rescue there was no choice but to deploy the ROV as quickly as possible. (TIGHAR photos by L. Rubin.)

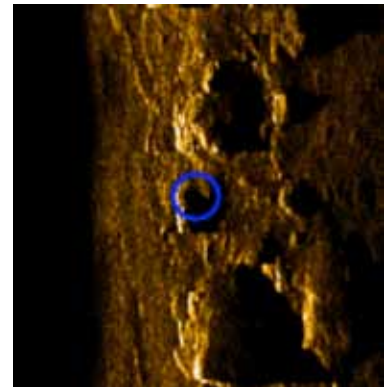
*The blue circle designates side-scan sonar target 14\_0048. Categorized by Phoenix as a "strong 2" – anomalous object, possibly man-made, roughly 2 x 6 meters with one sharp right-angle corner, this target was at a depth of 520 meters (1,705 feet) and directly offshore the Bevington Object location.*

The aborted run produced one "strong 2" target. Anomalous object roughly 2 x 6 m with one sharp right angle corner.

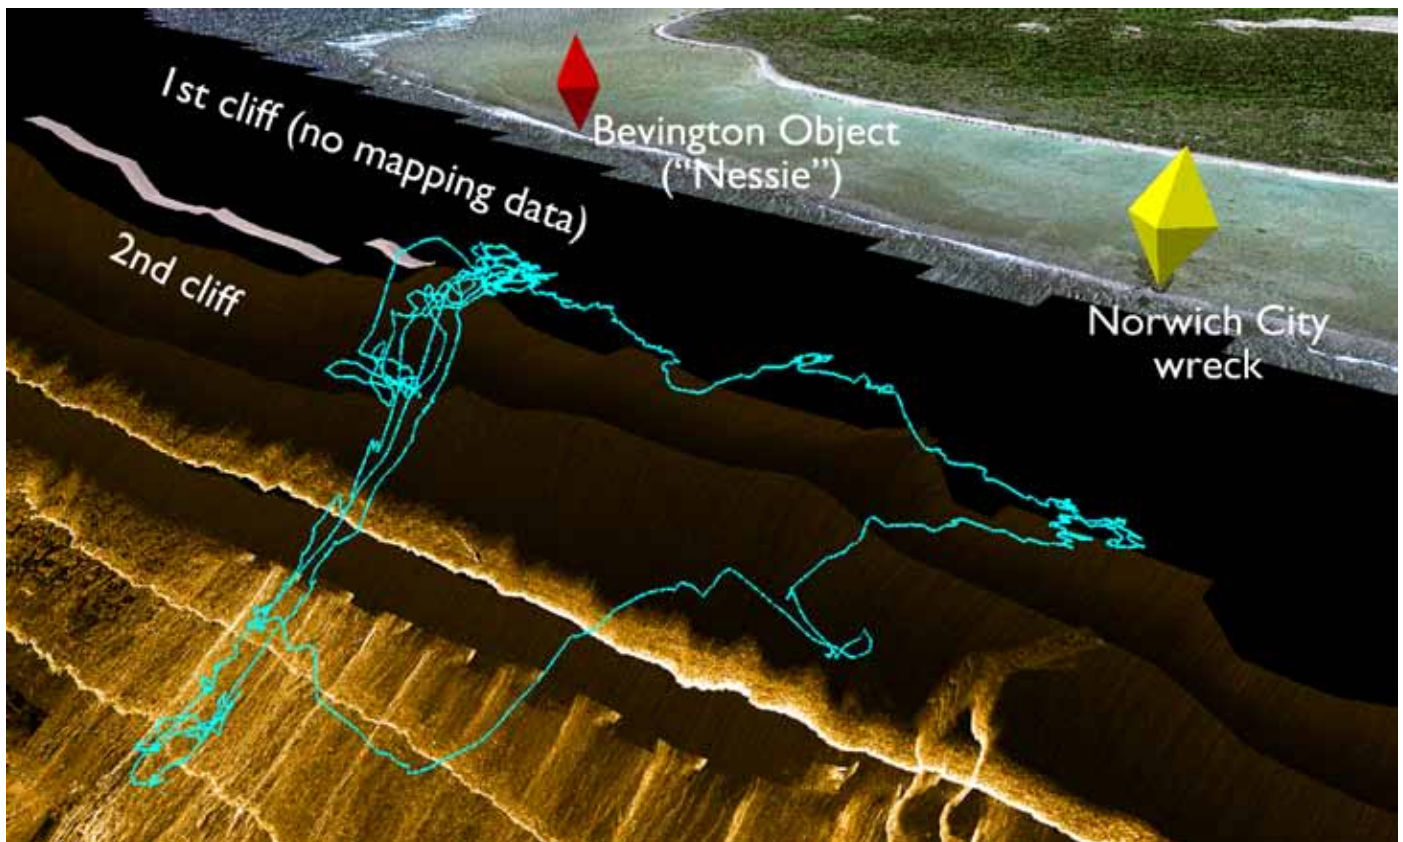
*In this schematic of ROV Dive 3 on July 14, 2012 the yellow pyramid marks the shipwreck on the reef and the red pyramid marks where the Bevington Object appears in the 1937 photo. The blue line is the track ("snail trail") of the ROV against the brown side-scan sonar map of the reef slope. HURL Graphic by J. Smith, Ph.D.*

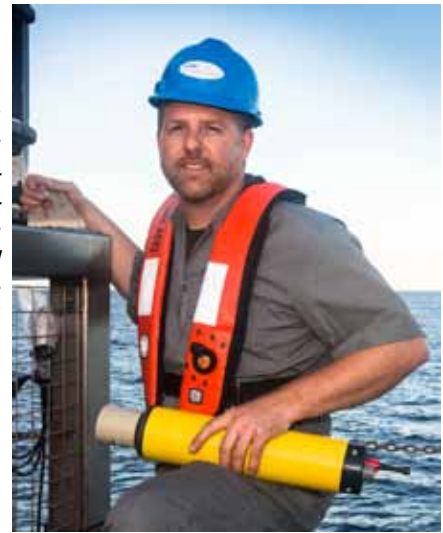
*Phoenix technician Jesse Doren with the SonarDyne acoustic positioning beacon that had to be transferred back and forth between the AUV and the ROV. TIGHAR photo by L. Rubin.*

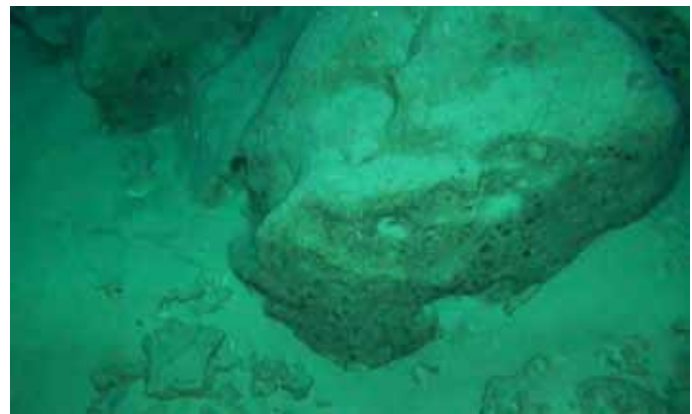
*Searching the reef slope at depths below about 300 meters (984 feet) is like exploring a rugged mountain side with a flashlight on a dark night in a snow storm. TIGHAR screen capture from HD video.*

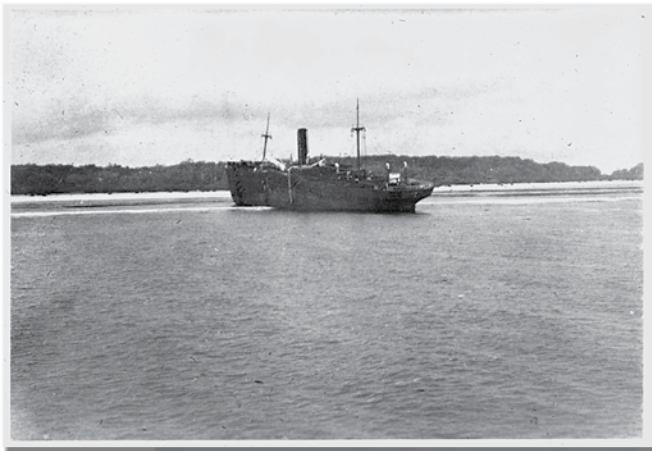
*This 1935 photo is the earliest known picture of SS Norwich City aground on the reef. The stern half of the ship, aft of the funnel, broke off and tumbled down the reef slope in 1939. TIGHAR collection.*

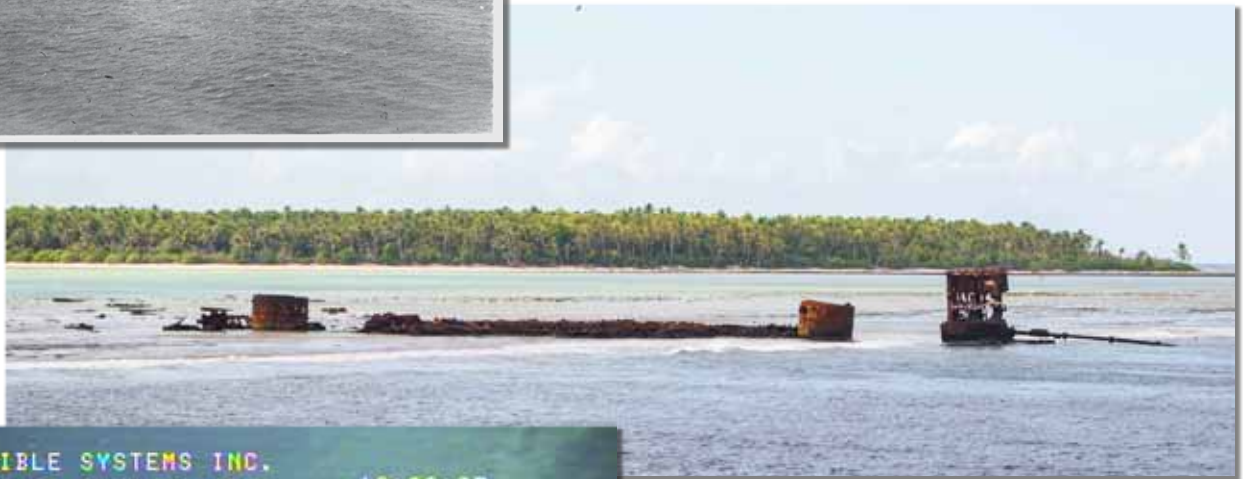
*SS Norwich City in 2012. The triple-expansion steam engine with protruding shaft was below the funnel in the 1935 photo.*

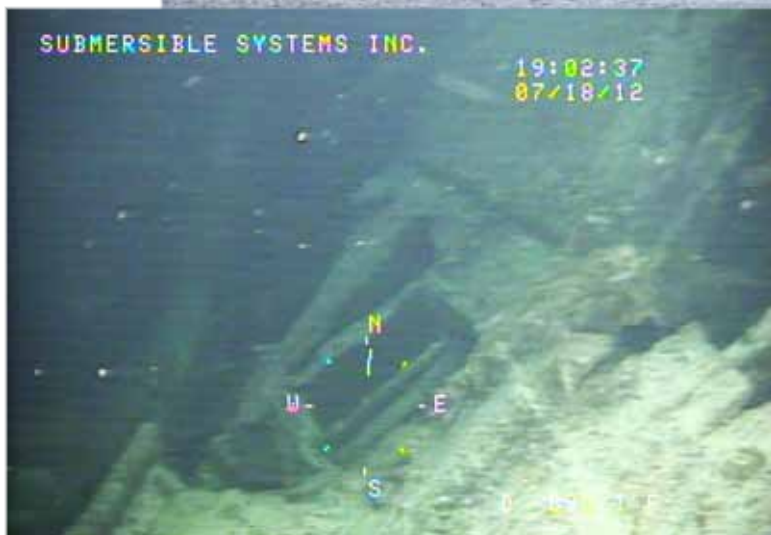
*Some of the wreckage of the stern half of SS Norwich City. Category 2 targets were turning out to be mostly coral boulders, and the problem-plagued AUV had failed to see a towering mass of ship wreckage. TIGHAR screen capture from ROV video.*

Another AUV-acquired target just north of the wreckage proved to be a heavy metal hatch, almost certainly *Norwich City* debris but reassuring in that at least it wasn't a rock. Less encouraging was the realization that the AUV had not seen the far larger main body of wreckage.

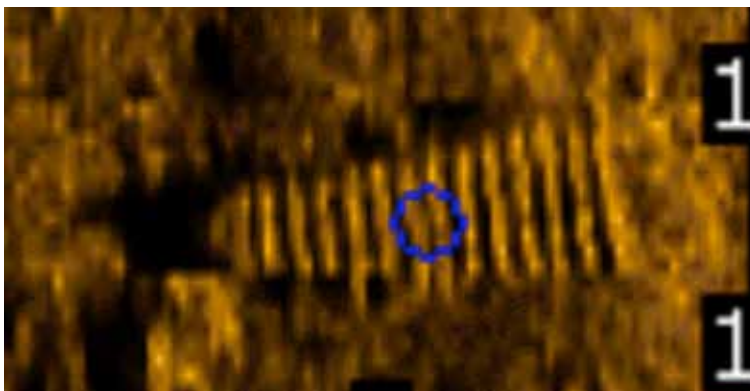
The target is a series of 12 parallel lines similar in shape and dimensions to an Electra outer wing panel. The AUV passed over it from several angles and the returns are consistent. Sonar often cannot see aluminum skin but picks up internal structure. There are twelve ribs in an Electra outer wing panel.

The target of special interest soon became known as the "wing target." TIGHAR sonar image by Phoenix International.

Initial plot of the target's position put it in 400 feet of water slightly north of *Norwich City*. We couldn't find it there. Refined plot put it at 1,000 foot depth roughly 10 meters southwest of the main body of NC wreckage. This is an extremely hazardous environment for the ROV with great danger of tether entanglement in the heap of ship wreckage. Also, increasing wind and sea conditions made *KOK* less stable. After struggling for two hours we ultimately called it off and returned to running search lines. We'll try again tomorrow.

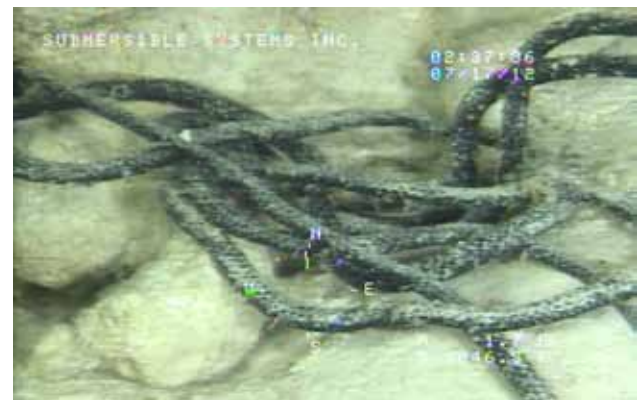
Examined and photographed tangled strip of black material at 1,100 feet. Appears to be man-made, possibly a gasket from around a hatch or door. Did not recover but feel we can find it again if necessary.

Found at a depth of 319 meters (1,046 feet), this object was later matched to sealing material of a type in use aboard *KOK*. TIGHAR screen capture from HD video.

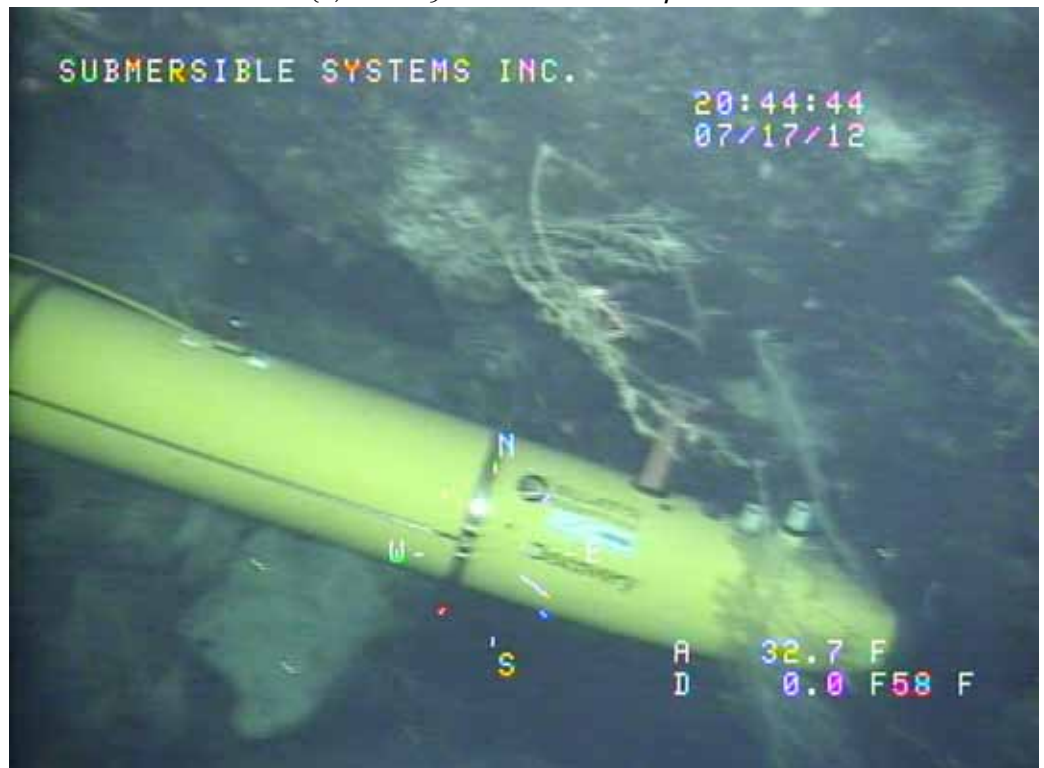
*The AUV was found stuck in a cave on the face of the 3rd cliff. Actual depth was 716 meters (2,349 feet). TIGHAR screen capture from ROV video.*

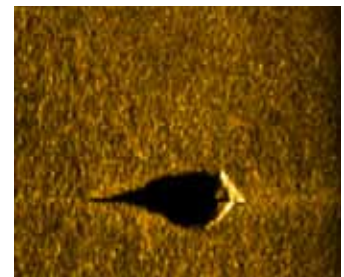
*We called this sonar target "the TeePee." It was all by itself on a fairly level plain far to north of our primary search area. Phoenix felt there was a high probability that it was a man-made object. It's a rock. TIGHAR sonar image by Phoenix International.*

Found and identified target. It's a large rock. Broke off search to recover ROV and relocate to continue mowing the lawn.

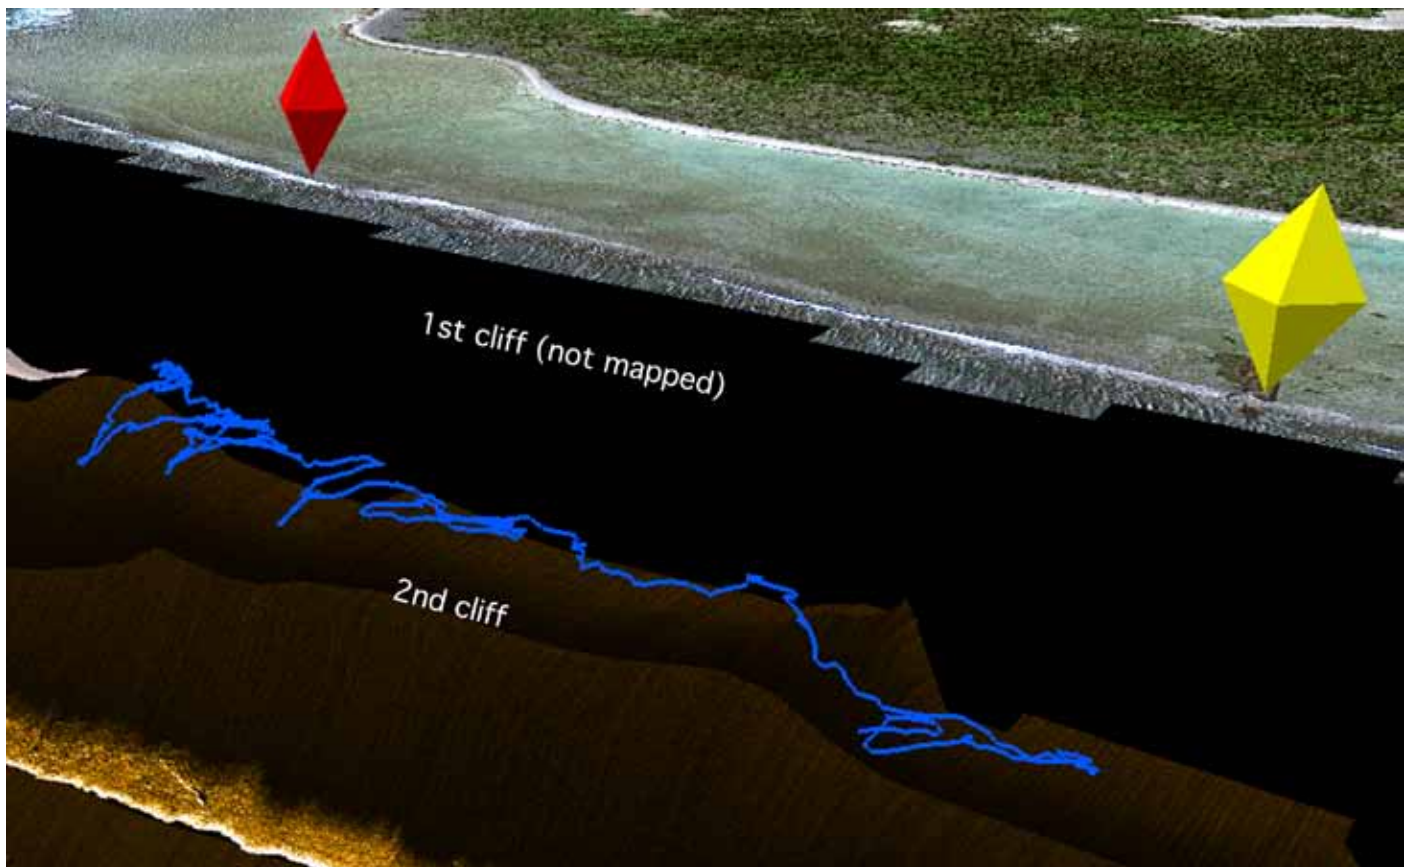
*ROV Dive 13 explored a relatively level area at the base of the first cliff.*

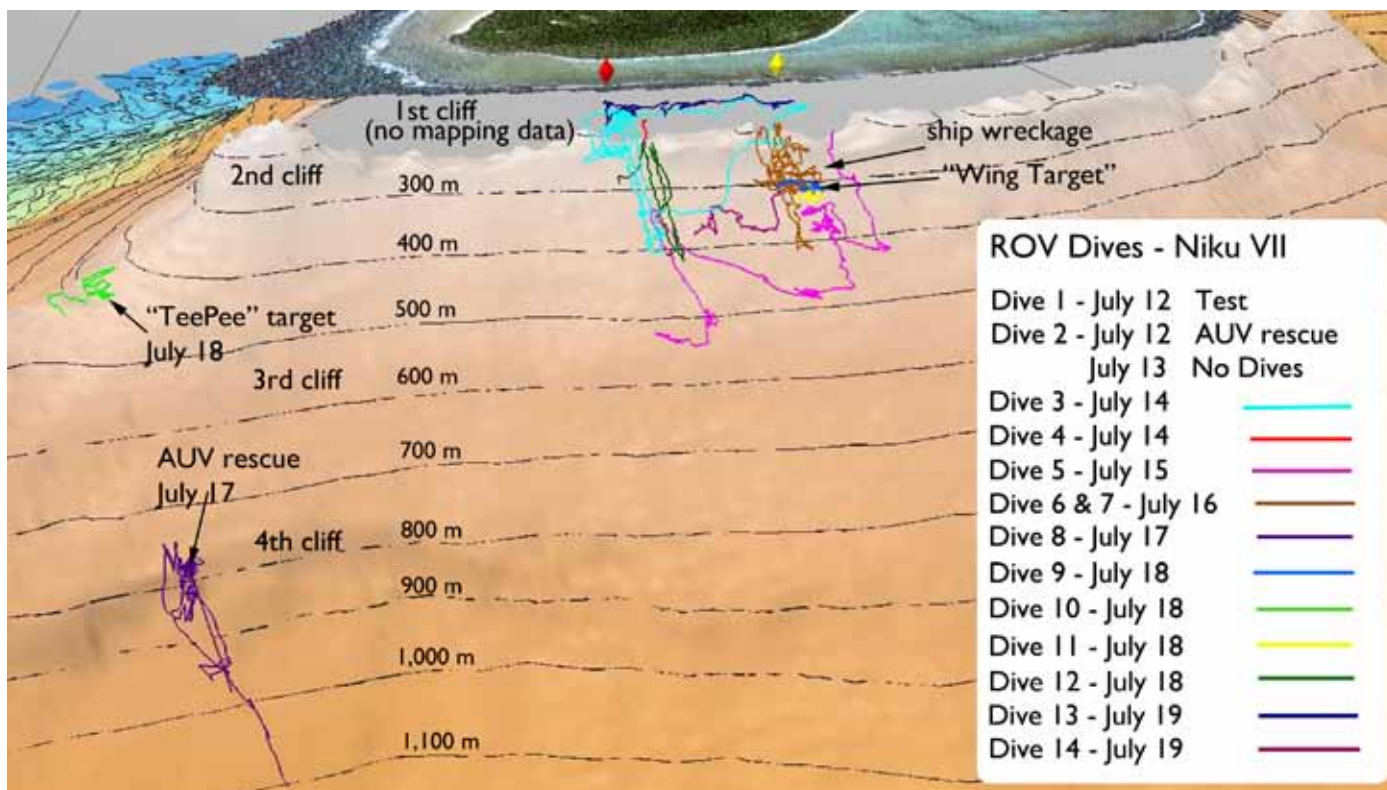
The color-coded lines trace the "snail trail" paths of the ROV on each of its dives.

This map combines data from all three technologies used during Niku VII. The underlying SeaBeam map is overlaid with the side-scan sonar data collected by the AUV and the ROV "snail trails." Note that some parts of the reef slope below the Bevington Object (red pyramid) were too steep for side-scan sonar coverage.
