THE OBJECT FORMERLY KNOWN AS NESSIE

ORIGIN OF THE PHOTO

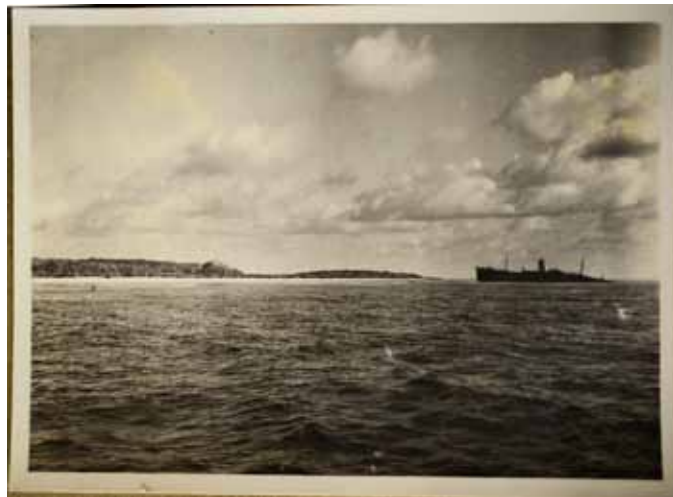
The Bevington Photo measures 2.5 by 3.5 inches and is reproduced here actual size.

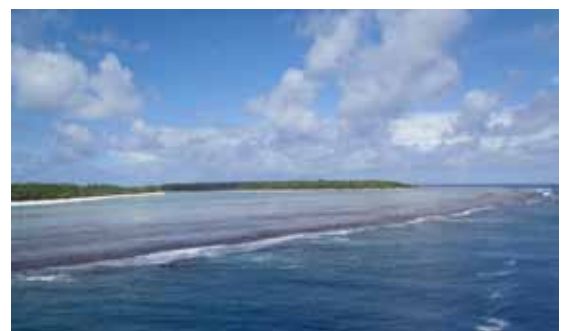
Nikumaroro is surrounded by a broad, flat reef that dries at low tide.

The broad, flat expanse of hard coral which surrounds the island's shore dries at low tide to provide a very attractive surface upon which to make a forced landing. However, a disabled aircraft on that reef-flat would, at high tide, be partially afloat in 3 to 4 feet of water. Over a period of a few days tidal cycles would move the aircraft inexorably toward and ultimately over the edge of the fringing reef. From there it's a steep plunge to depths of 2 to 4 thousand feet.

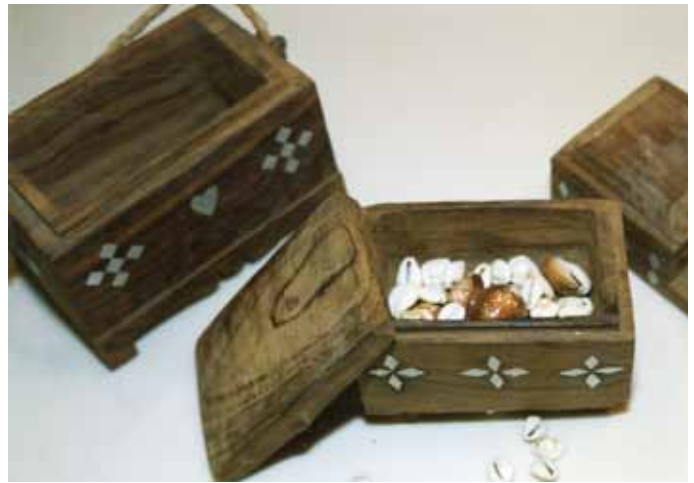
Carved wooden boxes inlaid with metal "from the wrecked plane."

Dr. Mims let us remove one of the inlaid pieces of aluminum and have it tested. It's 24ST AL-CLAD, the kind of aluminum sheet used in the construction of Earhart's Electra – and virtually every WWII American aluminum aircraft – but Mims was on Gardner before the locals had access to WWII wrecks.

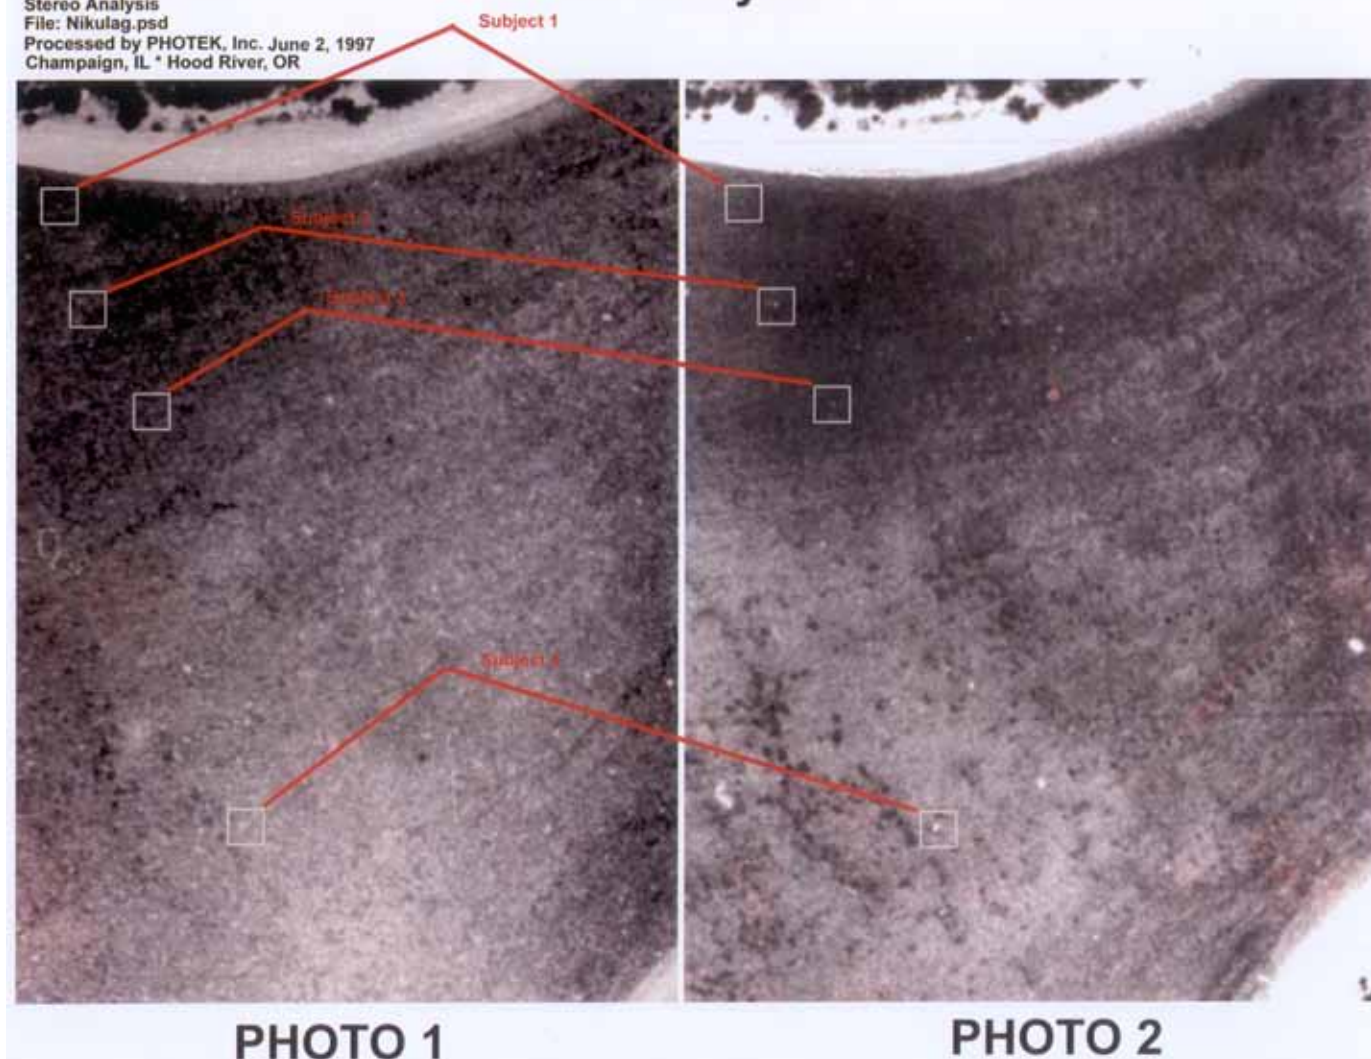
Light colored objects appearing in two 1953 aerial mapping photos.

Our lucky break came at the end of the 1997 expedition. During an unscheduled stop at Funafuti Atoll we met former Nikumaroro resident Tapania Taeke who told us of seeing aircraft wreckage on the reef near the main lagoon passage in the 1950s. When we got home we asked forensic imaging specialist Jeff Glickman if he could find corroboration of her recollection by examining aerial mapping photos taken in 1953. Jeff was able to find four light colored objects, possibly aluminum, on the reef surface in the area described by Tapania.

If there was aircraft aluminum near the main lagoon passage, where did it come from? Debris from the shipwreck is distributed on the reef surface to the southeastward. If the objects in the 1953 photos were aircraft debris, the aircraft must have broken up somewhere to the northwest. For the first time we had a general impression of where the plane may have landed. As research continued, a picture began to emerge.

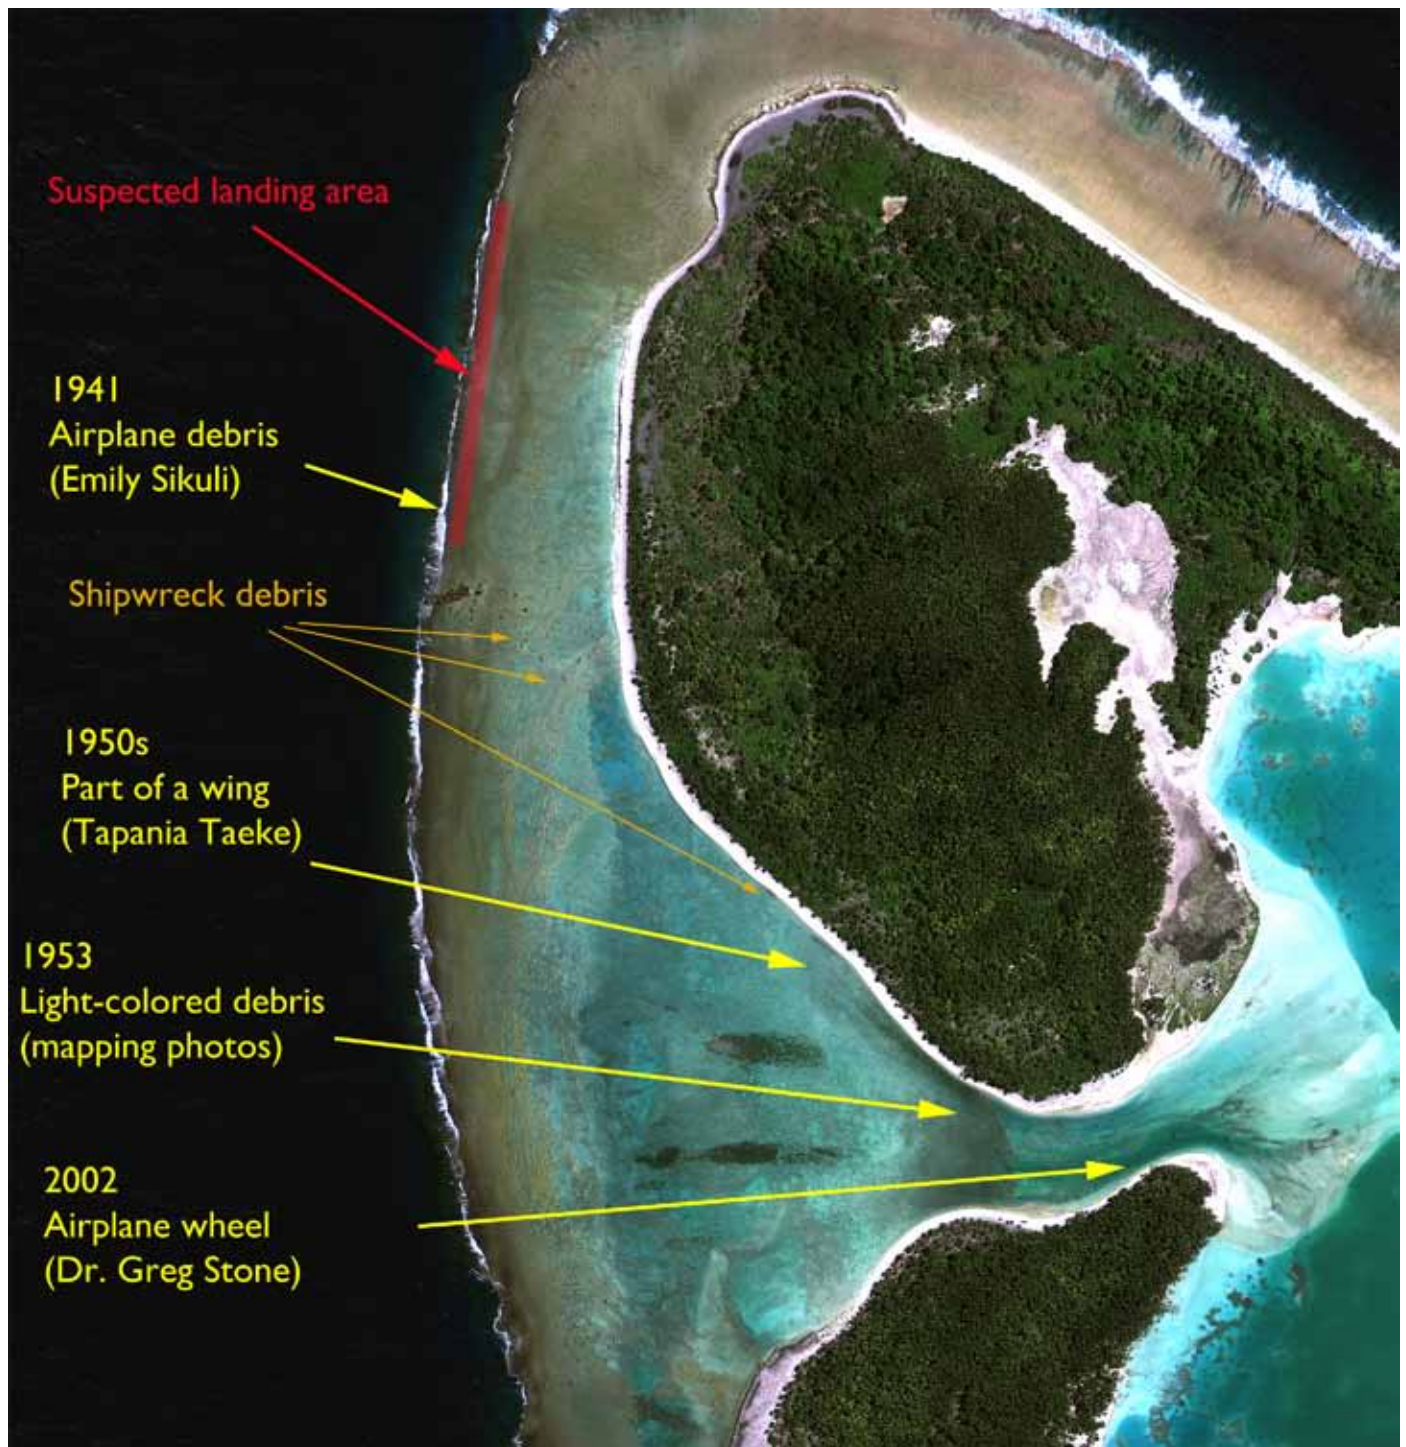
By January of 2010 the available evidence pointed to a relatively safe landing on a smooth stretch of reef north of the shipwreck, the subsequent break up of the aircraft in the surf, and the eventual distribution of some of the wreckage southeastward.

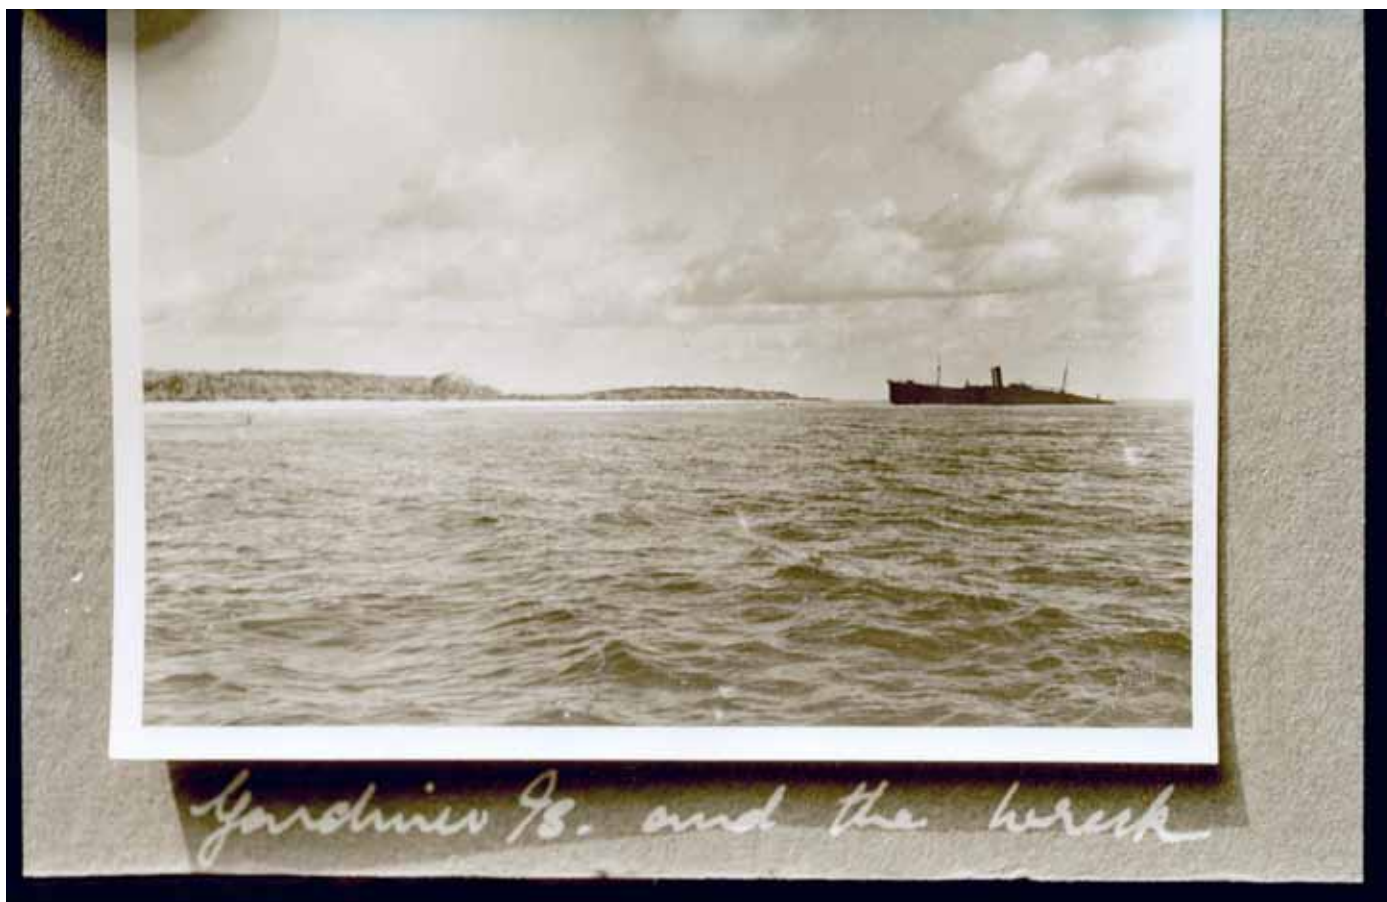
The full-frame 1992 copy photo. "What's the thing sticking up out of the water...?"

my copy of the photo (forgetting that it had been cropped) and replied that I didn't see anything. Jeff then sent me a scan of the full frame image derived from the copy negative.

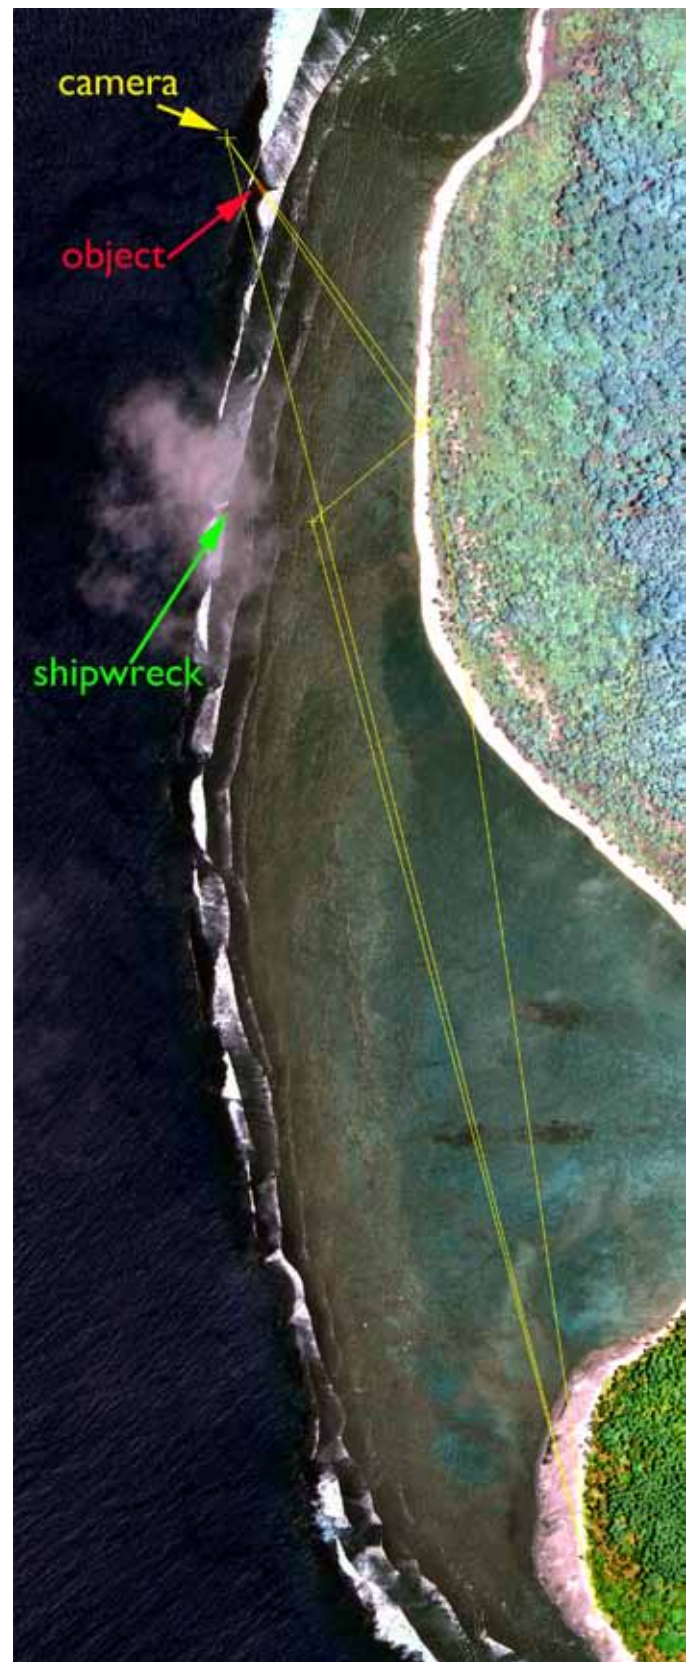
By identifying features visible in both the 1937 photo and a modern satellite image, Jeff Glickman was able to triangulate the position of the camera and the object.

Jeff calculated the object's position by triangulating features that are identifiable in both the 1937 photo and in a modern satellite image of the island. With the ship of known dimensions providing a convenient scale, Jeff was able to place Nessie 416 meters – about a quarter of a mile – north of the shipwreck and at the very edge of the reef flat. It was the same spot Emily Sikuli had marked on our map eleven years earlier.

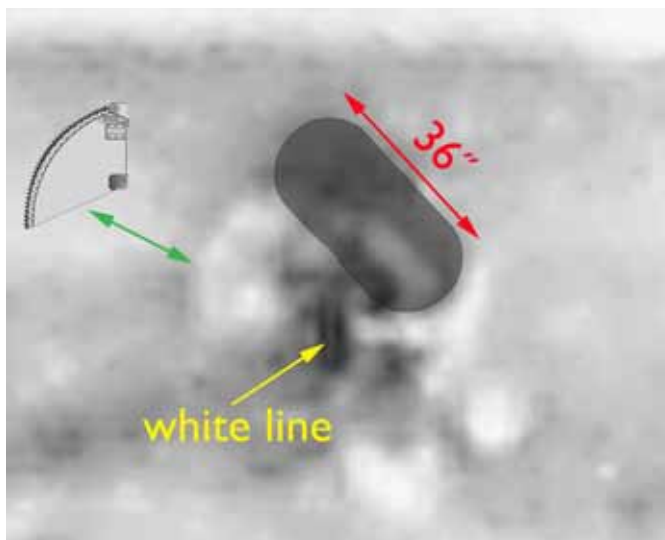
Elements in the scanned image resembled components in the landing gear of Earhart's Electra.

Using data TIGHAR had collected from Lockheed c/n 1052 at the New England Air Museum in Windsor Locks, Connecticut, Jeff was able to match the size and shape of components of the Electra landing gear to specific elements in the new scan of Nessie.

The first item of interest was that the diameter of what might be a tire appeared to be roughly 36 inches – the Goodyear Airwheels on Earhart's Electra had a diameter of 35 inches. The second item of interest in the new image was a fine white line on the central dark area. The line is an illusion caused by image processing software in the scanner but the fact that the scanner put a line there suggests a cylindrical shape consistent with a landing gear strut. A third item of interest was a light colored section on the left side of the strut-like area. The size and shape was similar to the worm gear on the landing gear of Lockheed Electras – or rather, some Lockheed Electras. (See "Part No. 40776" page 45.)

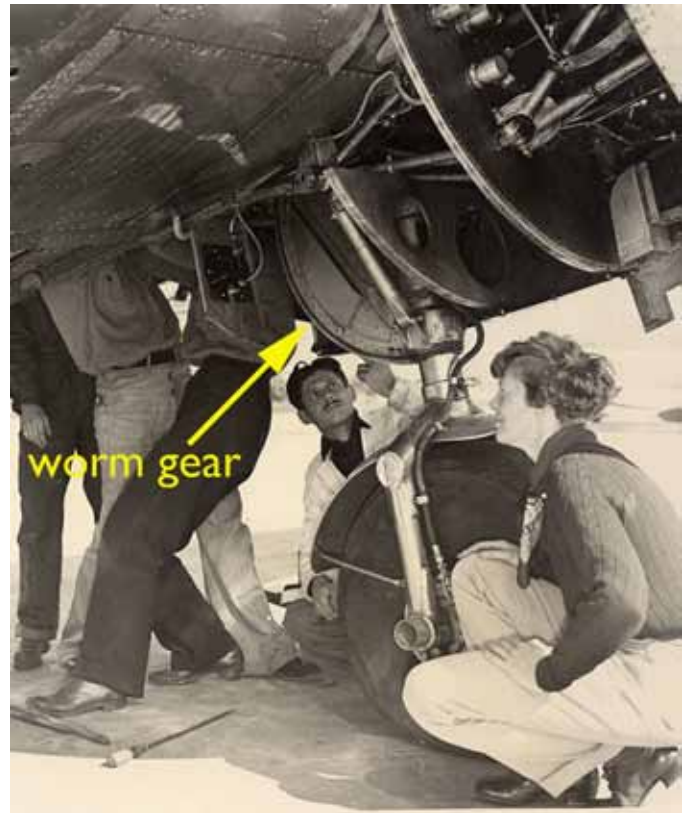
The first 55 Lockheed Electras featured Lockheed Installation 40650, a main landing gear assembly that featured a heavy steel "worm gear" as part of the retraction mechanism.

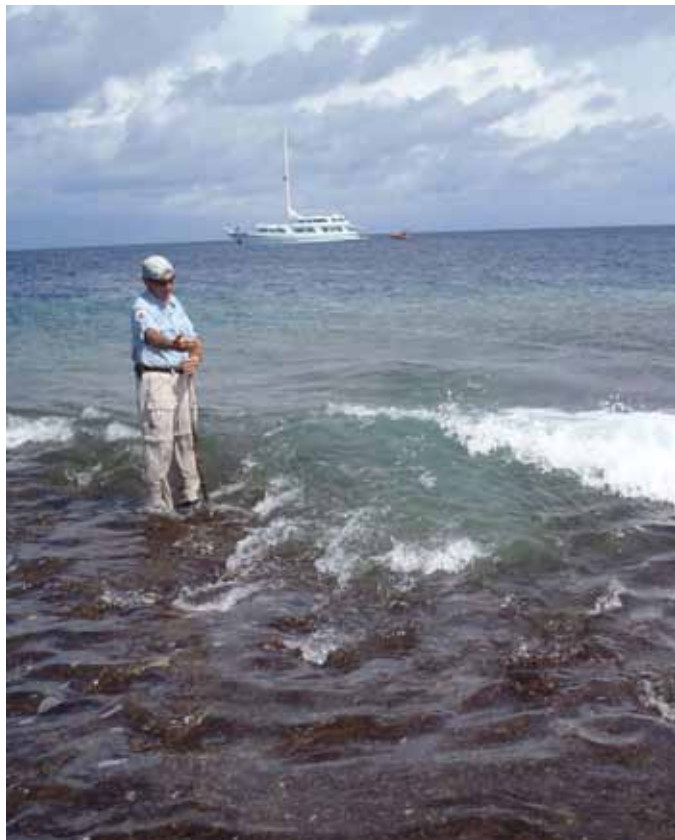
TIGHAR's Gary Quigg beside the reef groove at the Nessie location, May 27, 2010.

went to the GPS coordinates calculated from Jeff Glickman's placement of Nessie. We didn't expect to find surviving debris on the reef surface, and we didn't, but we did confirm that there is a deep natural groove in the reef surface in that location.

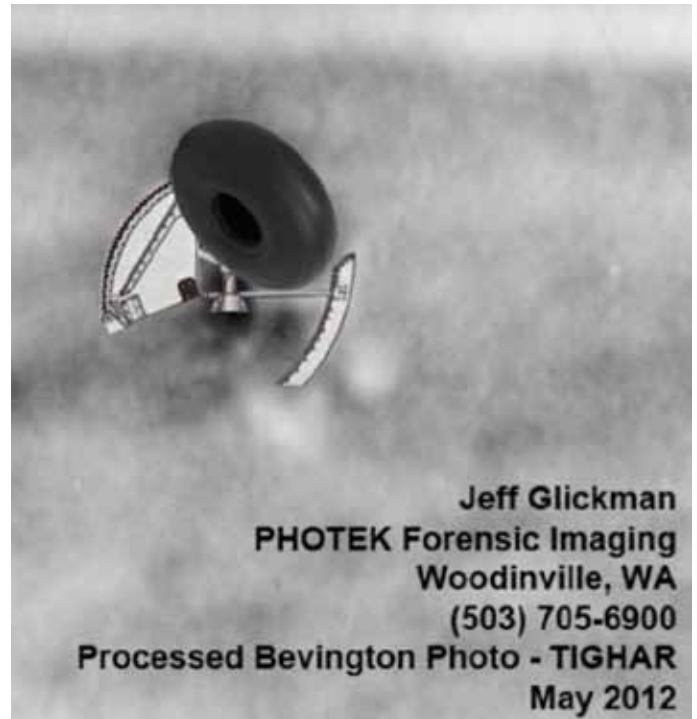
Initial parsing of the Bevington Object.

Jeff Glickman's initial parsing of the image, as presented at TIGHAR's Earhart Search 75 symposium in Washington on June 2, 2012, postulated that the strut was intact but partially submerged and the tire/wheel separated from the fork. An abbreviated video of Jeff's presentation is on the TIGHAR YouTube channel at <http://www.youtube.com/watch?v=iLxjEU1VJHA&feature=plcp>.

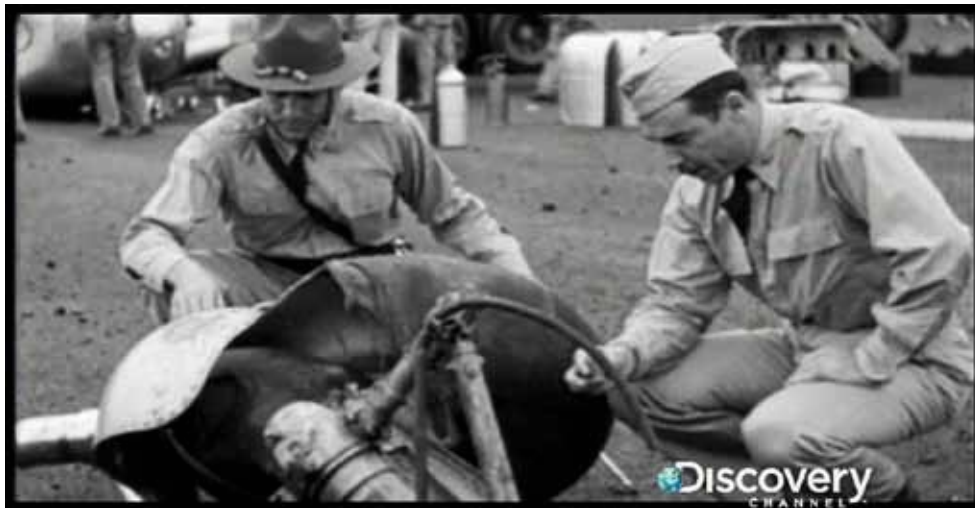
The clip in the Discovery Channel show was only three seconds long and did not show the entire landing gear but there was enough of it visible to reconstruct what had happened.

In September 2012 I stumbled upon a brief clip of old newsreel footage in the 2010 Discovery Channel special "Finding Amelia" that I had not previously noticed. The film was shot at Luke Field following the accident that ended Earhart's first world flight and showed two Army officers crouched over the Electra's right main landing gear. Although not mentioned in the extensive U.S. Army accident report, it was apparent from the clip that the entire landing gear assembly had separated from the airframe – and it looked startlingly familiar. Further research was clearly needed.

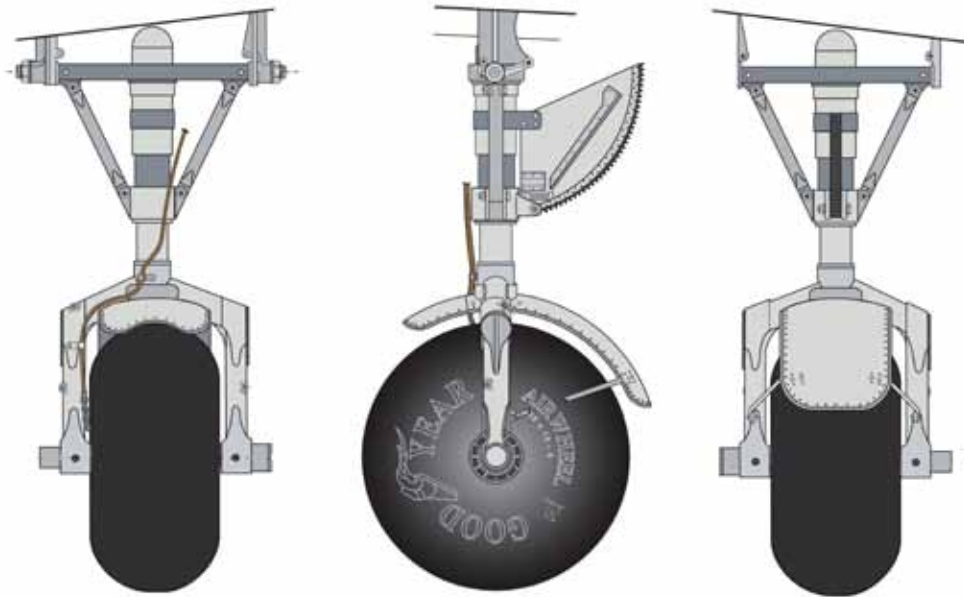
Front, profile and rear views of Lockheed Model 10 Landing Gear Installation 40650.

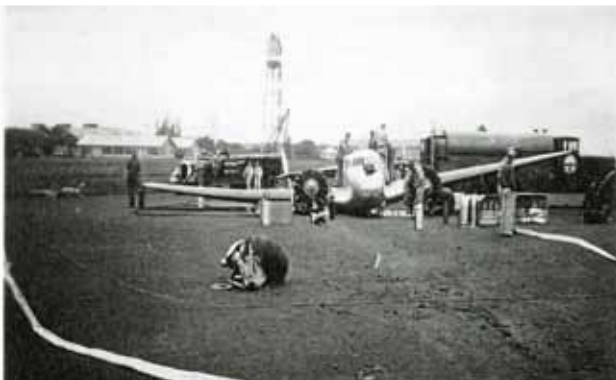
A photograph taken by Gerald Berger, the Navy mechanic who drove the crash truck at Luke Field, shows the mangled wreckage of the right main landing gear assembly where it lay after separating from the airframe during the crash. TIGHAR photo courtesy of G. Berger.

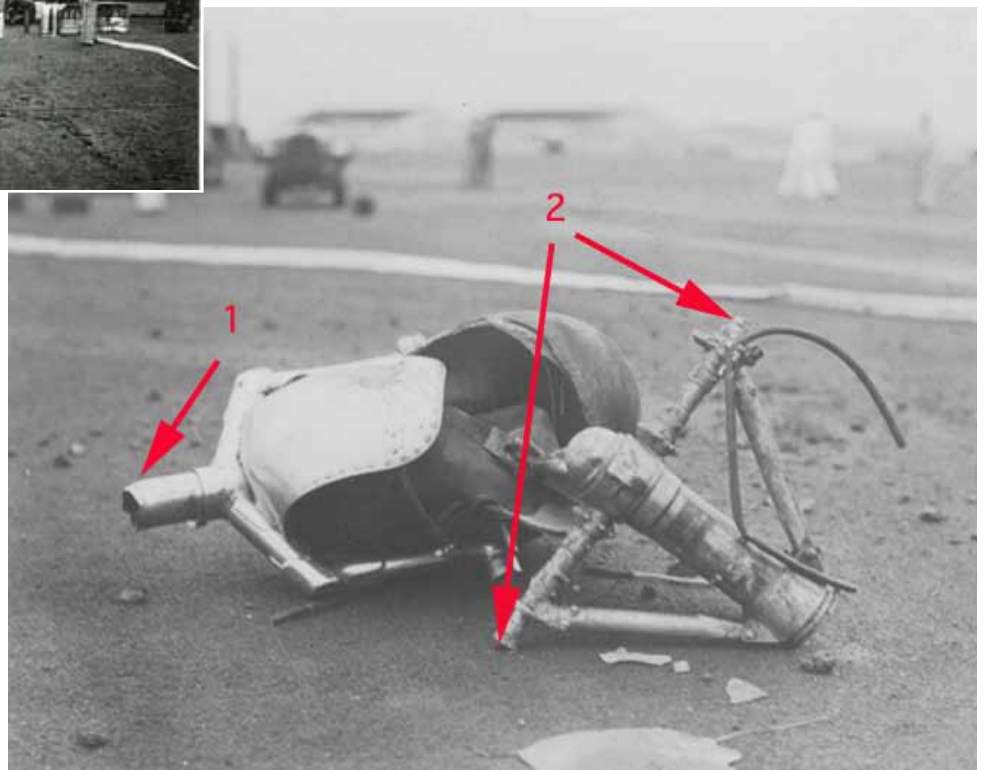
It appears the shaft of the oleo strut (1.) failed, dropping the full weight of the aircraft onto the upper part of the strut which separated from the airframe at the attach points (2.). The broken-off lower section rotated as it collapsed and the tire was torn open by the worm gear. San Diego Air & Space Museum.

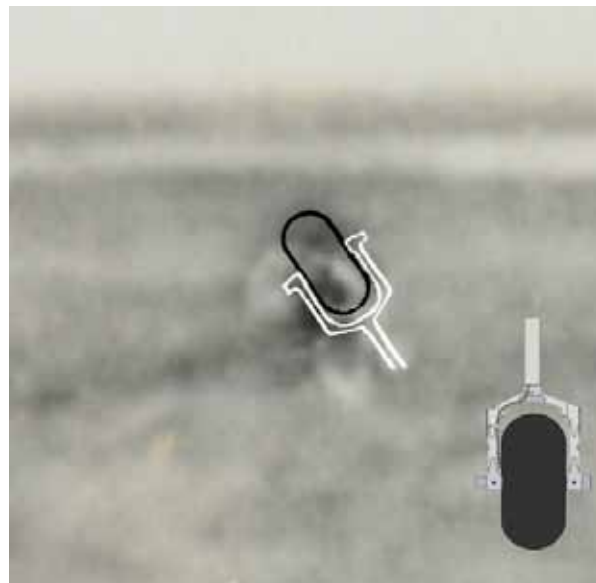
The distinctive shape of “Lockheed Part No. 40776 Fork, landing gear” had been there all the time but we hadn’t recognized it. The tire remained on the axle just as it did at Luke Field.

With a real-life model of how the landing gear on NR16020 could fail, the Bevington Object seems to pop into focus. The distinctive shapes of the tire, fork, and worm gear are clearly visible to the untrained eye. These three elements in the image are the right color, shape, and dimensions, and in the correct proportion to each other, to be the Goodyear Airwheel; Lockheed Part No. 40776 Fork, landing gear; and Lockheed Part No. 41065, Gear, worm – components of Lockheed Installation 40650. The assembly appears to have failed in much the same way it did in the Luke Field accident.
