TIGHARNews

Niku VII Analysis Update

Is This the Earhart Electra?

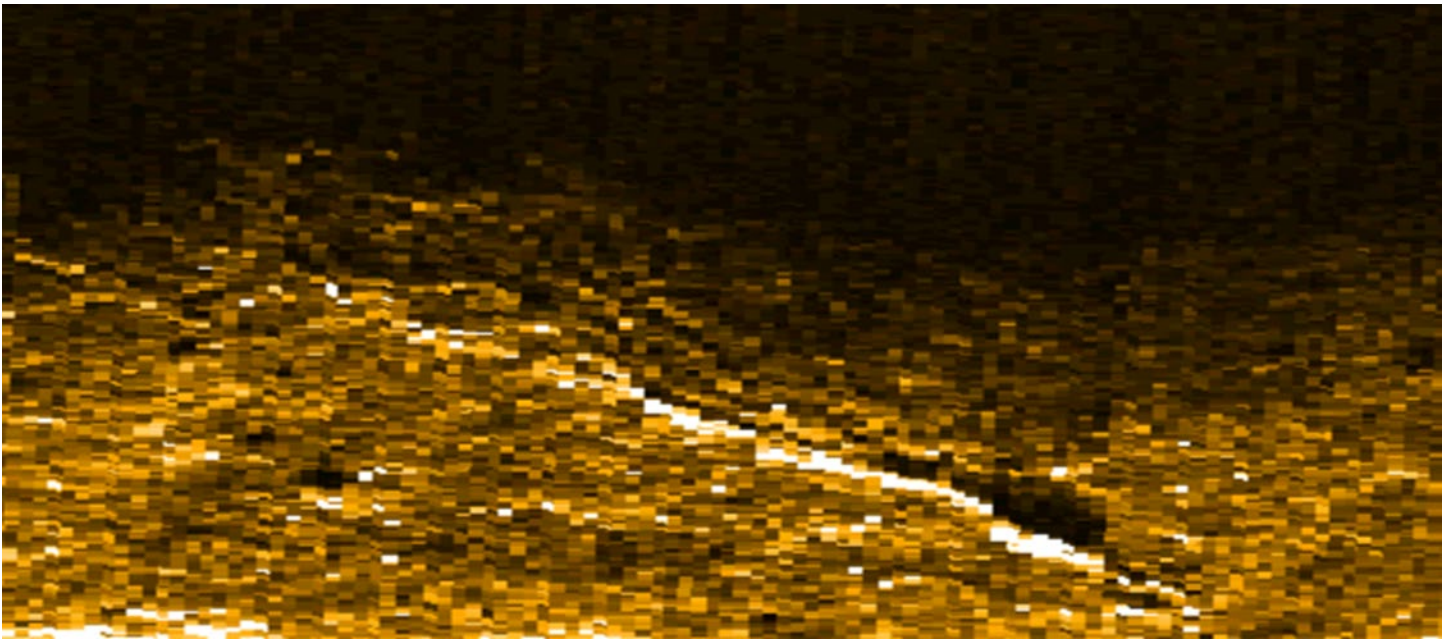
It's exciting. It's frustrating. It's maddening. There is a sonar image in the data collected during last summer's Niku VII expedition that could be the wreckage of Amelia Earhart's Lockheed Electra. It's looks unlike anything else in the sonar data, it's the right size, it's the right shape, and it's in the right place.

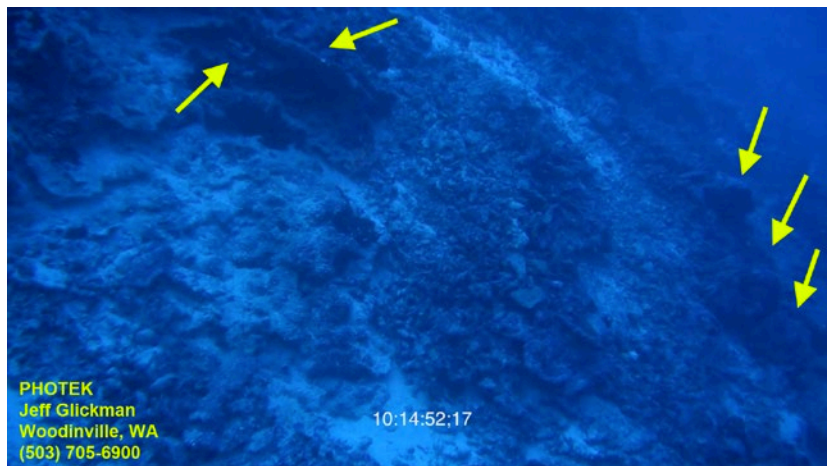
After reviewing all of the underwater HD video, the only site of interest identified by forensic imaging specialist Jeff Glickman is a small debris field of objects in relatively shallow water – 61 meters (200 feet). As reported in Debris Field Analysis (http://tighar.org/Projects/Earhart/Archives/Research/Bulletins/65_DebrisFieldAnalysis/65_DebrisFieldAnalysis.html), Glickman feels 100% certain that the objects in the debris field are man-made. He is 80% sure the objects are related to the Bevington Object seen at the reef edge in the 1937 photos taken by British Colonial Service Officer Eric Bevington. Jeff cautions, however, that these assessments "are subjective and are based upon my knowledge and experience as opposed to being objective, calculated probabilities." There just isn't enough resolution in the video to see the degree of detail needed to say more.

The debris field in the video is, however, in a catchment area at the base of a cliff and just downstream (the current flows southward in that area) of the spot where the Bevington Object appears in the 1937 photo. When Jeff was reviewing the video, so as not to bias his assessment, he purposely was not aware of where on the reef slope the video was taken. Only after he spotted the debris field did we calculate where it was.

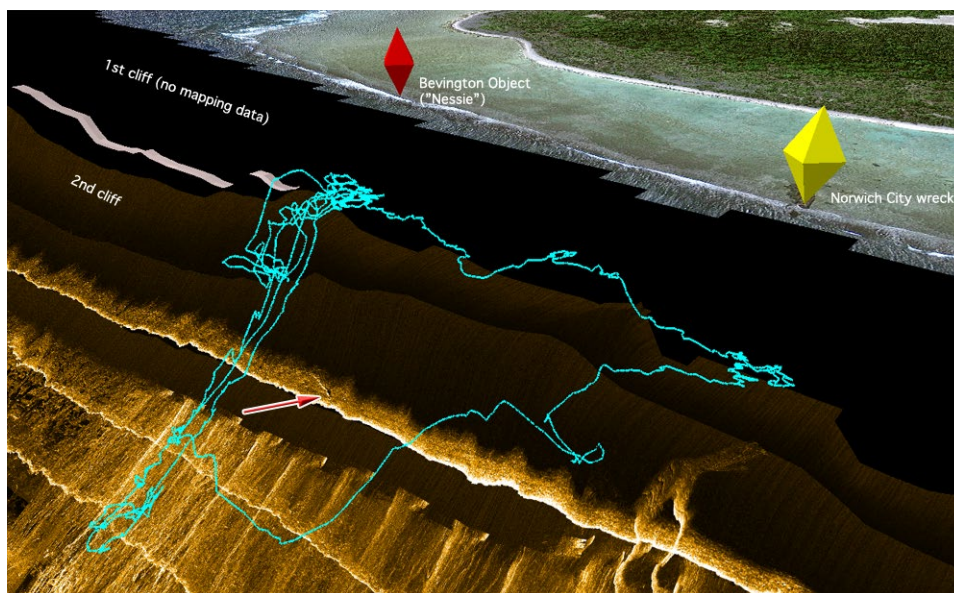
This is the map of ROV Dive 3 published in TIGHAR Tracks in which Richie Conroy spotted the anomaly.

"Ric, the image I have attached shows an anomaly below second cliff which arrow points to. Do you have a sonar image with better detail?"

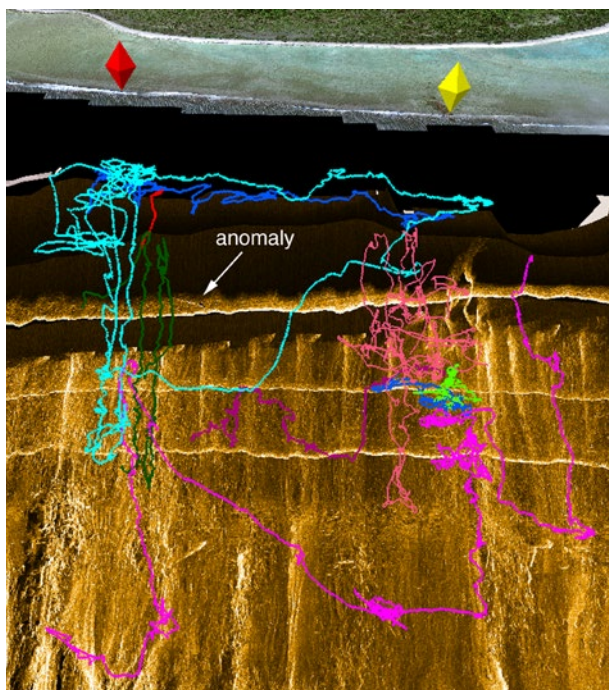
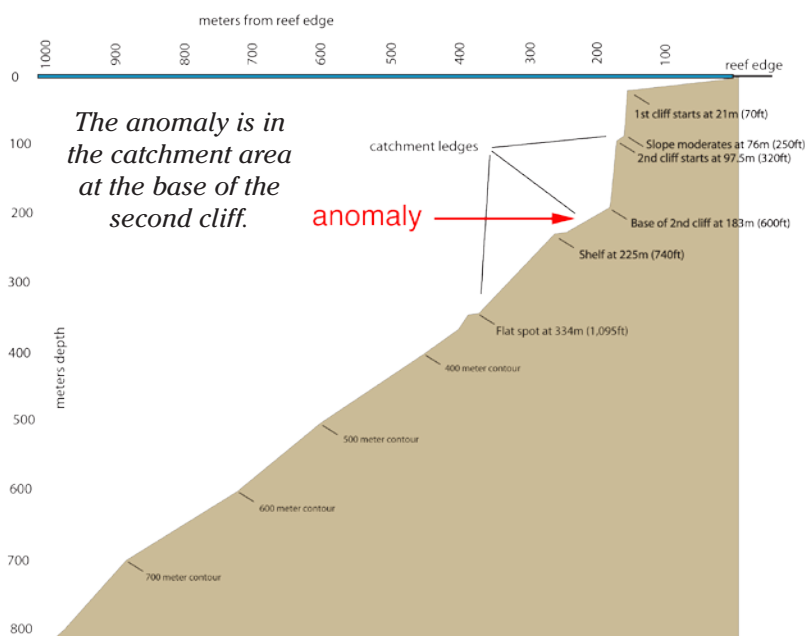
Looking at the map of all the ROV tracks it was apparent that we had never been to the place where the anomaly appears.

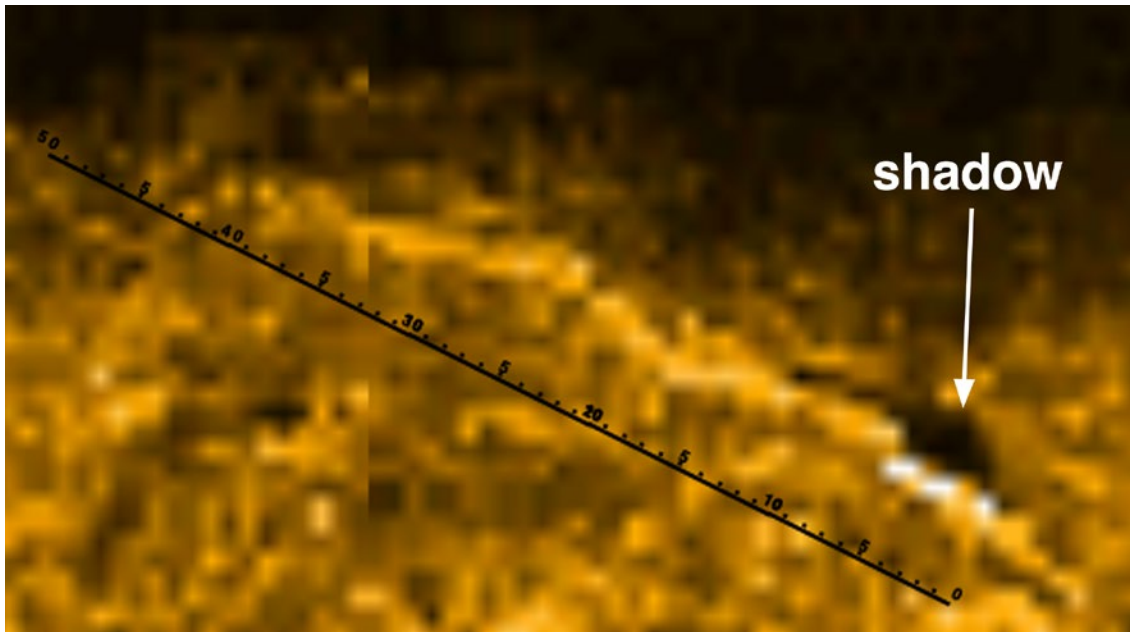
The next question is scale. How big is it? It can't be wreckage from the airplane if it's bigger than the airplane. By scaling it to known distances and the reported dimensions of identified targets, the most prominent part of the anomaly appears to be less than 10 meters (32 feet) long. The Electra fuselage was 11.76 meters (38 feet 7 inches) long. The height of the anomaly is harder to estimate. The only clue we have is the shadow – remember that it's a sound shadow, not a light shadow – which suggests that the object is higher on the downhill end.

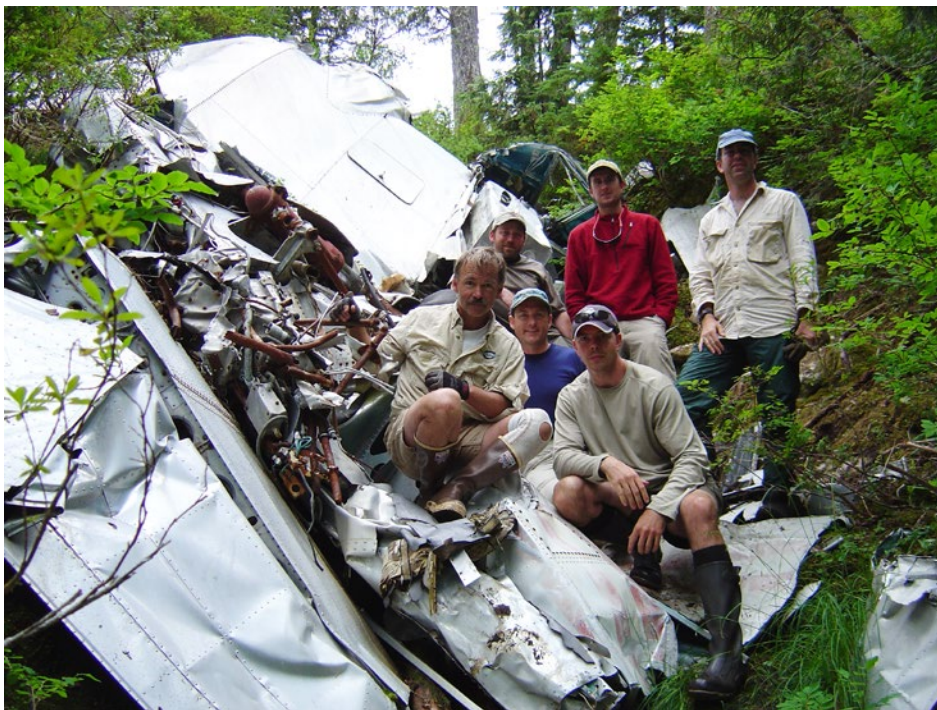
One possibility is that we're seeing the center section lying at an angle, much as we see in the Alaska crash, with the port-side wing stub causing the elongated shadow in the sonar image.

Each wreck has given us valuable information about what happens to a Lockheed Model 10 in different crash scenarios. Of the three, the Alaska wreck is the most analogous to the forces and damage to be expected in the case of an Electra going into the surf on a coral reef. In the Alaska crash the aircraft shed its engines, right wing, and tail surfaces as it came down through the trees. The “center section,” with its massive “main beam,” reinforced inner wing sections and thick belly skins, held together but the thinner cockpit and cabin skins were torn open. The empennage (tail section) separated just behind the wing.

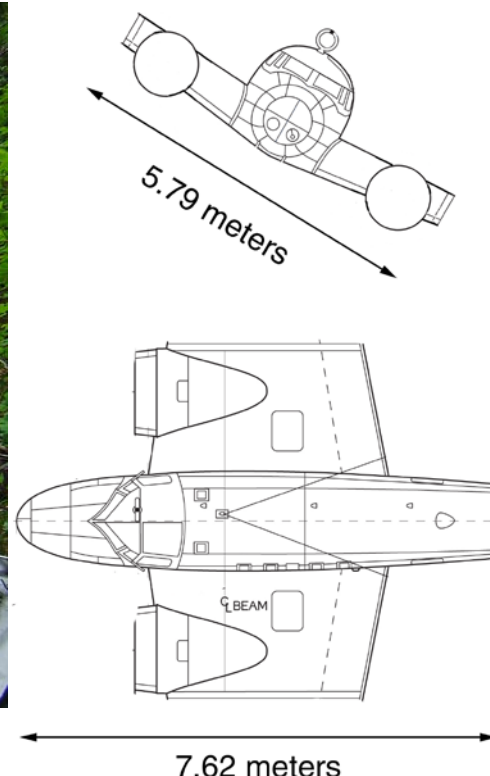
The wreckage of c/n 1021 faces uphill behind the TIGHAR / U.S. Forest Service team that surveyed the site in 2003.

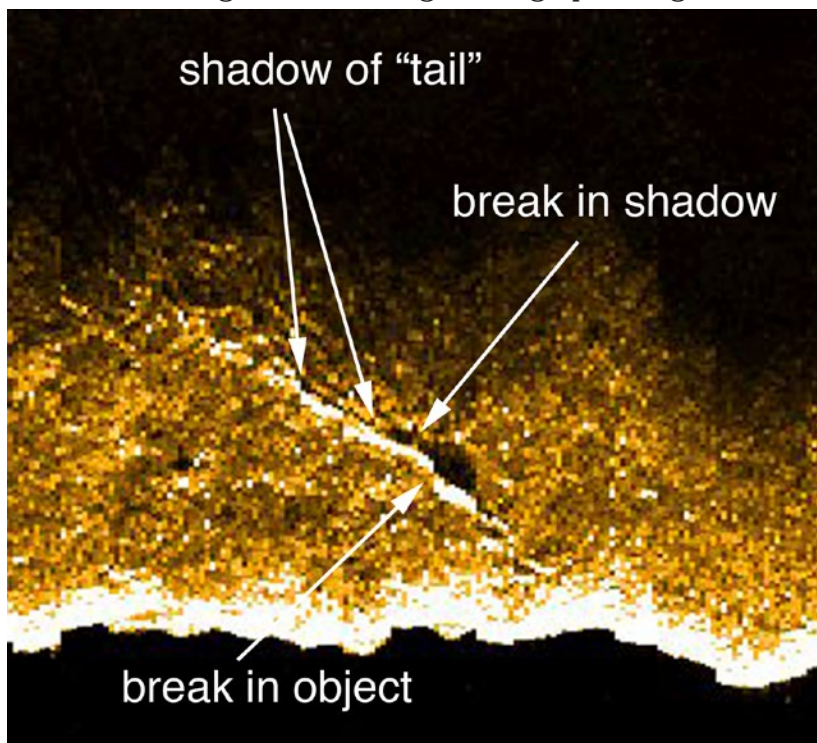
A higher-resolution copy of the image captured from the raw sonar data reveals details that suggest another explanation for the tail. There appears to be a break in the prominent part of the anomaly, corroborated by a break in the shadow. Also, some of the tail is casting a low shadow so it must have some elevation. Something that always strikes us about Electra wrecks or repair shops where Electras are being restored or rebuilt is the incredible amount of “junk” that came out of the airplane. Rather than a ground scar, a more likely hypothesis is that the tail is a debris field of fuselage wreckage, internal components, cables, crushed fuel tanks, etc. strewn behind the eviscerated center section.

A unique feature of the anomaly is the “tail” that extends uphill and northward behind the more prominent portion of the target that is casting a large shadow. Our initial impression was that the tail is, in aircraft crash investigation parlance, a “ground scar.” Such scarring is common when aircraft come to earth in ways other than we would normally prefer. However, after examining the nature of the underwater terrain in video (see Base of the 2nd Cliff <http://www.youtube.com/watch?v=e5TALXiBUgk>) taken at about the same depth 50 meters away (the closest we have), it’s difficult to imagine a skidding fuselage plowing a furrow that would persist for 75 years.

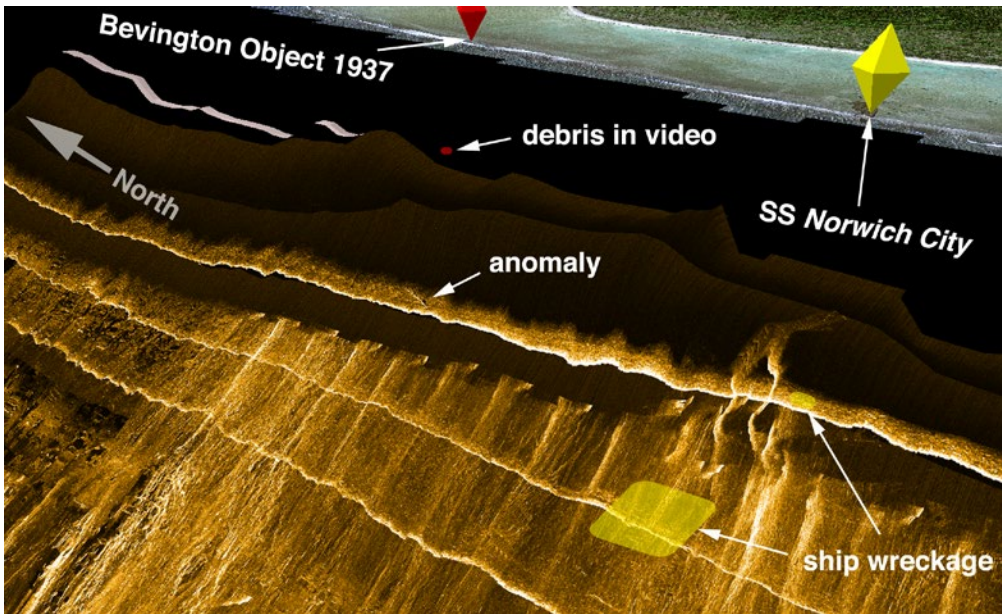
Finally, it's worth noting that the anomaly lines up nicely with the Bevington Object and Jeff Glickman's debris field. You can draw a straight line between any two points – but a line that connects three points, each point deeper than the next and consistent with the southerly flowing current – suggests that the three points are related.
