TIGHAR TRACKS

THE JOURNAL OF THE INTERNATIONAL GROUP FOR HISTORIC AIRCRAFT RECOVERY

CONTENTS

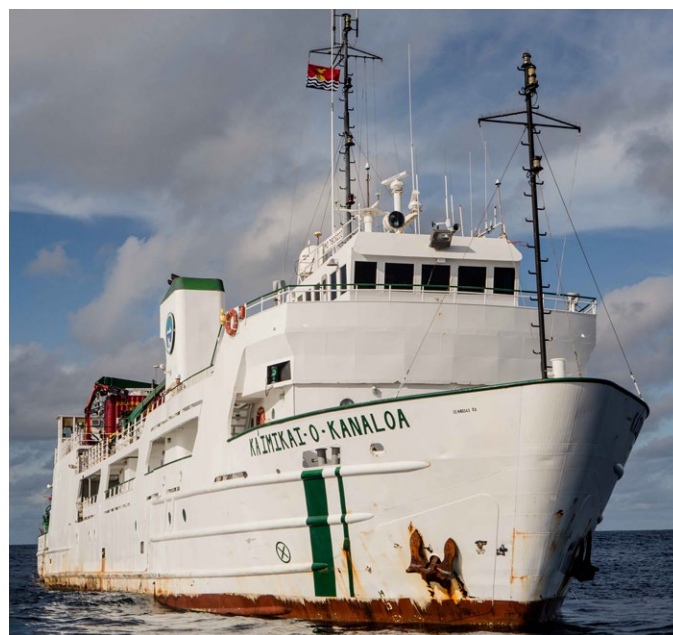
The expedition vessel was the University of Hawaii oceanographic research vessel R/V Ka'imikai-O-Kanaloa or more commonly "KOK." The ship would map the underwater environment in the search area using its hull-mounted SeaBeam multi-beam sonar. TIGHAR photo by L. Rubin.

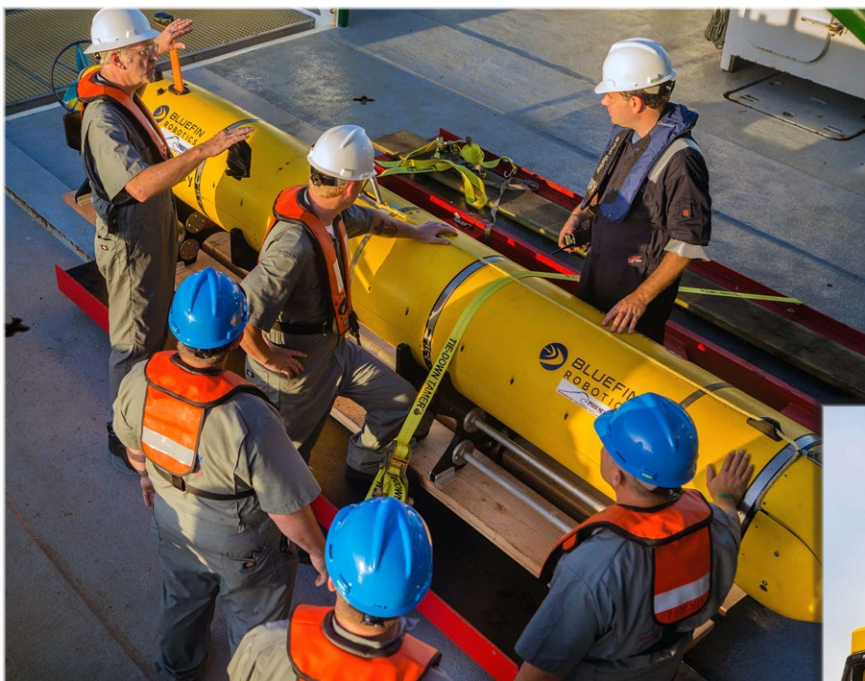
The primary search contractor for Niku VII was Phoenix International of Largo, MD. Five Phoenix technicians, assisted by two technicians from Bluefin Robotics of Quincy, MA would collect side-scan sonar imagery using a Bluefin 21 autonomous underwater vehicle (AUV). TIGHAR photo by L. Rubin.

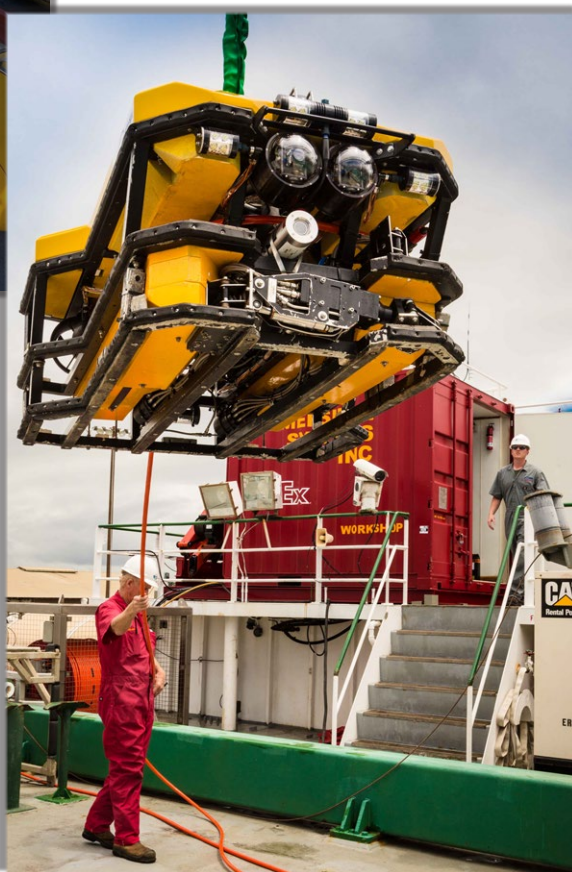
Targets identified by Phoenix would be investigated by sub-contractor Submersible Systems, Inc. (SSI) using a TRV-M Remote Operated Vehicle (ROV) equipped with a High-Definition video camera provided by Phoenix. TIGHAR photo by L. Rubin.

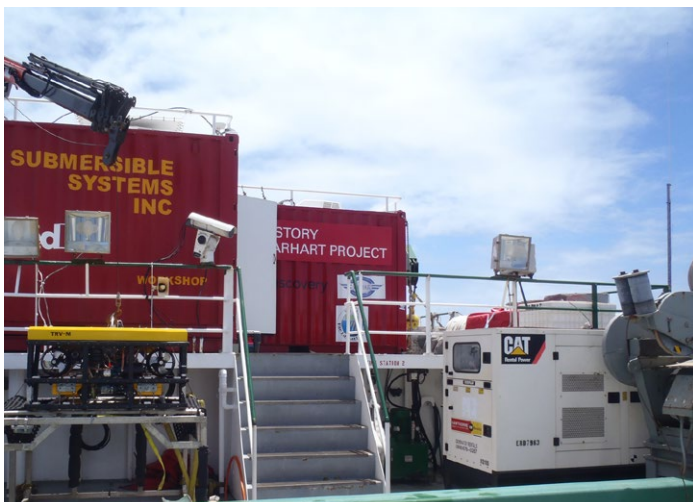
The addition of a dedicated generator (white unit at right) to the ROV system solved the "dirty power" problem. TIGHAR photo.

A dedicated generator for the ROV is located, arrives, and is lifted aboard. If it doesn't solve the "dirty power" problem it will mean that there is a flaw within the ROV system, but tests indicate that it does solve the problem and it gets welded to the deck.

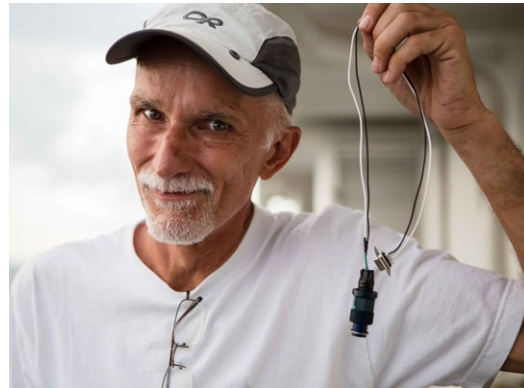
Mark Smith with the connector that proved to be the key to making the HD underwater video camera at least marginally operational. TIGHAR photo by L. Rubin.

By the end of the day, Mark has the HD camera situation to the point where we have a reasonable expectation of it being usable.

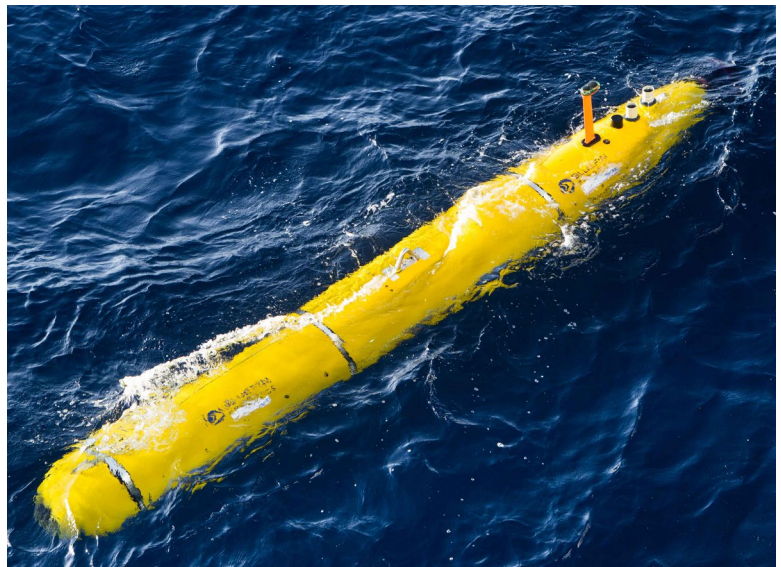
The AUV must be properly balanced and ballasted. TIGHAR photo by L. Rubin.

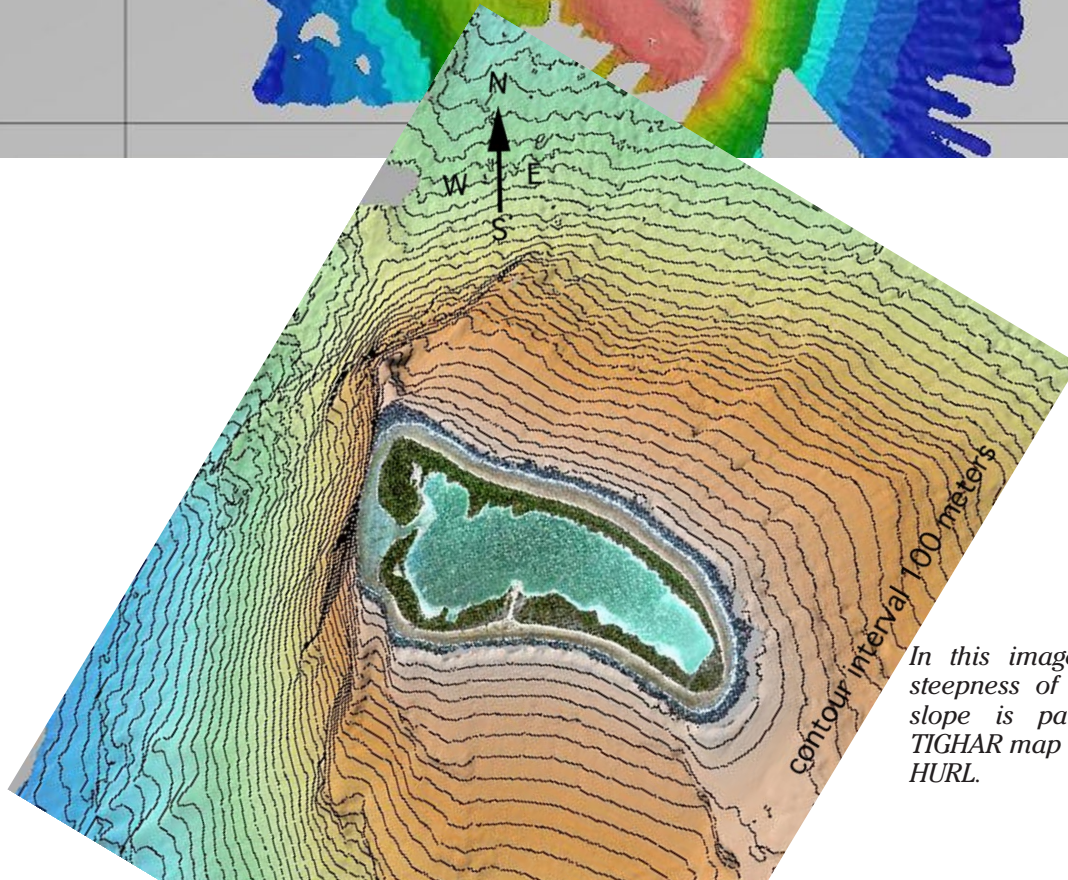
In this image, the staggering steepness of the western reef slope is painfully apparent. TIGHAR map by J. Smith, Ph.D., HURL.

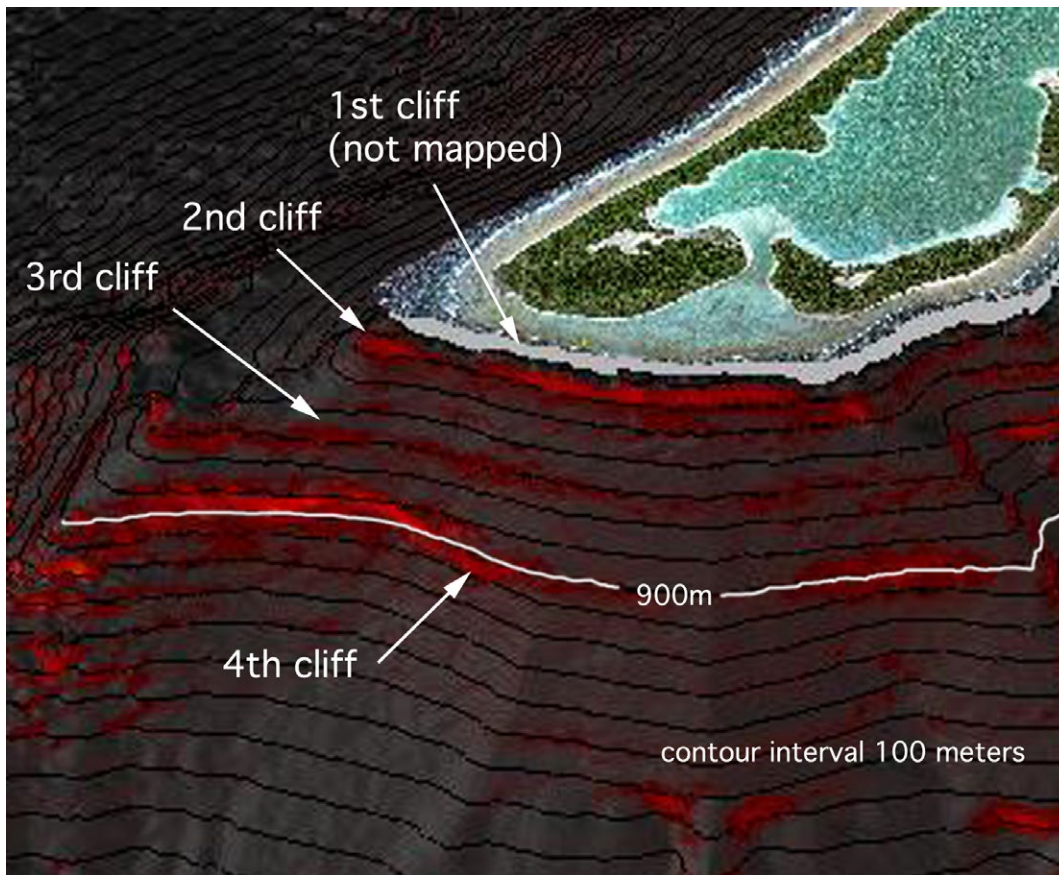
In this image, the red areas indicate extreme "rugosity." Nikumaroro's western reef slope is a series of four virtually vertical cliffs. The first cliff is close to the reef edge in water too shallow to map. The ROV could investigate down to a maximum depth of roughly 900 meters (2,952 feet). TIGHAR map by J. Smith Ph.D., HURL.

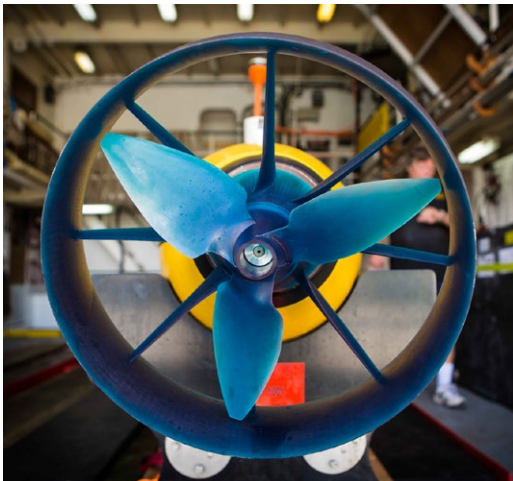
The AUV's articulated propulsion system. TIGHAR photo by L. Rubin.

AUV is repaired. Prop was not turning on prop shaft. Ready to deploy on another test as soon as ROV is recovered.

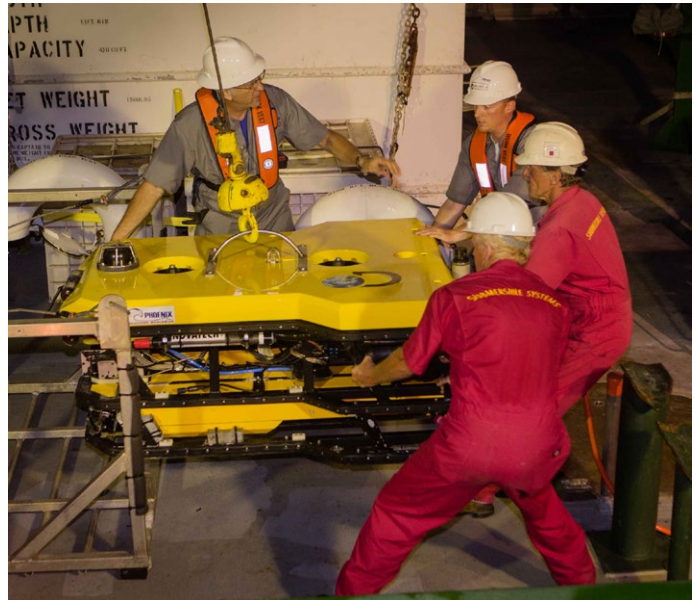
Launching the ROV. TIGHAR photo by L. Rubin.

The need to make a deep dive so soon worried Wolfgang Burnside, the ROV pilot. The tether for the ROV had been modified to accommodate the feed for the high-definition video camera and the seal had not had time to properly cure. If the seal failed at depth it would flood and ruin the tether. No tether, no ROV – but with a \$2 million dollar AUV needing immediate rescue there was no choice but to deploy the ROV as quickly as possible. (TIGHAR photos by L. Rubin.)

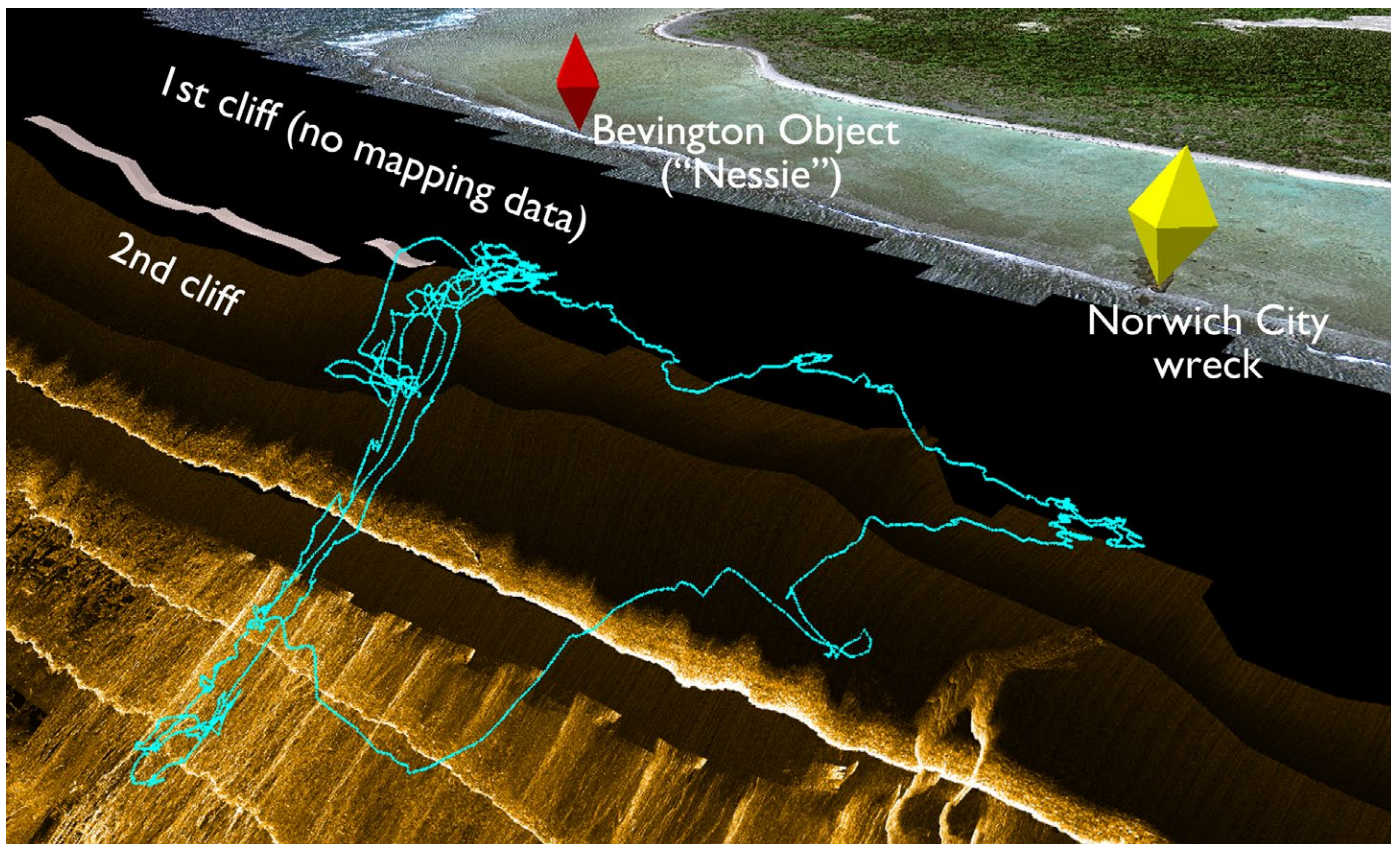
In this schematic of ROV Dive 3 on July 14, 2012 the yellow pyramid marks the shipwreck on the reef and the red pyramid marks where the Bevington Object appears in the 1937 photo. The blue line is the track ("snail trail") of the ROV against the brown side-scan sonar map of the reef slope. HURL Graphic by J. Smith, Ph.D.

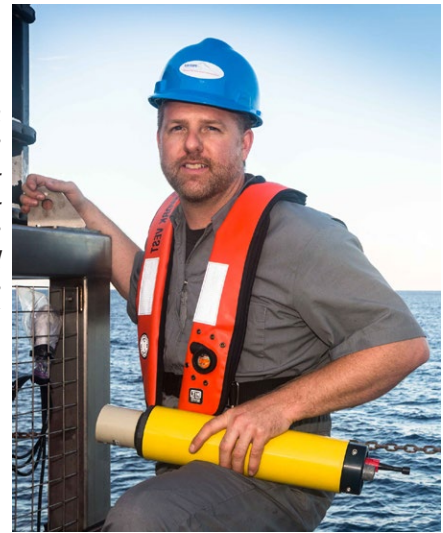
Phoenix technician Jesse Doren with the SonarDyne acoustic positioning beacon that had to be transferred back and forth between the AUV and the ROV. TIGHAR photo by L. Rubin.

AUV has completed its all-night mission and been recovered. Now downloading data and recharging the navigation beacon before installing it on the ROV. We only have one beacon operational and it must do double duty on both the AUV and ROV.

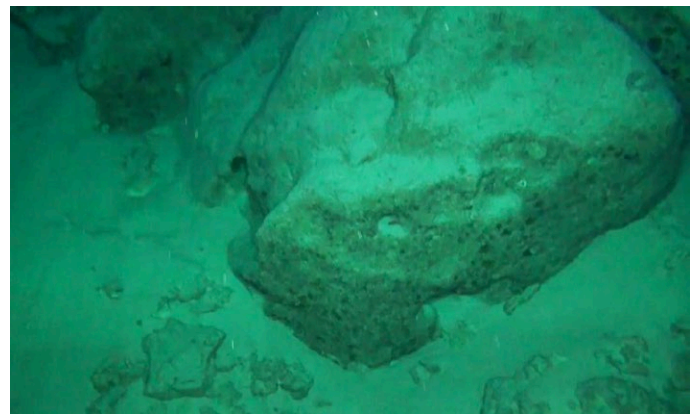
Searching the reef slope at depths below about 300 meters (984 feet) is like exploring a rugged mountain side with a flashlight on a dark night in a snow storm. TIGHAR screen capture from HD video.

ROV launched for "ground-truthing" mission. "Esmerelda," as Wolfgang calls her, will examine several targets identified in the side-scan imagery collected by the AUV. The first target is at 520 meters (1,705 feet). At that depth the reef slope is an undulating, barren mountainside with a light dusting of snow (coral "talus" drifting down from above). The target turned out to be car-sized hunk of coral with one flat side that produced a strong sonar return.

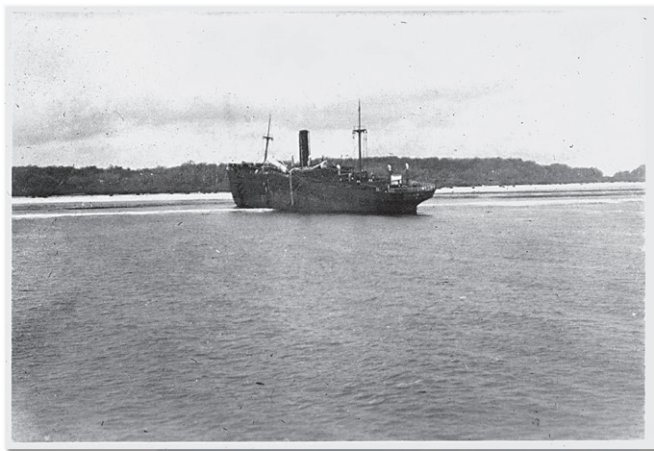
This 1935 photo is the earliest known picture of SS Norwich City aground on the reef. The stern half of the ship, aft of the funnel, broke off and tumbled down the reef slope in 1939. TIGHAR collection.

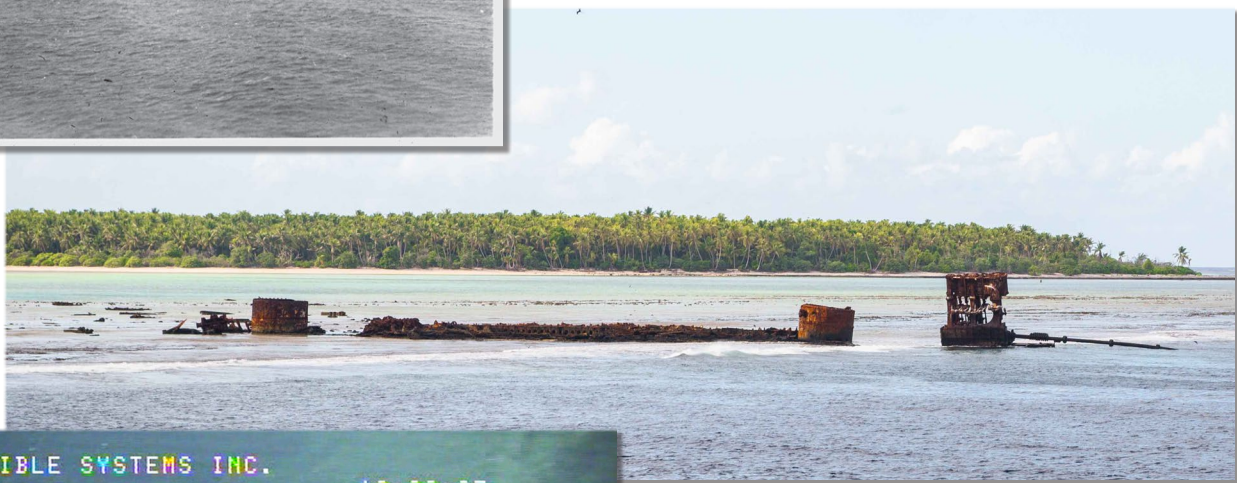
SS Norwich City in 2012. The triple-expansion steam engine with protruding shaft was below the funnel in the 1935 photo.

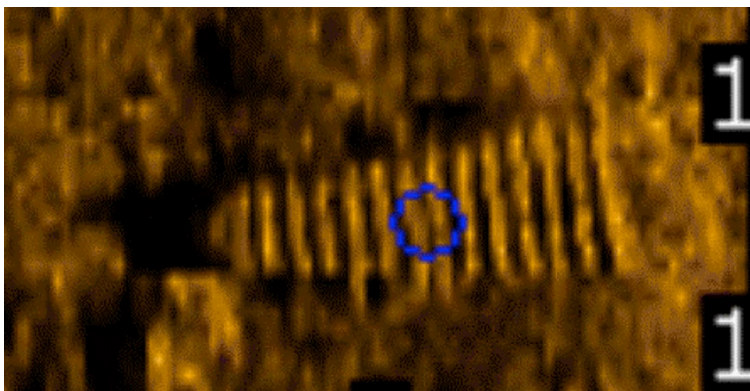
The target is a series of 12 parallel lines similar in shape and dimensions to an Electra outer wing panel. The AUV passed over it from several angles and the returns are consistent. Sonar often cannot see aluminum skin but picks up internal structure. There are twelve ribs in an Electra outer wing panel.

The target of special interest soon became known as the "wing target." TIGHAR sonar image by Phoenix International.

Initial plot of the target's position put it in 400 feet of water slightly north of *Norwich City*. We couldn't find it there. Refined plot put it at 1,000 foot depth roughly 10 meters southwest of the main body of NC wreckage. This is an extremely hazardous environment for the ROV with great danger of tether entanglement in the heap of ship wreckage. Also, increasing wind and sea conditions made *KOK* less stable. After struggling for two hours we ultimately called it off and returned to running search lines. We'll try again tomorrow.

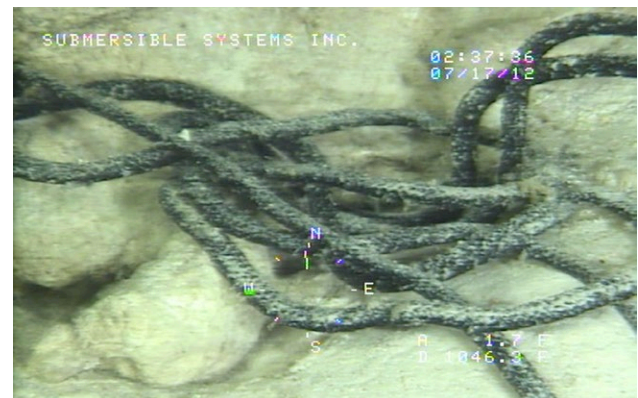
Found at a depth of 319 meters (1,046 feet), this object was later matched to sealing material of a type in use aboard *KOK*. TIGHAR screen capture from HD video.

Examined and photographed tangled strip of black material at 1,100 feet. Appears to be man-made, possibly a gasket from around a hatch or door. Did not recover but feel we can find it again if necessary.

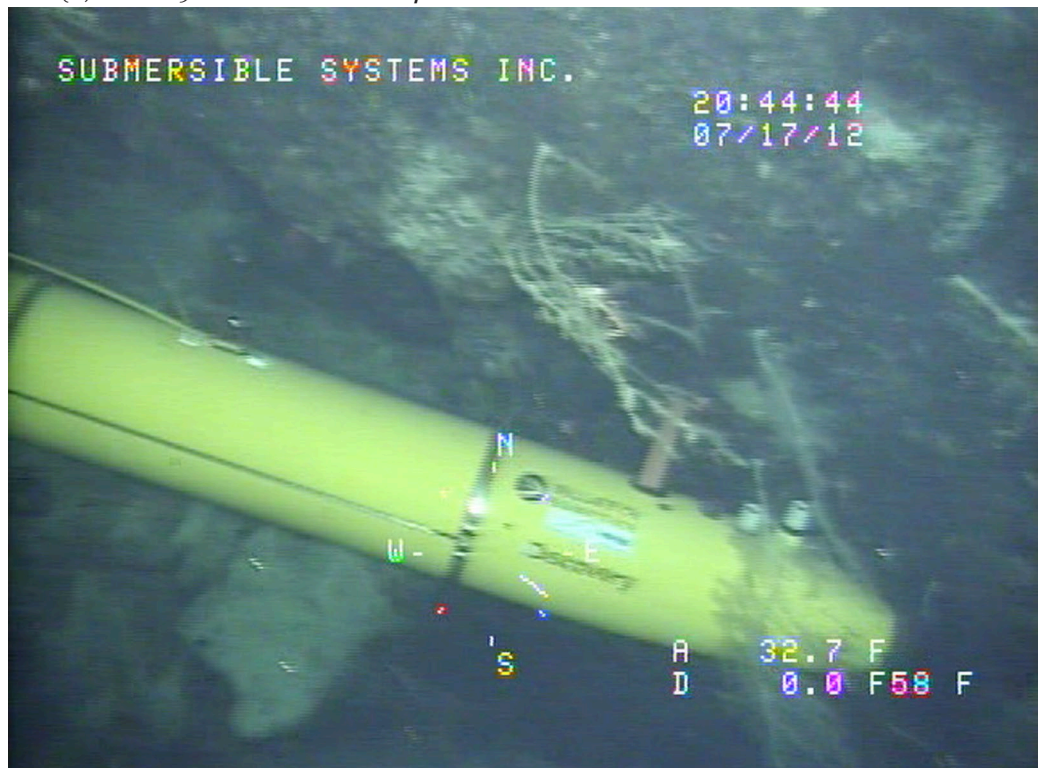
The AUV was found stuck in a cave on the face of the 3rd cliff. Actual depth was 716 meters (2,349 feet). TIGHAR screen capture from ROV video.

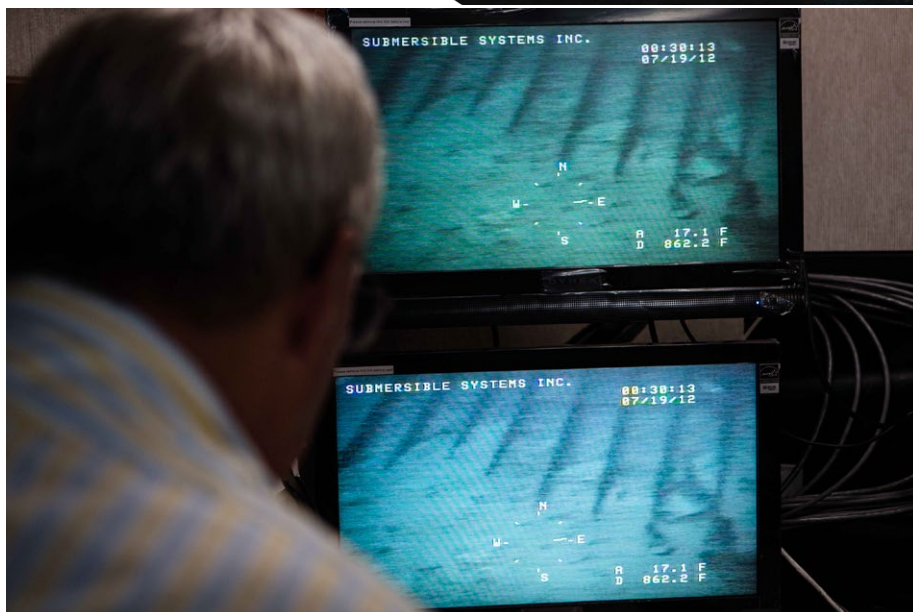
Tim Mellon watches the video monitors from the ROV as it inspects the "wing target." TIGHAR photo by L. Rubin.

A drawing of the object identified as the “wing target” doesn’t look much like the sonar image. The box nearby appears to have been some sort of storage cabinet.

Reconsidering identification of wing-shaped target. After reviewing video and comparing to sonar target, we disagree with Phoenix. We don't think we found the target. We will go back and try again.

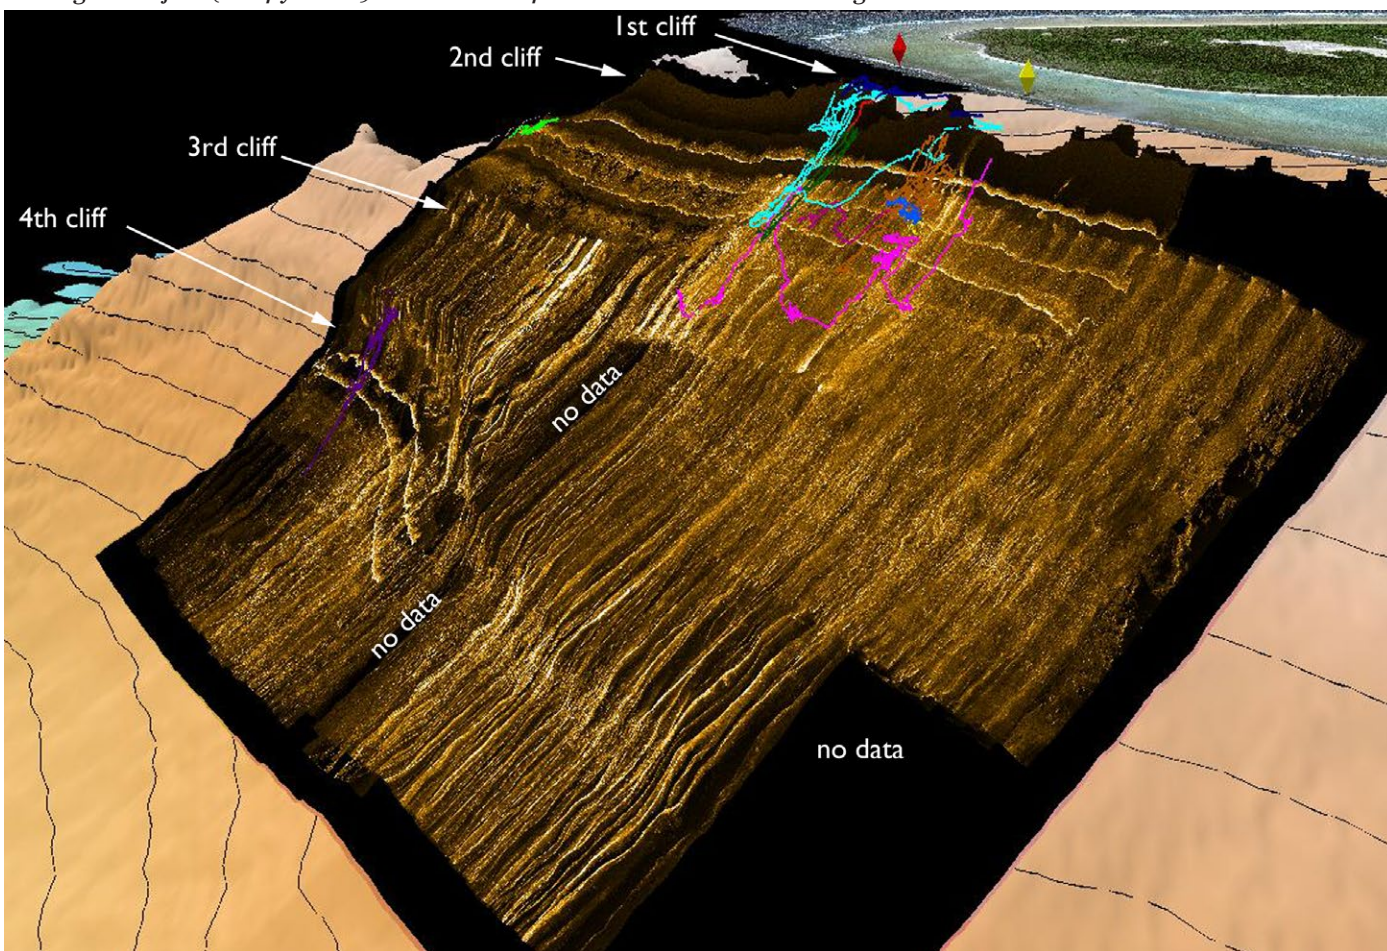
This map combines data from all three technologies used during Niku VII. The underlying SeaBeam map is overlaid with the side-scan sonar data collected by the AUV and the ROV "snail trails." Note that some parts of the reef slope below the Bevington Object (red pyramid) were too steep for side-scan sonar coverage.

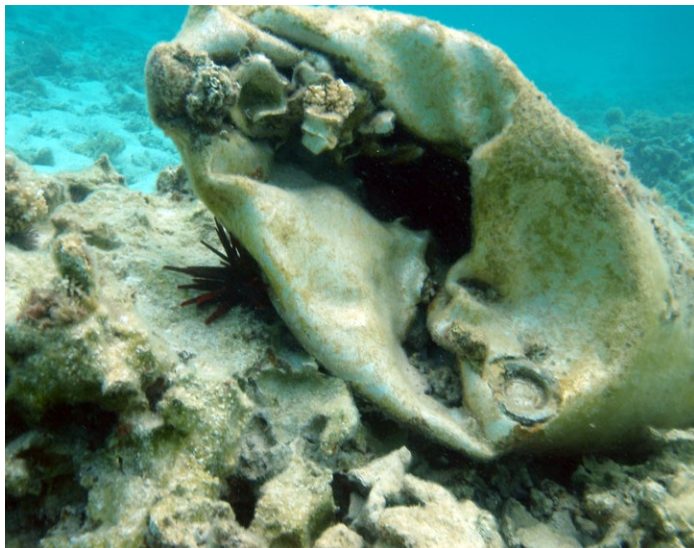
The aluminum skin of the Buffalo's tail cone appears free of any significant coral growth or corrosion. NOAA/Cathy Green.

The good news is that the wreckage of the Buffalo is not difficult to see. There is little-to-no coral growth obscuring the shape of artifacts and the aluminum skin of the tail cone, which apparently tore loose as the plane flipped, looks remarkably pristine after more than 70 years in shallow salt water. One landing gear leg and wheel are present, ripped off

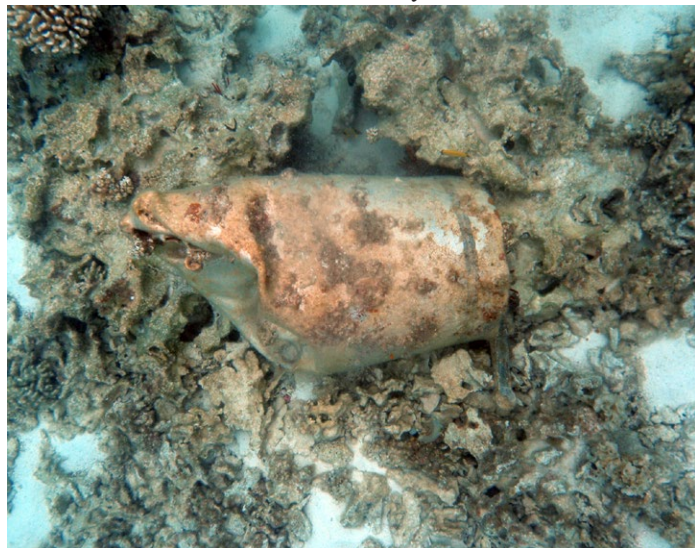
The tail cone was apparently torn loose as the aircraft flipped inverted. The tail wheel was found at the opposite end of the debris field. NOAA/Cathy Green.

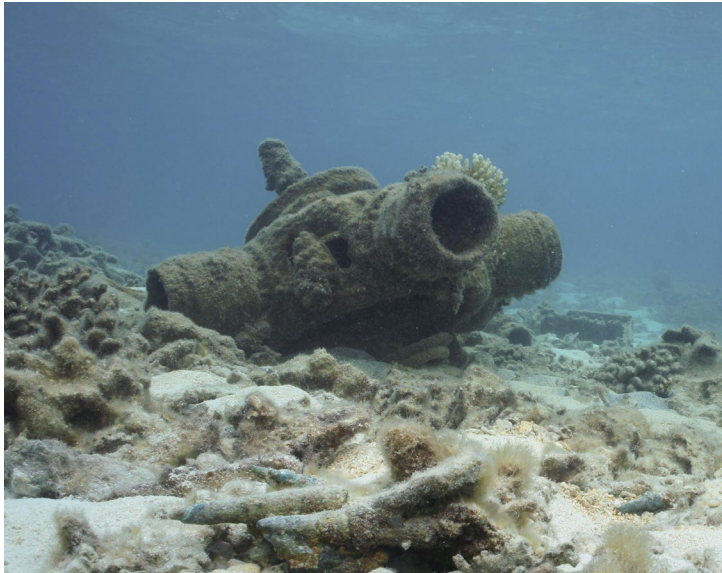
Most of the engine is missing. NOAA/Bert Ho.

- ◆ the light-weight aluminum cowlings are gone, apparently carried away by underwater forces.
- ◆ the prop has come off the crankshaft.
- ◆ most of the massive Wright R-1820 engine is missing.
- ◆ the guns, once together in the cowlings, are more than ten meters apart.

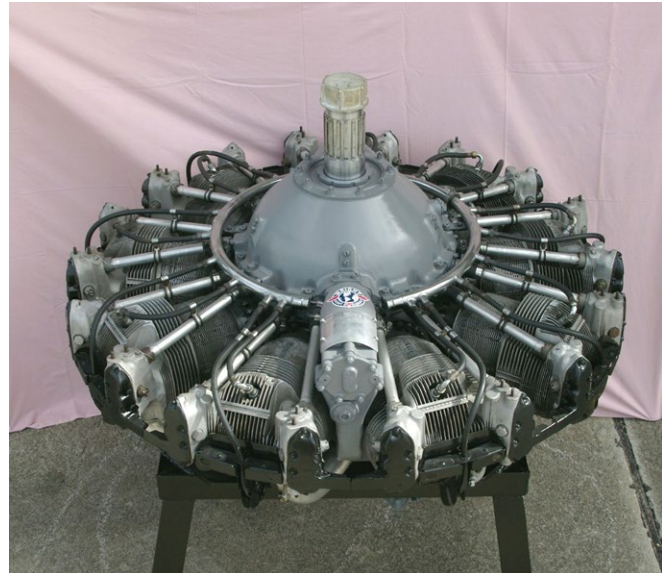
The Buffalo's Wright R-1820-40 Cyclone, was similar in construction to the Electra's smaller Pratt & Whitney R-1340 S3H1 Wasp engines.

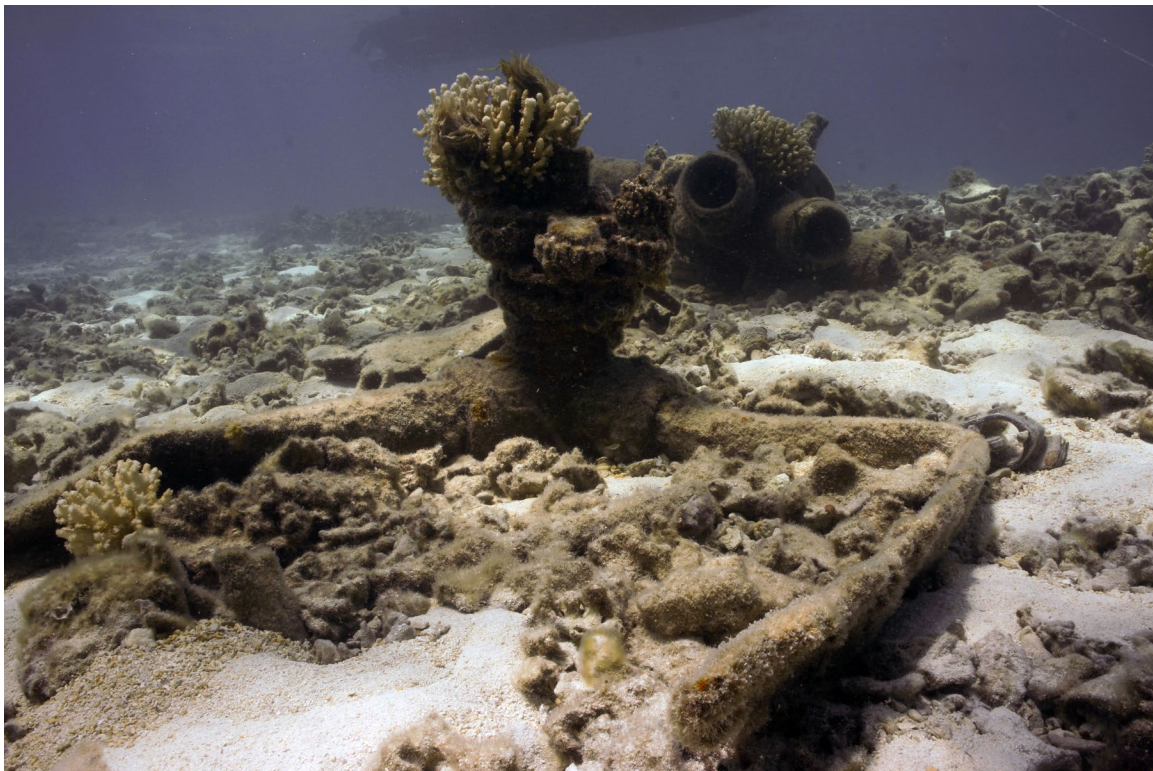
The propeller shows the effects of striking the bottom during the crash. NOAA/Bert Ho.

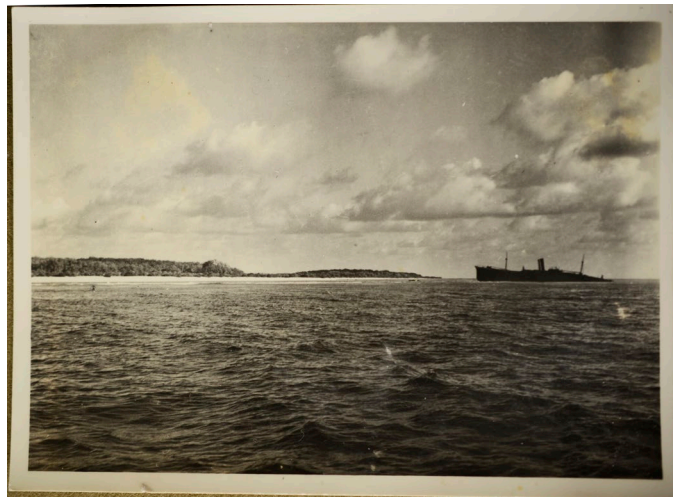
The Bevington Photo measures 2.5 by 3.5 inches and is reproduced here actual size.

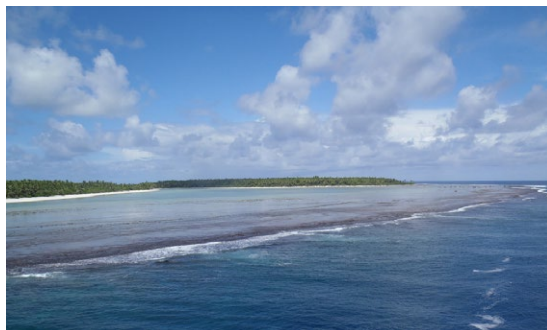
Nikumaroro is surrounded by a broad, flat reef that dries at low tide.

The broad, flat expanse of hard coral which surrounds the island's shore dries at low tide to provide a very attractive surface upon which to make a forced landing. However, a disabled aircraft on that reef-flat would, at high tide, be partially afloat in 3 to 4 feet of water. Over a period of a few days tidal cycles would move the aircraft inexorably toward and ultimately over the edge of the fringing reef. From there it's a steep plunge to depths of 2 to 4 thousand feet.

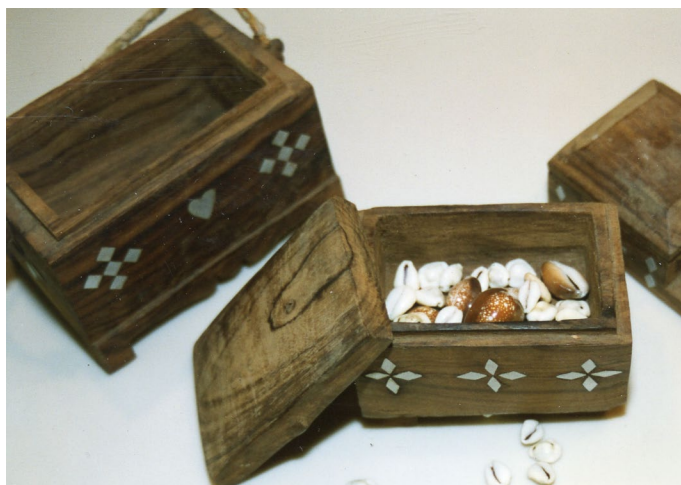
Carved wooden boxes inlaid with metal "from the wrecked plane."

Dr. Mims let us remove one of the inlaid pieces of aluminum and have it tested. It's 24ST AL-CLAD, the kind of aluminum sheet used in the construction of Earhart's Electra – and virtually every WWII American aluminum aircraft – but Mims was on Gardner before the locals had access to WWII wrecks.

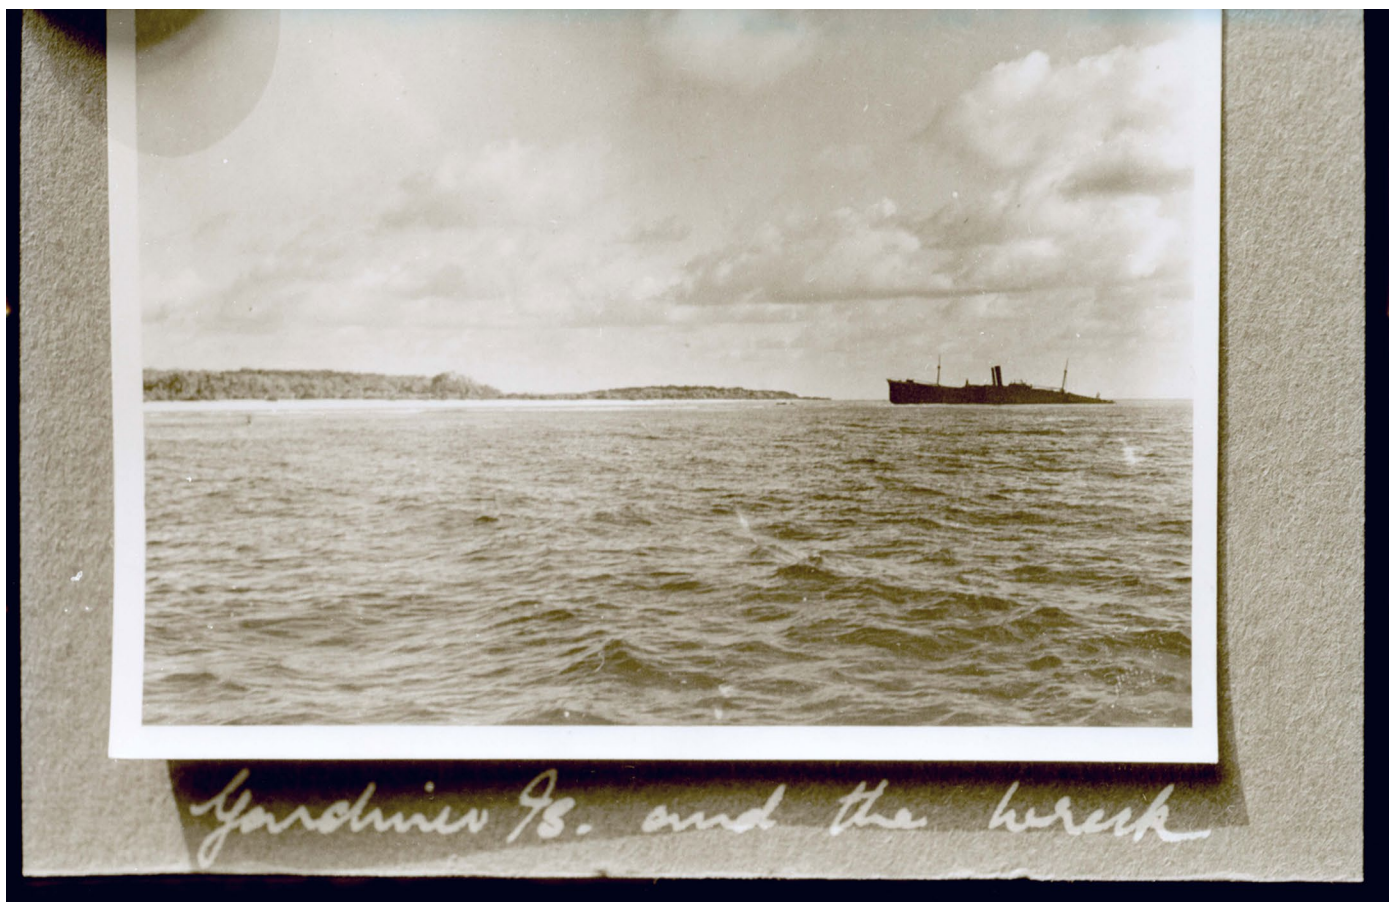
The full-frame 1992 copy photo. "What's the thing sticking up out of the water...?"

- ◆ A flaw in the photo? Jeff said no.
- ◆ A coral block thrown up onto the reef surface by a storm? No. Wrong shape and too complex.
- ◆ *Norwich City* debris? Too far from the shipwreck and in the wrong direction.
- ◆ Airplane wreckage? Maybe.

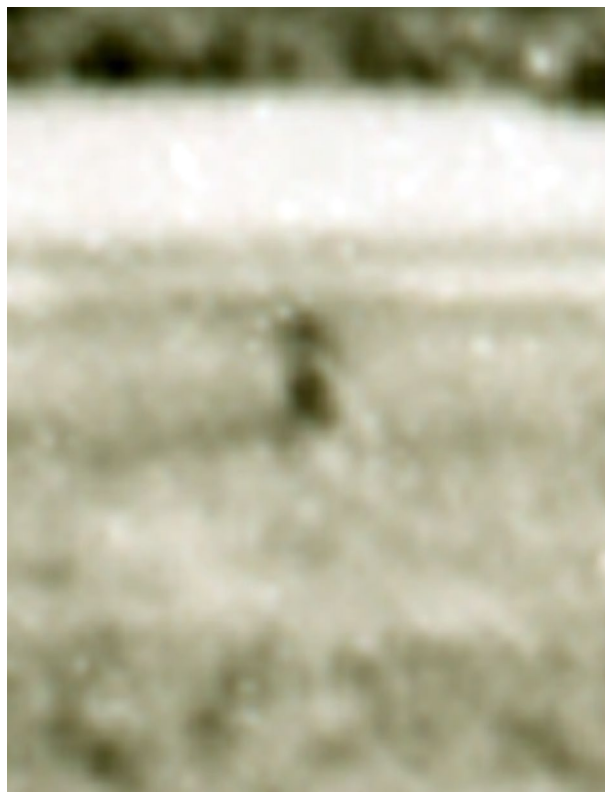
Jeff calculated the object's position by triangulating features that are identifiable in both the 1937 photo and in a modern satellite image of the island. With the ship of known dimensions providing a convenient scale, Jeff was able to place Nessie 416 meters – about a quarter of a mile – north of the shipwreck and at the very edge of the reef flat. It was the same spot Emily Sikuli had marked on our map eleven years earlier.

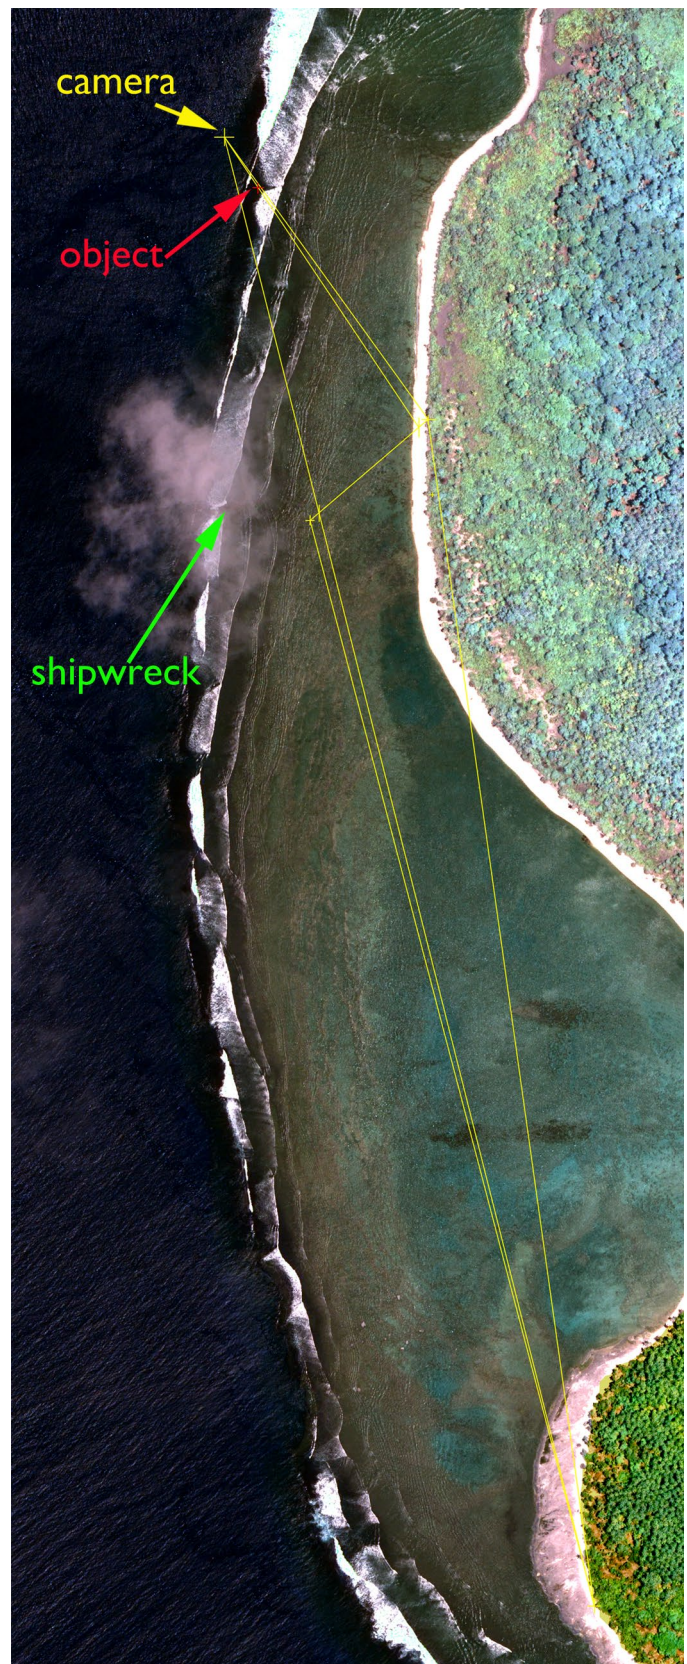
By identifying features visible in both the 1937 photo and a modern satellite image, Jeff Glickman was able to triangulate the position of the camera and the object.

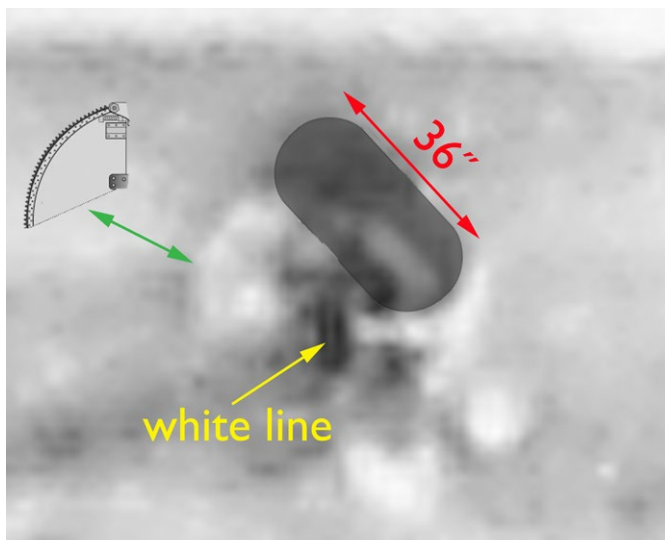
Elements in the scanned image resembled components in the landing gear of Earhart's Electra.

The first item of interest was that the diameter of what might be a tire appeared to be roughly 36 inches – the Goodyear Airwheels on Earhart's Electra had a diameter of 35 inches. The second item of interest in the new image was a fine white line on the central dark area. The line is an illusion caused by image processing software in the scanner but the fact that the scanner put a line there suggests a cylindrical shape consistent with a landing gear strut. A third item of interest was a light colored section on the left side of the strut-like area. The size and shape was similar to the worm gear on the landing gear of Lockheed Electras – or rather, some Lockheed Electras. (See "Part No. 40776" page 45.)

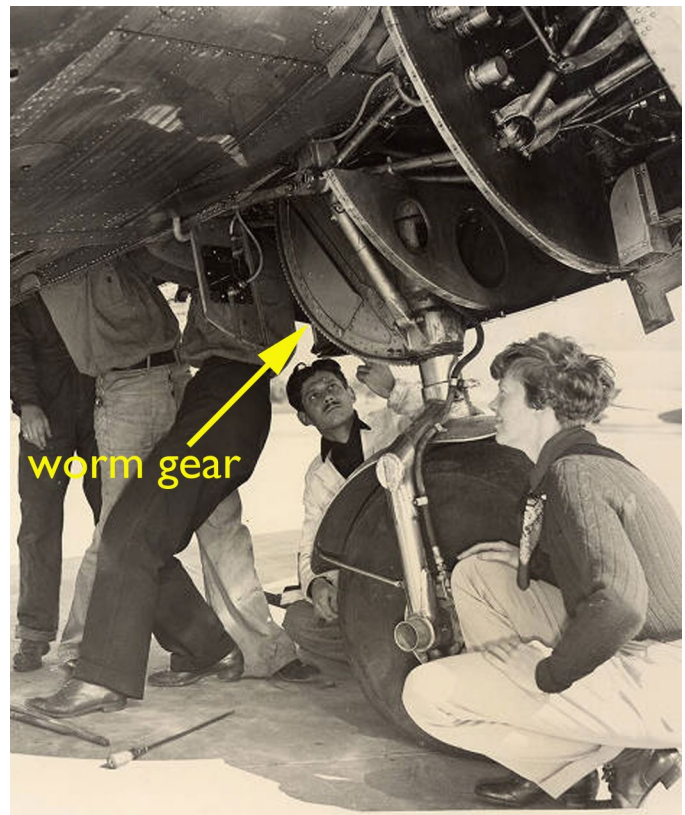
The first 55 Lockheed Electras featured Lockheed Installation 40650, a main landing gear assembly that featured a heavy steel "worm gear" as part of the retraction mechanism.

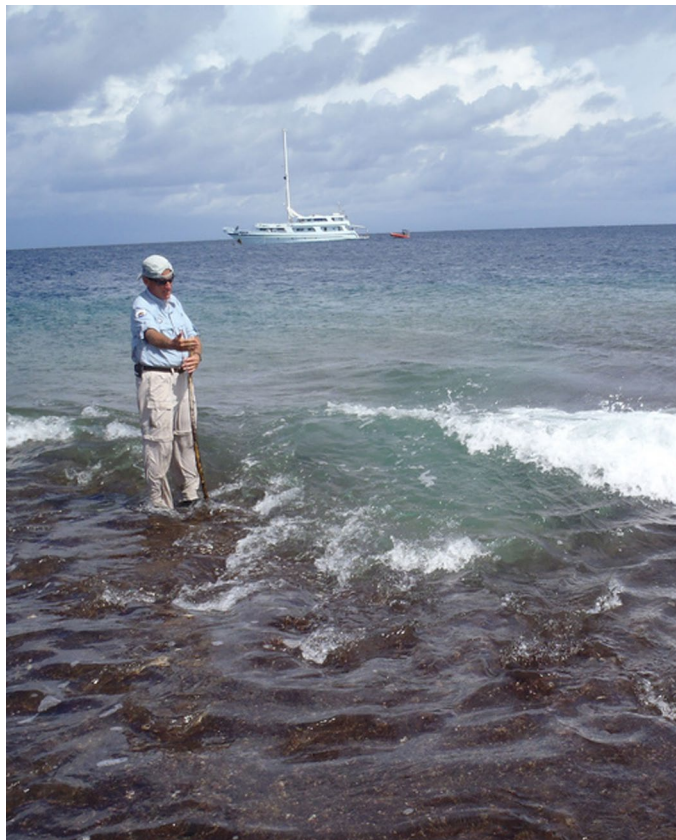
TIGHAR's Gary Quigg beside the reef groove at the Nessie location, May 27, 2010.

went to the GPS coordinates calculated from Jeff Glickman's placement of Nessie. We didn't expect to find surviving debris on the reef surface, and we didn't, but we did confirm that there is a deep natural groove in the reef surface in that location.

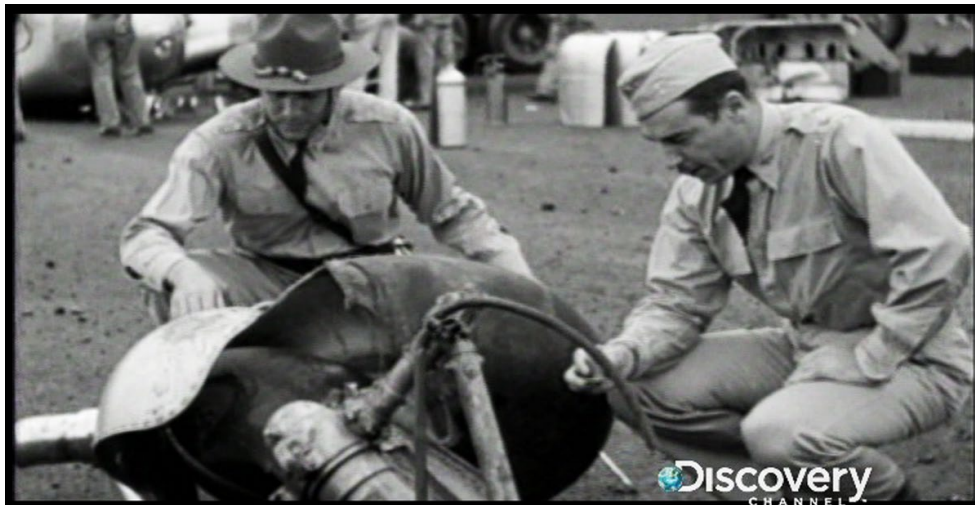
The clip in the Discovery Channel show was only three seconds long and did not show the entire landing gear but there was enough of it visible to reconstruct what had happened.

In September 2012 I stumbled upon a brief clip of old newsreel footage in the 2010 Discovery Channel special "Finding Amelia" that I had not previously noticed. The film was shot at Luke Field following the accident that ended Earhart's first world flight and showed two Army officers crouched over the Electra's right main landing gear. Although not mentioned in the extensive U.S. Army accident report, it was apparent from the clip that the entire landing gear assembly had separated from the airframe – and it looked startlingly familiar. Further research was clearly needed.

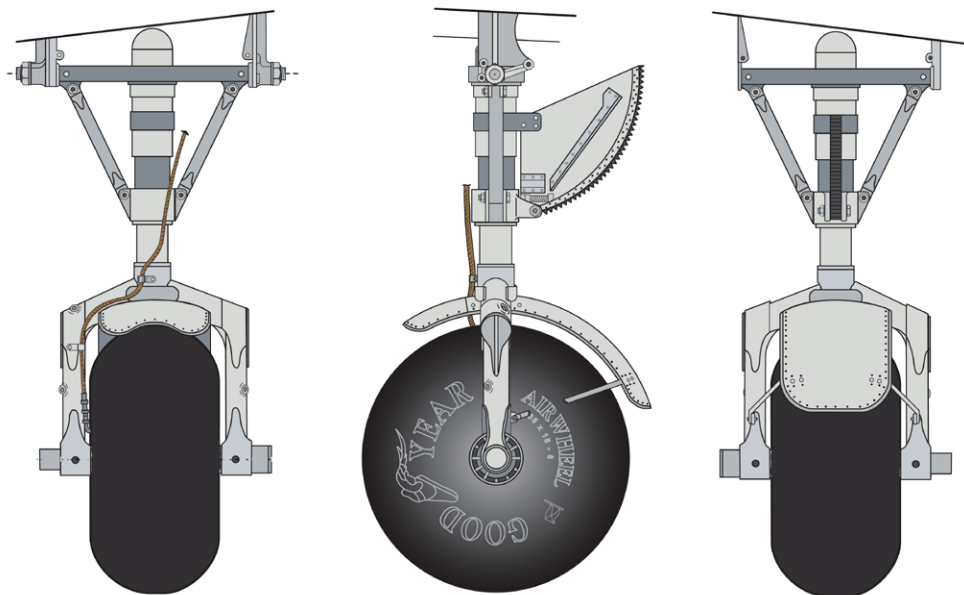
Front, profile and rear views of Lockheed Model 10 Landing Gear Installation 40650.
