TIGHAR TRACKS

THE JOURNAL OF THE INTERNATIONAL GROUP FOR HISTORIC AIRCRAFT RECOVERY

CONTENTS

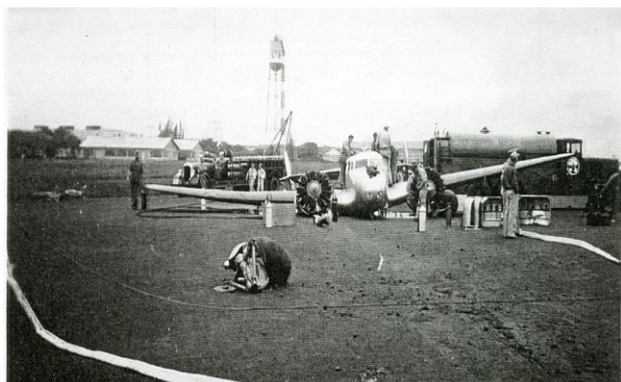
A photograph taken by Gerald Berger, the Navy mechanic who drove the crash truck at Luke Field, shows the mangled wreckage of the right main landing gear assembly where it lay after separating from the airframe during the crash. TIGHAR photo courtesy of G. Berger.

With a real-life model of how the landing gear on NR16020 could fail, the Bevington Object seems to pop into focus. The distinctive shapes of the tire, fork, and worm gear are clearly visible to the untrained eye. These three elements in the image are the right color, shape, and dimensions, and in the correct proportion to each other, to be the Goodyear Airwheel; Lockheed Part No. 40776 Fork, landing gear; and Lockheed Part No. 41065, Gear, worm – components of Lockheed Installation 40650. The assembly appears to have failed in much the same way it did in the Luke Field accident.

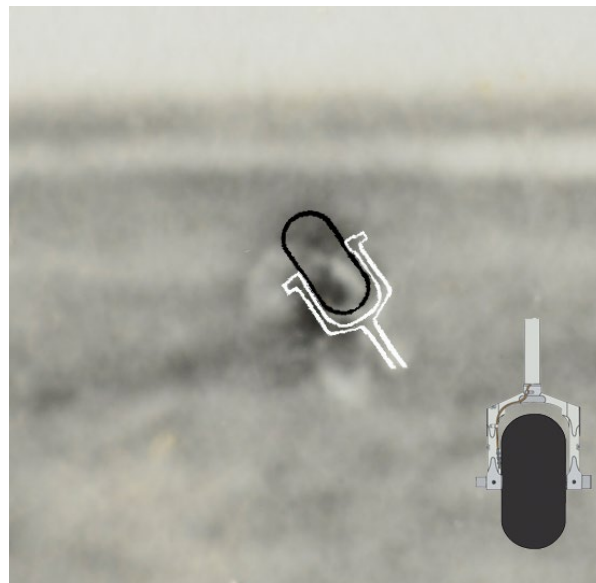
The distinctive shape of “Lockheed Part No. 40776 Fork, landing gear” had been there all the time but we hadn’t recognized it. The tire remained on the axle just as it did at Luke Field.

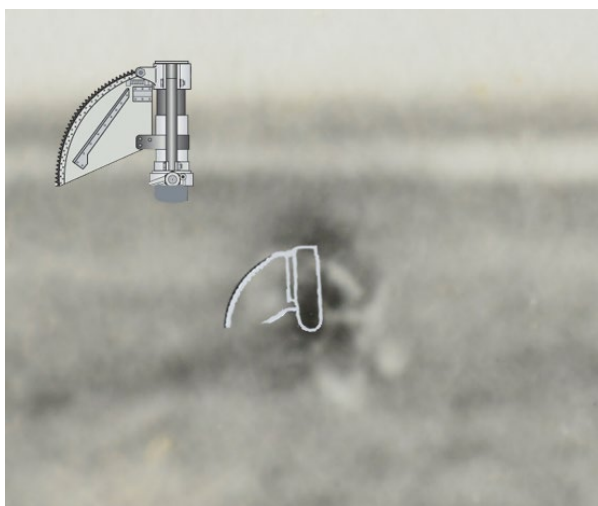
The upper part of the oleo strut appears to be inverted and, in this case, “Lockheed Part No. 41065, Gear, worm” does not appear to be inside the tire. Part of the worm gear may be underwater.

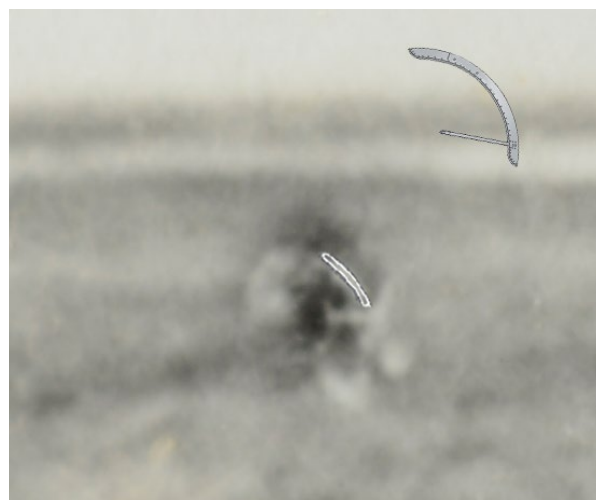
The curved light-colored shape may be part of the fender.

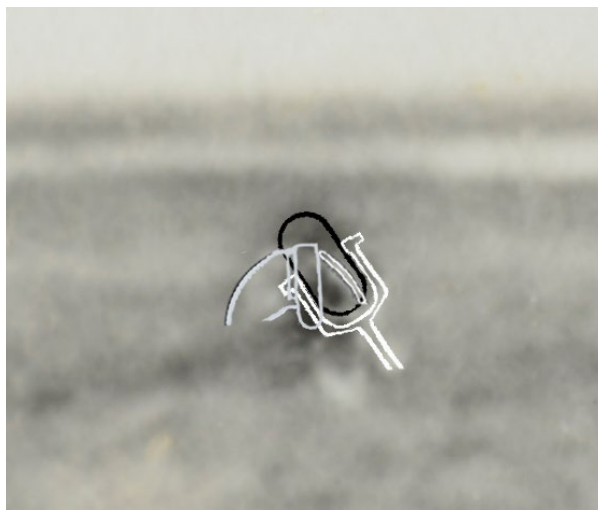
The identifiable elements in the Bevington Object are consistent in size, shape, and color with the components of the landing gear of Earhart’s Electra and are distributed in much the same way they were in the Luke Field accident.

The statistical probability of an unknown object that is not the wreckage of Electra landing gear having all of the quantifiable characteristics present in the Bevington Object is vanishingly small. The fact that the object is in the area where abundant other evidence had already led us to conclude the aircraft was landed adds a further level of likelihood that the object in the photo is what it appears to be: a photo of wreckage from NR16020 on the reef at Gardner Island in October 1937. ◆

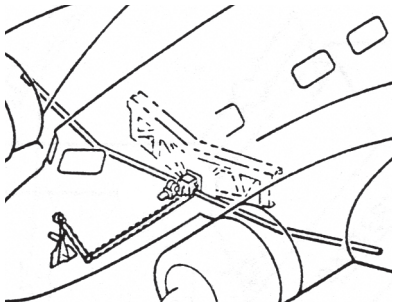
As illustrated in the Model 10 Maintenance Parts Catalog, the Electra's retractable landing gear was driven by steel shafts that extended out from an electric motor and transmission mounted on the girder-like main beam.

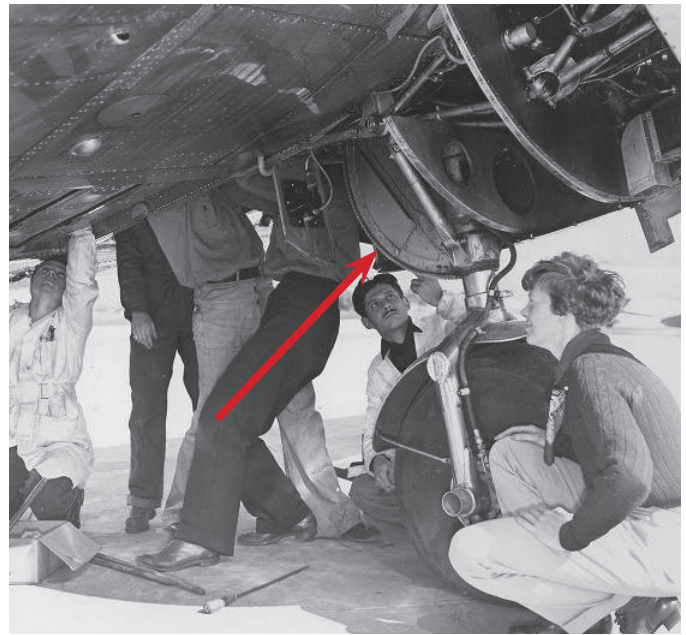
In this photograph the worm gear can be seen on the left main landing gear strut of Earhart's Electra.

The price of simplicity was weight. The massive “worm gear” has been described as “something you’d normally see on a cement mixer” and its bulk was the cause of the first Electra accident. On the prototype’s final Bureau of Air Commerce certification test flight in August 1934 one of the wheels failed to extend for landing. Apparently one of the drive shafts was not up to the task. Lockheed test pilot Marshall “Babe” Headle made a successful one-wheel landing but the cost of repairs was a blow to the struggling young company.³

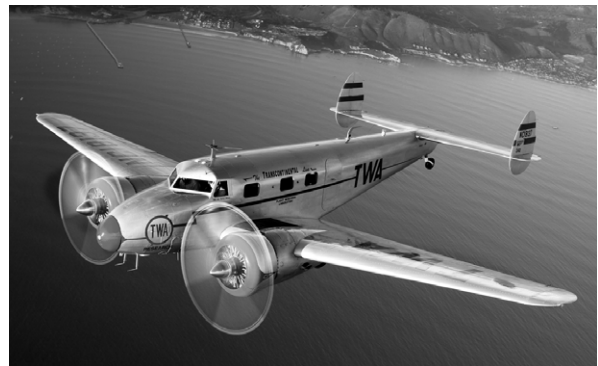
The Model 12 Electra Junior was smaller, lighter and faster than its big sister.

a full 18% lighter than its big sister, aided in large part by a new, lighter, faster landing gear retraction system.⁵ Instead of the clunky worm gear, the Electra Junior's landing gear featured an articulating “knuckle” that was hinged in the middle and jack-knifed forward as the wheel was pulled up and back.

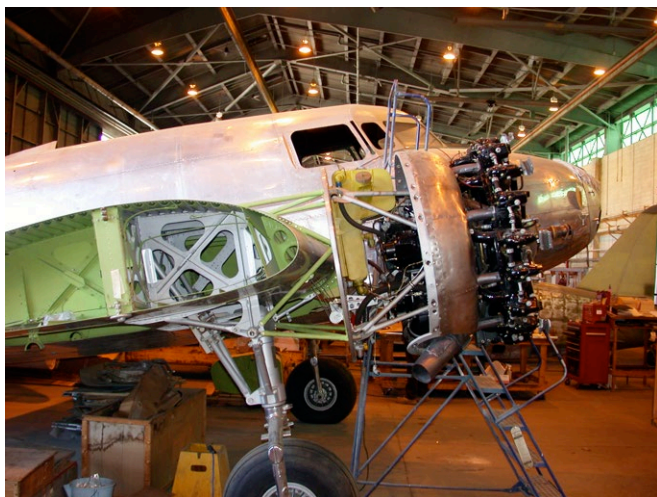
In this photo of Lockheed Model 10A c/n 1130, under rebuild at the National Museum of Naval Aviation, the "new" retraction system – Installation 45100 – is clearly visible.

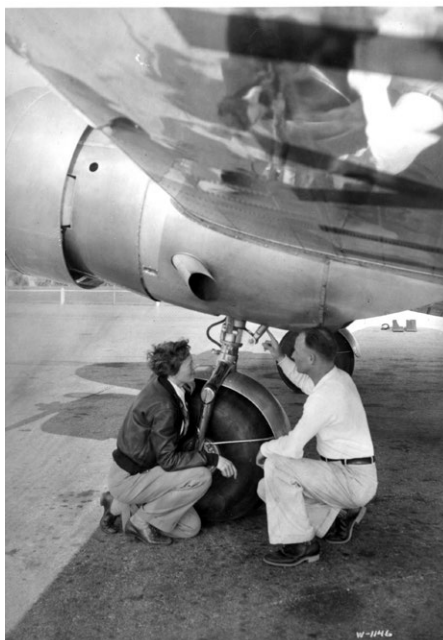
Lockheed test pilot Marshall "Babe" Headle with Amelia Earhart. "You see Amelia? We got rid of that heavy worm gear mechanism like the one on your airplane and replaced it with this new drag strut system." Ironically, the Electra in the photo is Model 10A c/n 1060, registered VH-UXH and destined for Guinea Airways in Lae, New Guinea.

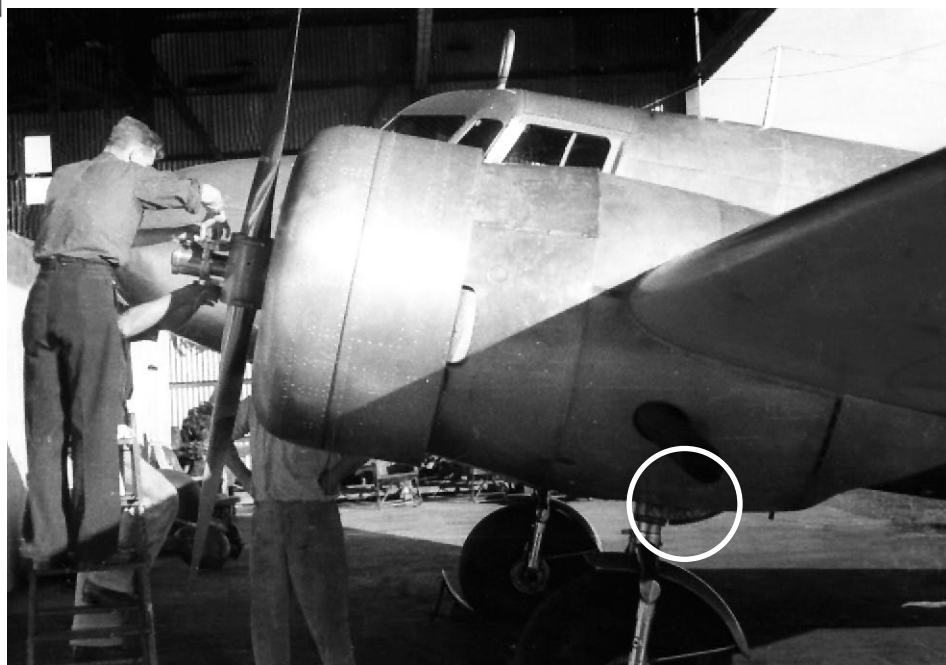
In Lae, New Guinea Fred Noonan assists with maintenance on the left engine propeller hub of NR16020. The bottom edge of the worm gear is clearly visible on the rear side of the left main landing gear strut.

Earhart's Model 10E Special, c/n 1055, was the last airplane built with the old worm gears.⁷ It is a bit surprising that the system was not upgraded when the airplane was in the shop for extensive repairs following the Luke Field debacle but that was probably because time and money were in short supply. Photos of NR16020 in Lae, New Guinea leave no doubt that the airplane still had the 40650 system when it disappeared.

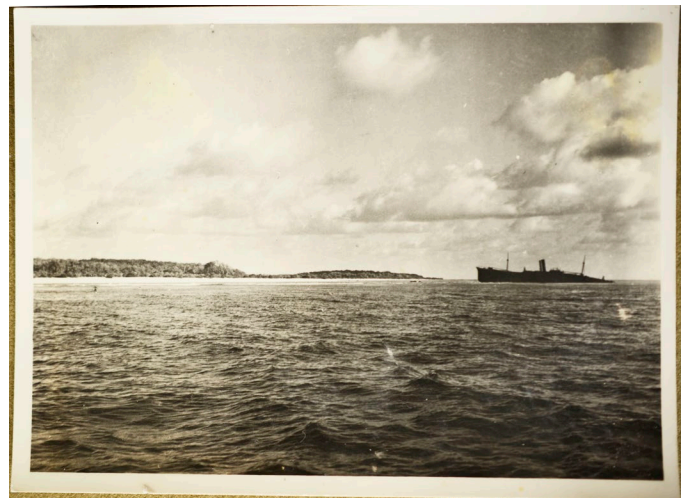
The object on the reef north of the shipwreck, visible in a photo taken by Eric Bevington in October 1937, appears to be the wreckage of one of the *Electra's* main landing gear assemblies.

One of the fifteen photographs Bevington took during their visit appears to show a separated landing gear assembly from Earhart's *Electra* on the reef about a quarter mile north of the shipwreck (see "The Object Formerly Known As Nessie," p. 30) but this piece of debris went unnoticed at the time and, once again, the dogs didn't bark.

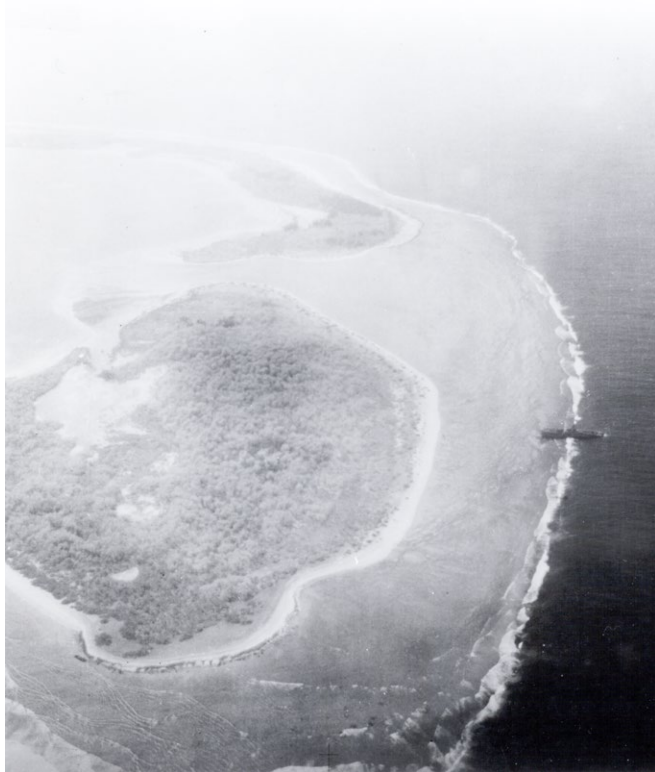
This December 1, 1938 aerial photo clearly shows the shipwreck on the reef but the object in the 1937 Bevington Photo is not discernible.

On November 30, 1938 a ten-man team arrived at Gardner Island to map the atoll and lagoon as part of the New Zealand Pacific Aviation Survey. The next day a Supermarine Walrus launched from the cruiser HMS *Leander* took aerial photos of the island. In those photos no aircraft or aircraft debris are apparent on the reef or in the water. The

object in the October 1937 photo is either gone or hidden by the surf.

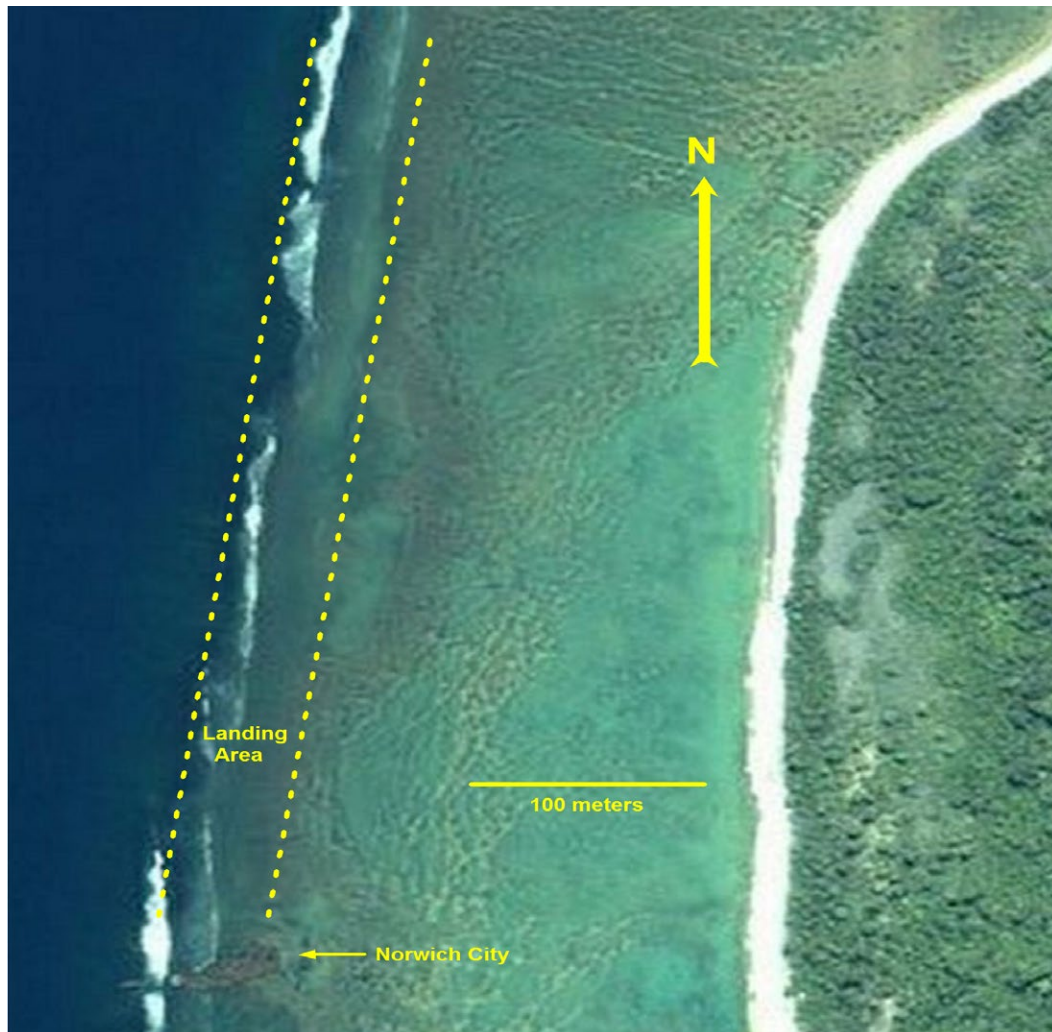
Pilots experienced in aircraft with tires similar to those on the Electra inspected the western reef during TIGHAR expedition Niku III¹ in September 2001. They found the surface dry at low tide, and suitable for landing the Electra in a strip (see photo previous page) about 50 meters wide,² bounded by the seaward edge of the reef, extending north from the wreck of the SS *Norwich City*, a ship that went aground there in 1929. They estimated the Electra could land safely with up to 0.15 meter (6 inches) of water on the surface. The reef immediately shoreward of the landing area was found too rough for landing, but suitable for taxiing the plane.

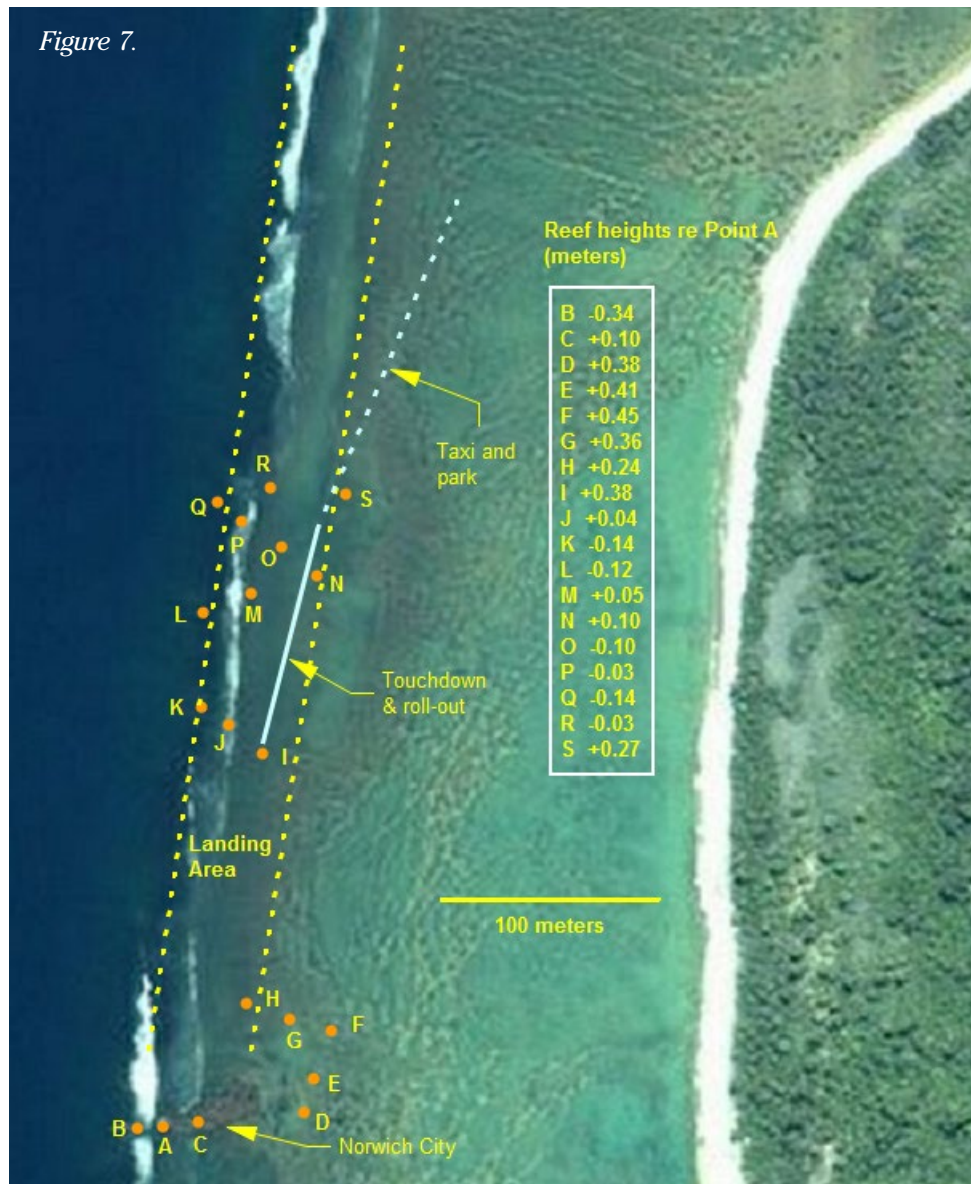
Figure 7 (next page) shows a possible scenario for landing at point I before 11:25, with touchdown at point I, followed by roll-out and taxiing to a parking place somewhere upslope where the transmitter would be dry and the engine-driven generator could be operated. The feasibility of the taxi, parking, and engine-operation components of the scenario, in relation to tide, is examined in the next section.

At least one credible radio signal²⁴ was heard each day during the period 2-8 July 1937, suggesting the plane was parked where the transmitter was dry and operable. The reef height at survey point F – 0.45m greater than point A – shows it was possible for the required height to be found upslope of the landing area. The reef slope indicated by the survey data suggests the required parking area height could be found within 50 meters shoreward of the landing area. Clearly, Earhart had no way of knowing the reef height anywhere, but she could have found a suitable parking place merely by taxiing as far upslope as the reef surface permitted. Therefore, the evidence supports a conclusion that it was possible to satisfy the dry transmitter constraint by taxiing as shown in Figure 7.
