The Riddle of Artifact 2-2-V-1

REPORT OF TIGHAR'S ARTIFACT 2-2-V-1 COMMISSION

RESEARCH CONDUCTED AT THE NATIONAL MUSEUM OF THE UNITED STATES AIR FORCE FRIDAY, MARCH 28, 2014

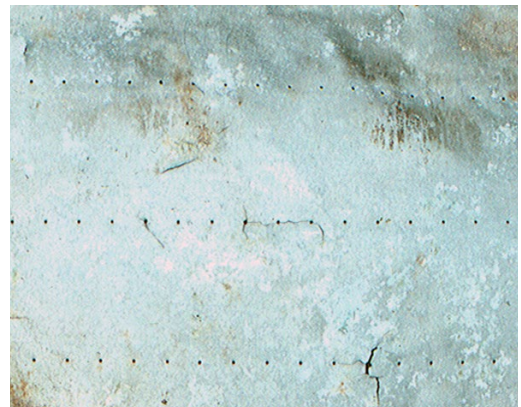
Artifact 2-2-V-1 as found on October 18, 1991. TIGHAR photo by P. Thrasher.

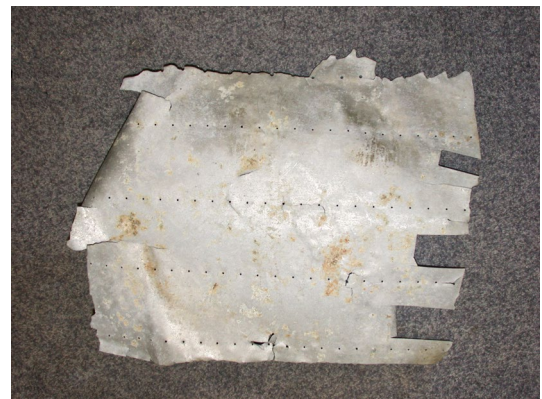
Artifact 2-2-V-1 now. TIGHAR photo by P. Thrasher.

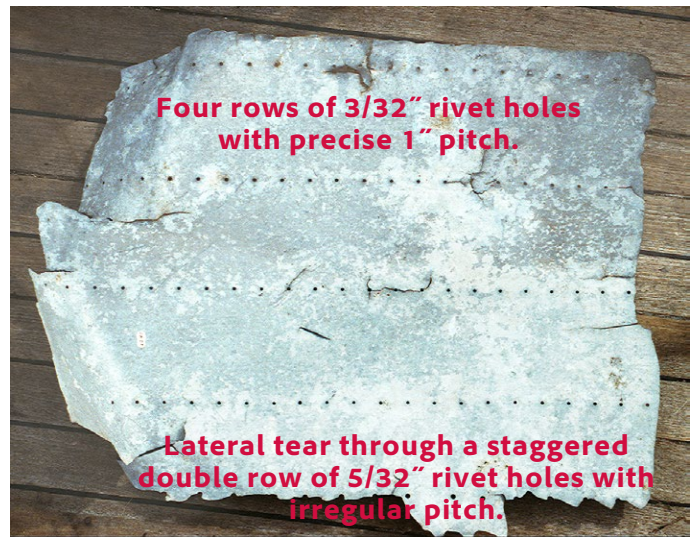
The sheet is perforated with four rows of rivet holes 3/32" in diameter with a precise pitch (interval between holes) of 1". There is no crossing line of rivet holes.

One edge of the sheet failed along a staggered double row of rivet holes 5/32" in diameter with irregular pitch.

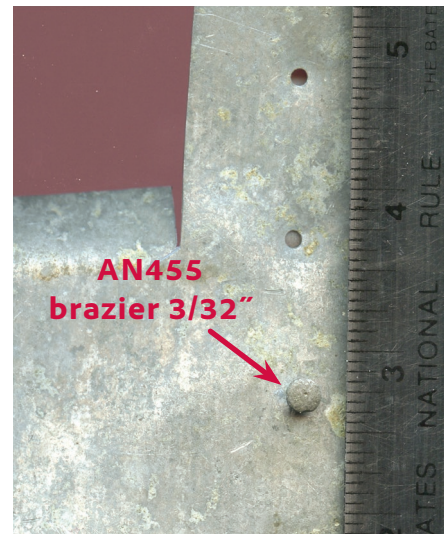
The single surviving rivet is an AN455-AD "brazier head" rivet with a shaft diameter of 3/32" (colloquially a "#3" size rivet). The "brazier head" has a low profile and was used on external surfaces to reduce aerodynamic drag.

The rivet has a shaft length of 3/16" indicating that the underlying structure to which it was once attached was approximately .06" in thickness.

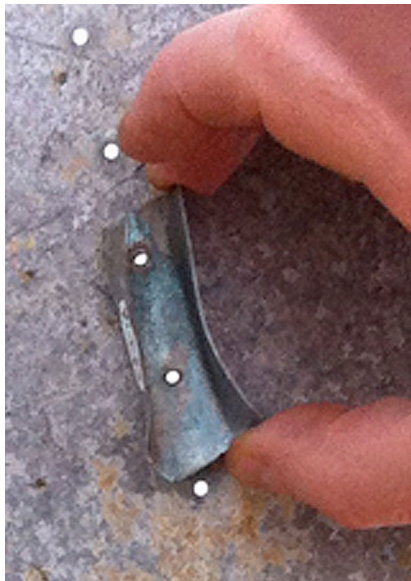
This fragment of stringer from the wreck of Electra c/n 1024 in Idaho is .06" inch in thickness and has #3 size rivet holes with a 1" pitch.

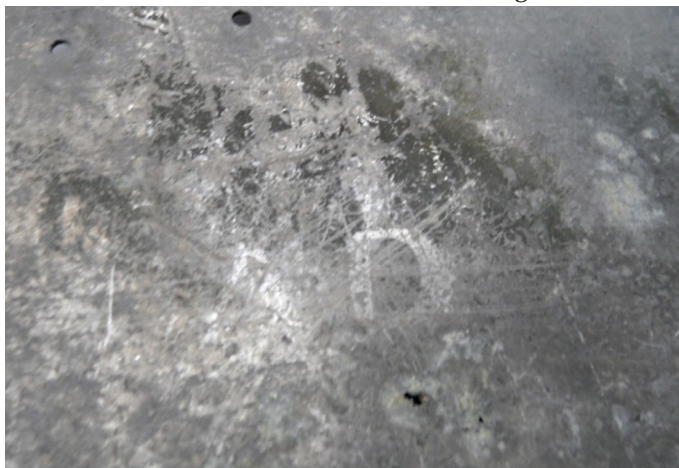
Below: On the exterior surface of the sheet the letters "AD" are clearly visible and are presumed to be remnants of the original Alcoa labeling.

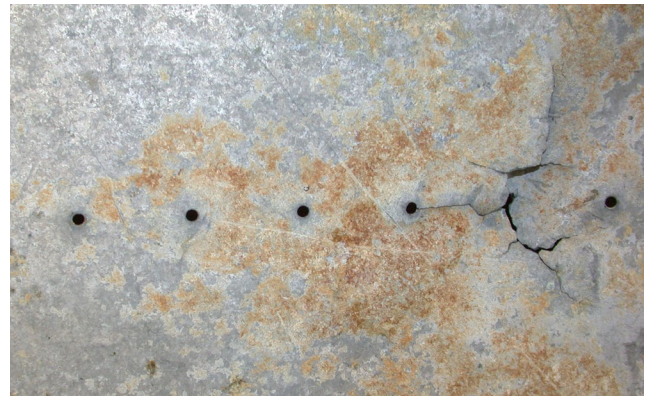
Portions of the sheet have suffered a loss in ductility through exposure to heat – more heat than can be explained by simple exposure to intense sunlight, but not enough heat to melt the metal. Aluminum melts at 1,221°F. The loss of ductility in portions of the sheet is consistent with exposure to heat in the realm of 800°F such as might result from brief exposure to flame. A former resident of Nikumaroro has described cooking fish on a sheet of metal with many small holes.

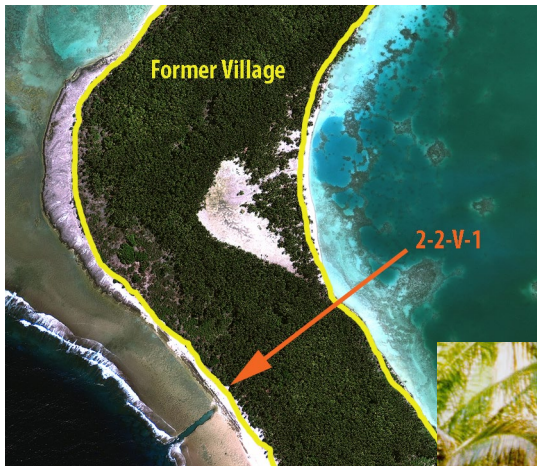
Although found on land, the sheet exhibits several areas of carbonate (coral) encrustation suggesting that it spent months and perhaps years submerged in relatively shallow water.

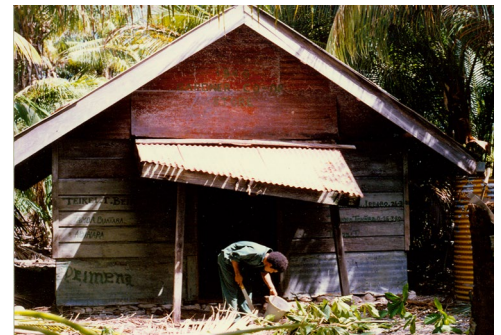
The "1940 Gardner Co-Op Store" was located near the head of the landing channel. This is how it appeared during TIGHAR's first expedition to Nikumaroro in 1989.

When TIGHAR returned to the island in 1991, the beach exhibited severe storm damage. Artifact 2-2-V-1 was discovered among the washed-up beachfront vegetation near the collapsed seaward-facing wall of the store.

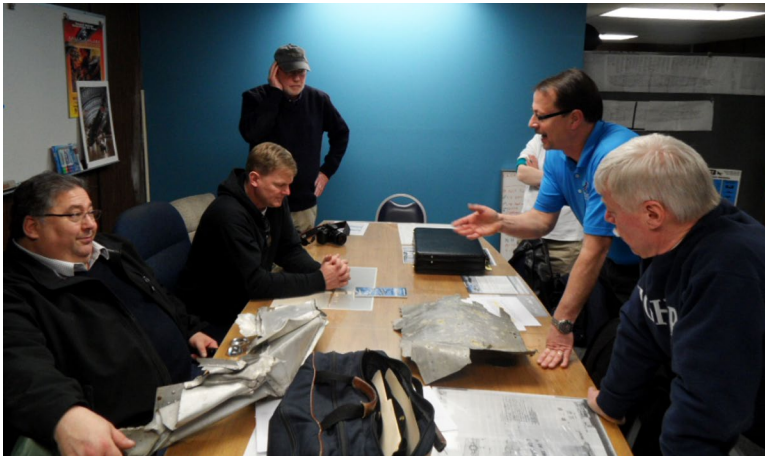
Aris Scarla (left) and Greg Hassler (right) debate the significance of features on Artifact 2-2-V-1. Photo courtesy W. Mangus.

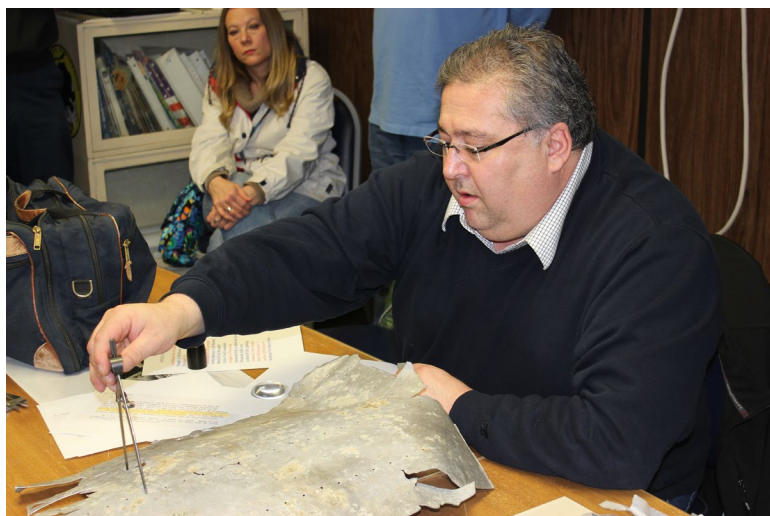
- b. Careful measurement of the space between lines of rivets holes revealed that the lines do not taper or converge as previously believed – including by the National Transportation Safety Board (NTSB) Lab. There are, however, slight irregularities in the spacing between lines suggesting that the underlying structures, presumably stringers, were not precisely aligned. These irregularities suggest that 2-2-V-1 may be part of a repair.

Aris Scarla uses dividers to check span between lines of rivet holes on Artifact 2-2-V-1. Photo courtesy W. Mangus.

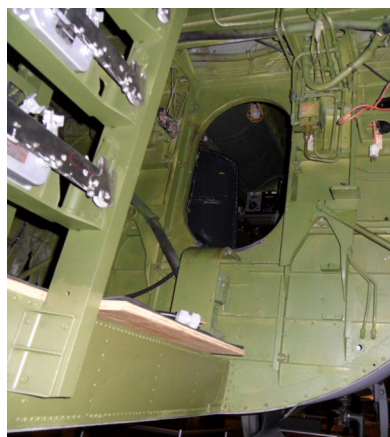
Zinc chromate corrosion inhibitor on the interior surfaces of the NMUSAF B-24 Liberator.

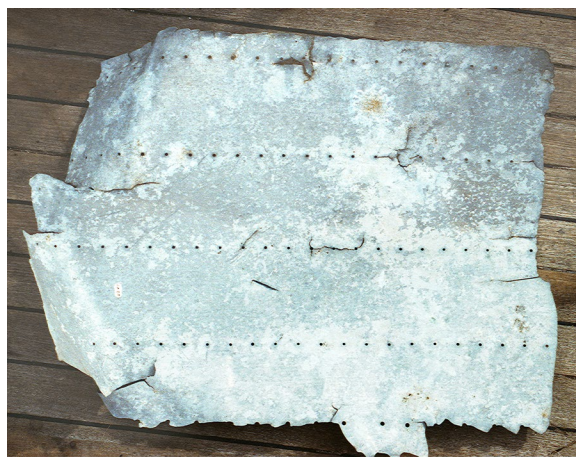
Zinc chromate did not come into common use in aircraft until the late 1930s. Earhart's Electra, constructor's number (c/n) 1055, the 55th Model 10, was built in the spring of 1936. Lockheed sales literature for the Model 10 Electra dated March 2, 1936, specifies that "Although its aluminum coating renders Alclad highly resistant to corrosion, every part of the interior of the airplane is painted for further protection." A section of wreckage recovered by TIGHAR in 2004 from the crash site of Lockheed 10A constructor's number (c/n) 1024, which flew into an Idaho mountain in December 1936, has aluminum-colored paint on the interior surface. A close examination of the interior surface of 2-2-V-1 reveals what may be surviving traces of aluminum-colored paint.

Are there remnants of aluminum-colored paint on the interior surface of Artifact 2-2-V-1? TIGHAR photo by P. Thrasher.

Laboratory testing is presently underway to determine whether there is paint on the interior surface of the artifact. If paint is found it will be compared to the paint on the interior surface of known Lockheed Electra wreckage dating from 1936.

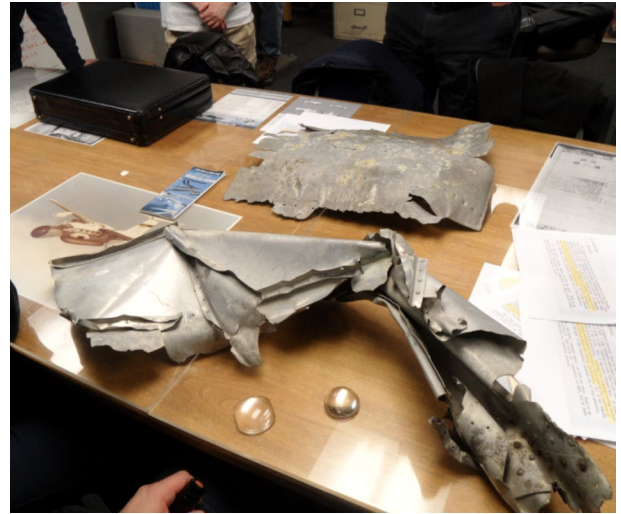
The section of known Electra wreckage in the foreground has aluminum-colored paint on the interior surfaces. Photo courtesy W. Mangus.

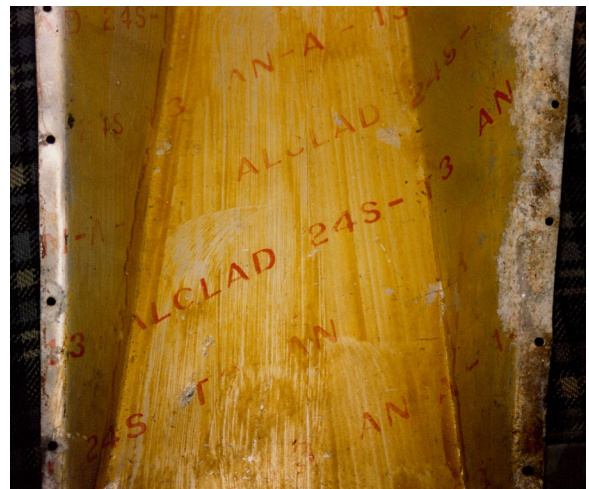
This example of AN-A-13 labeling was on the inside of a flap actuator cover in the passenger cabin of Electra c/n 1052 at the New England Air Museum in Windsor Locks, Connecticut. Whether it is original to the aircraft or a later replacement is unknown. TIGHAR photo by P. Thrasher.

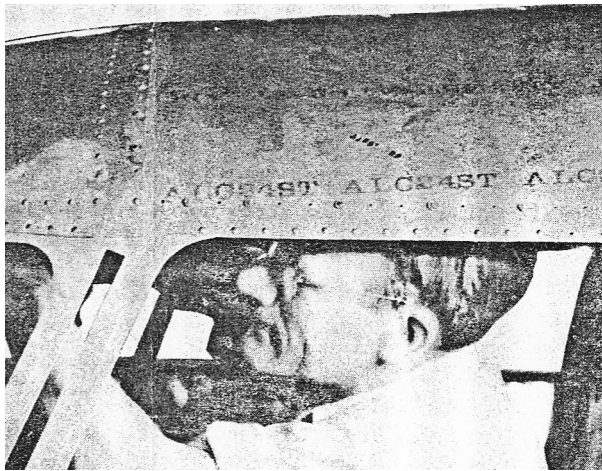
Alcoa labeling on this Electra under construction is simply the repeated designation ALC24ST.

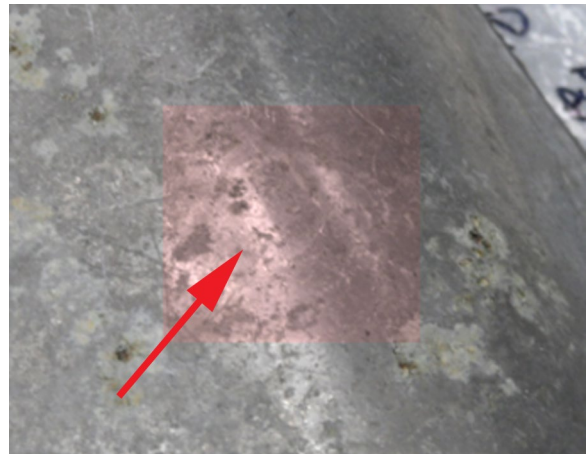
Commission member Mark Appel’s fiancée Michelle Martin found another “D” on 2-2-V-1. It is hard to see and somewhat distorted by a bend in the metal, but it’s definitely there. Photo courtesy J. Neville.

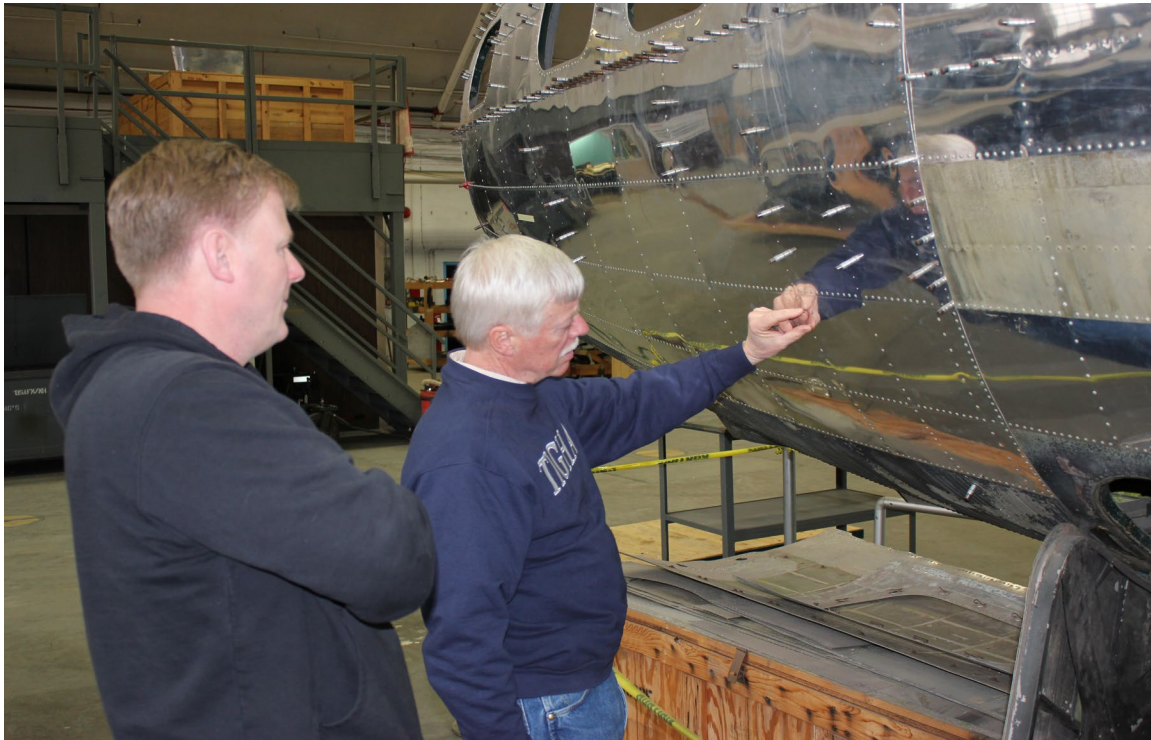
*Ric Gillespie and Jeff Lange discuss the rivet pitch on B-17D "The Swoose."
Photo courtesy W. Mangus.*

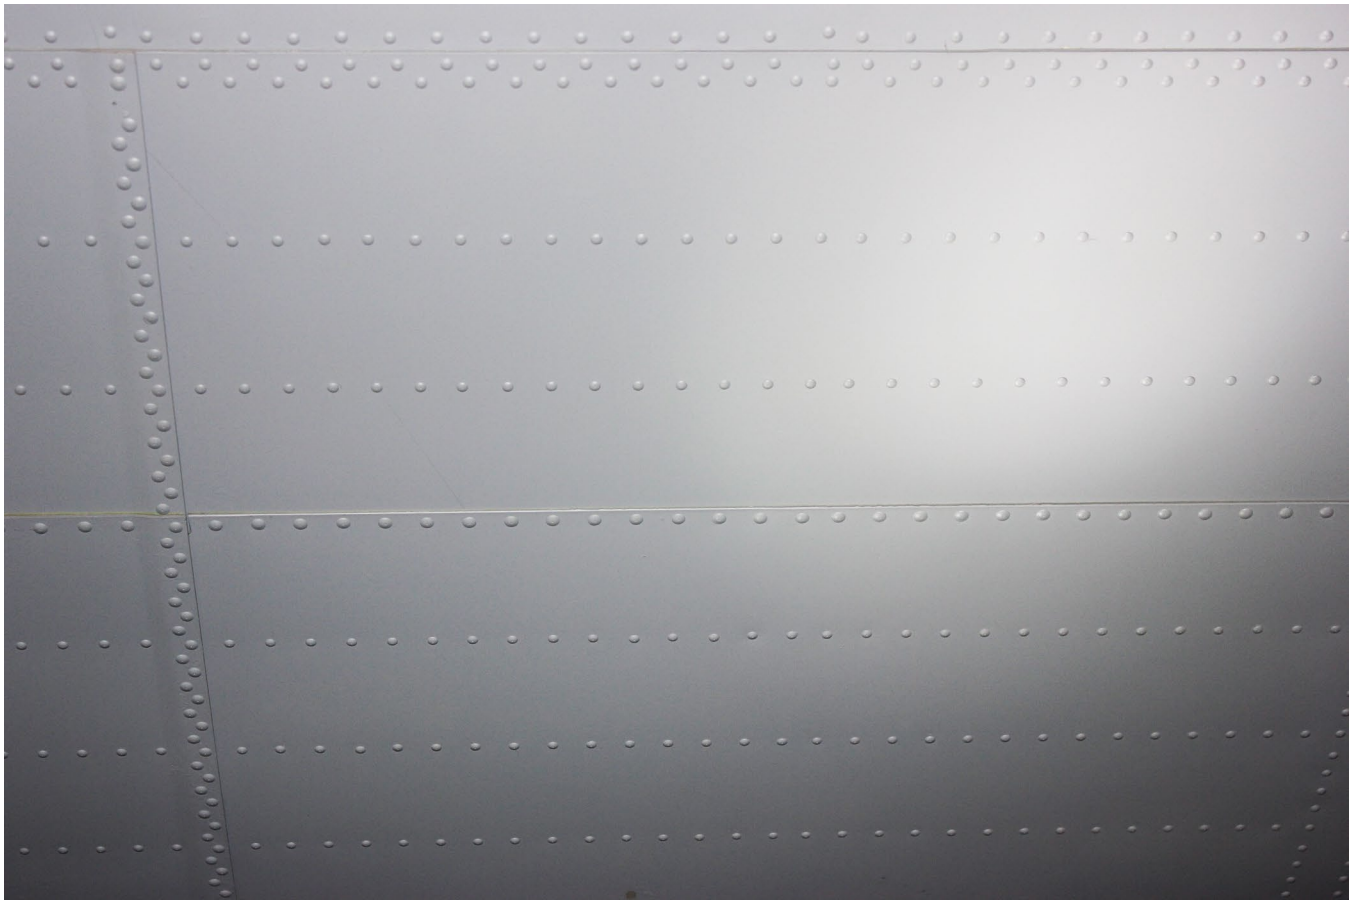
The rivet pattern on the underside of the B-24 horizontal stabilizer was somewhat similar to the pattern on 2-2-V-1. Photo courtesy J. Neville.
