Found Objects

The following is a description and evaluation of the twelve aircraft-related objects found on Nikumaroro to date. The artifacts are presented in the order in which they were discovered. In most cases, their physical properties have been established with the help of governmental or private laboratories. The opinions expressed about their probable origins are solely TIGHAR's. The map on page 22 shows where each artifact was found.

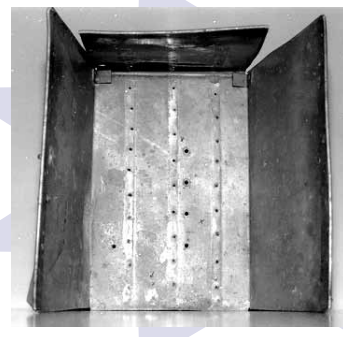
1. Navigator's Bookcase (TIGHAR Artifact 2-1)

Description: An open box constructed of .040 inch aluminum with a single row of four .25 inch diameter holes offset left of center on the side facing the opening. Traces of a sloppily-applied greenish yellow coating are present on the interior surfaces. Stamped into the metal in three locations is the designation 28F4023.

Condition: One side of the box has been removed, possibly with a hack saw, and the remaining corners have been cut apart, apparently with the same tool. Interior fixtures once secured with #4 ($\frac{4}{32}$ inch) AN442 (flat head) rivets have been removed, leaving enlarged and deformed holes.

Identification: Artifact 2-1 is Consolidated Aircraft Part Number 28F4023, officially described as “Box–Furn., Navig. Book & Paper Stowage.” Although designed for the PBY (Consolidated Model 28), this particular bookcase has been modified for installation in a B-24 type airplane. Early examples of the Consolidated Model 32 (B-24C and some B-24D/PB4Y-1 aircraft, a total of 1,653 machines) were equipped with PBY bookcases. Later, Consolidated designed a special bookcase for the Liberator which carried a 32F** part number.

Commentary: At first, this artifact really had us stumped. It was obviously a PBY part, but the mounting holes indicated that it was never installed in a PBY. Could it have been aboard Earhart’s airplane? It took two years of research to determine that the answer is no, but knowing that it came from a B-24 became important in the light of later discoveries.

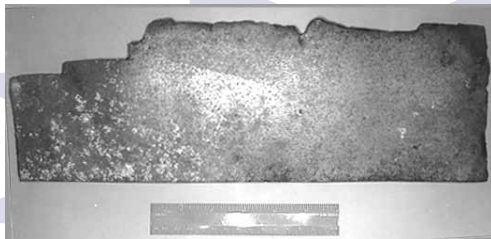
2. Sheet of aluminum with red paint (TIGHAR Artifact 2-2)

Description: The sheet is about 5.25 inches wide by 15.5 inches long and is 0.032 inches thick. The long straight edge of the piece appears to have been an original manufacturer’s cut. The piece appears to have been further mechanically cut where right angle corners are evident. Magnified examination of the inside corner sections of these cuts revealed deformation patterns typical of cuts made with a pair of tin snips. The remaining edges of the sheet appear to be typical tearing fractures. One surface of the sheet has a rusty brown stain on about half of its area. The opposite surface has a faint red coloration over a portion of its surface. The material is 2024 (previously known as 24ST) aluminum but is not Alclad (a corrosion inhibiting treatment).

Condition: Even though the aluminum is not Alclad, the piece exhibits only mild surface corrosion. The area of apparent red paint on one surface may or may not be a result of local adaptive use.

Commentary: The absence of rivet holes along the original manufacturer’s cut edge, and the fact that it is not Alclad, argue against this piece ever having been part of the skin of an airplane. The small rectangular strips cut from one end suggest that this might be connected to an incident remembered by Coast Guard veteran Ernest Zehms who was stationed on the island in 1944. In 1992 Zehms recalled that one of his friends collected some small pieces of aluminum from a B-25 wreck on Canton Island and brought them to Nikumaroro for the purpose of making aluminum watch bands. However, when shown a photograph of this artifact Zehms did not recognize it. It is worth noting that an inventory of the Earhart aircraft taken after the March 20, 1937 crash in Hawaii lists “2 Pcs. Sheet metal Alcoa” (Item #66) as being among the spare parts carried.

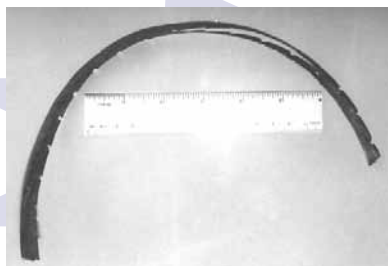
3. Cut Strip of Aluminum (TIGHAR Artifact 2-3)

Description: This is a 14 inch long by $\frac{1}{2}$ inch wide strip of .040 inch nominal thickness aluminum alloy (Alclad). The strip has a manufactured edge along one side and an unidentified edge separation along the other side that intersects a line of $\frac{4}{32}$ inch diameter holes. The holes are nominally spaced $\frac{3}{4}$ inch on center. The strip is deformed in a spiraling curl suggestive of the waste side strip produced from cutting with a pair of tin snips.

Condition: One end of the strip exhibits exfoliated corrosion.

Commentary: Nowhere on a Lockheed Model 10 are there #4 rivets so closely spaced. The only other artifact found on Nikumaroro which exhibited exfoliated corrosion is Riveted Assembly 2-2-V-8, a known B-24 part.

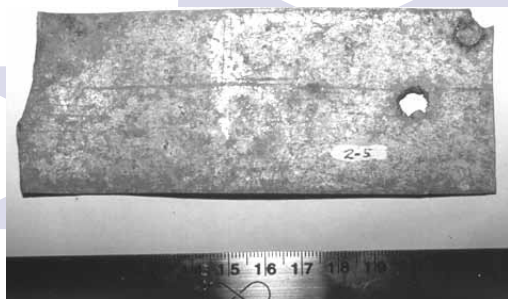
4. Aluminum Plate (TIGHAR Artifact 2-5)

Description: This is a roughly rectangular piece of 2024 Alclad about 2 inches by 5 inches and 0.062 inches thick.

Condition: There is a straight sheared edge (manufacturer's cut) along one long side, a bending overstress fracture along one short edge, and the other two edges exhibit typical saw cut markings. A ragged hole went through one end of the plate as if cut by multiple strikes with a thin narrow instrument such as a small chisel or screwdriver. A second similar hole was cut partially through the plate.

Commentary: The plate is the same thickness as Riveted Assembly 2-2-V-8, a known B-24 part. There are no .062 skins on either the B-24 or the Lockheed 10. This is probably part of a structural member and may be part of 2-2-V-8.

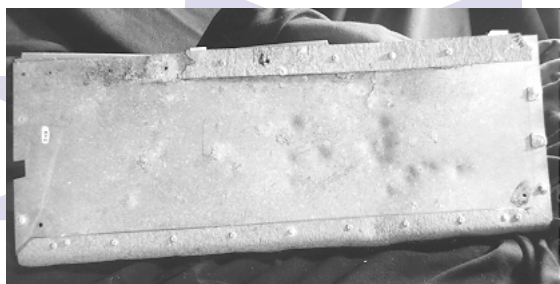
5. Dado (TIGHAR Artifact 2-18)

Description: This aluminum sheet metal assembly is made up of at least four separate components, a wide web (0.032" thick), a narrow flat strip (0.022" thick), a 180° flange (0.022" thick), and a 90° flange 0.022" thick. Overall, the assembly is 16.75 inches long by 6.5 inches wide. All four edges of the web appear to be manufacturer's cuts with $\frac{3}{32}$ inch diameter rivet holes and remnants of rivets nearby. The 90 degree flange is attached to one long edge of the web by rivets spaced

1.75 inches apart. The 180 degree flange and the flat strip were riveted to opposite sides of the other long edge of the web.

Condition: Corrosion of the assembly components is heavy with the areas of the 180 degree flange and flat strip showing perforations. The space between the flange, web, and strip was filled with what the NTSB judged to be corrosion products, but TIGHAR researcher Frank Lombardo has performed a more detailed inspection and believes that these "corrosion products" are, in fact, remnants of micarda stripping installed to inhibit corrosion. A long rivet tail is located in the area of severe corrosion. During optical examination, the NTSB noted small remnants of a bluish woven fabric around the rivet tail.

Identification: This type of assembly, known as a dado, was used in the interior finishing of small cabin-class airplanes to protect the juncture between the cabin wall and floor. Although we have the complete assembly, there is no part number as is found on military fixtures (for example, the Navigator's Bookcase) Military aircraft do not normally carry this type of interior furnishing.

Commentary: Because they are interior furnishings rather than structural components, dados can vary greatly depending upon the cabin configuration of the particular aircraft. The available plans for the Lockheed Model 10 are for the airline version and include structures similar, but not identical,

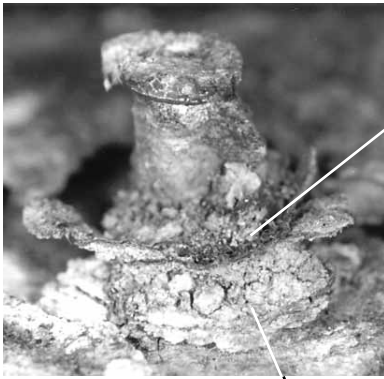
This photo of the "long rivet tail" with "bluish woven fabric" at its base was taken prior to the NTSB's examination. It shows that the fabric was actually the top layer of a sandwiched structure which included .25 inch of kapok-

like material. Unfortunately, further analysis is not possible. The fabric and the material were lost during the NTSB's examination.

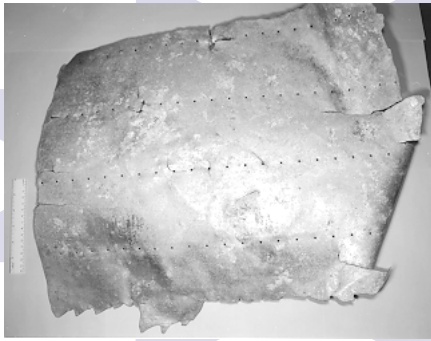
6. Aircraft Skin (TIGHAR Artifact 2-2-V-1)

of 1.25 inches along its long dimension. There is no line of rivet holes across the width of the sheet. The rows of rivet holes are not parallel but show a slight angling toward the row of larger holes. Nominal spacing between rows is 4.25 inches at one end of the sheet and $\frac{1}{8}$ to $\frac{1}{4}$ inch closer at the other end. One rivet is still present. The length of the undeformed rivet shank (distance between the manufactured head and the formed head) indicates that the skin was previously attached to an underlying member approximately 0.06 inch in thickness. The faint outline of $\frac{1}{2}$ inch tall letters "AD" are present on what was the exterior surface of the skin. Also visible in this area is the streaked remnant of a much-degraded greenish coating.

Condition: The sheet is bounded by fractures on all four edges (no manufacturer's cut is present) and has a pronounced curvature across the short dimension. On one side the fracture runs generally along the line of $\frac{5}{32}$ rivet holes. The fracture intersects all of the $\frac{5}{32}$ inch diameter holes except for three unfractured holes which are unevenly spaced. The skin around the $\frac{3}{32}$ inch diameter rivet holes is dimpled inward toward the concave side of the sheet suggesting that the surface was area loaded from the concave side while the rivets and underlying structure were intact. Scratch marks on the interior (concave) surface adjacent to some of the rivet holes suggests the further removal of underlying structure by prying with a hand tool. Post-separation abrasion and erosion damage have obliterated the fracture faces and, in the opinion of the NTSB, positive determination of the modes of fracture can not be established. However, the NTSB did note that the fracture geometry along the line of $\frac{5}{32}$ rivet holes is consistent with tearing separations in both directions away from the area of the intact holes. Deformation adjacent to the fracture along one edge of the sheet indicated that it had been folded 90 degrees toward the convex side at least twice prior to separation. The only place on the sheet exhibiting significant corrosion is an area roughly 1.5 inches in diameter located immediately adjacent to the "tab" with the three undamaged $\frac{5}{32}$ rivet holes. The corrosion originated on the interior surface of the sheet and has perforated the exterior surface in three pinpoint-sized locations.

Identification: This is a forcibly removed section of aluminum which was once part of an airplane skin. The aircraft was of all-metal construction and was manufactured in the United States, probably before 1939. The surviving rivet is an AN 455 AD 3/3. The head style, known as the "brazier" head, was replaced in most applications by the "universal" head (AN470) sometime after 1940. The letters "AD" noted on the exterior (convex) surface are the last two letters in the word "ALCLAD" which was stamped onto the aluminum in red ink at the time of manufacture by Alcoa Aluminum as part of the product labeling. Complete examples of this same size and style of lettering (ALCLAD 24S T3) have been noted on aluminum used in repairs or modifications to two surviving Lockheed 10s: c/n 1015, recently rebuilt as a replica of Earhart's

Commentary: This is, by far, the largest and most complex aircraft artifact found on Nikumaroro to date. It is also the most controversial. The skin's material components, dimensions and rivet pattern are similar, but not identical, to some portions of the Lockheed Model 10. TIGHAR initially noted the artifact's similarity to the underside of the Electra just forward of the cabin door and attributed the differences to changes made when the Earhart aircraft was repaired following its March 20, 1937 accident in Hawaii. Critics correctly pointed out that such structural changes could not have been made without a wholesale re-engineering of the aircraft for which there is no evidence. Subsequent research has identified another location on the Earhart aircraft which seems more promising.

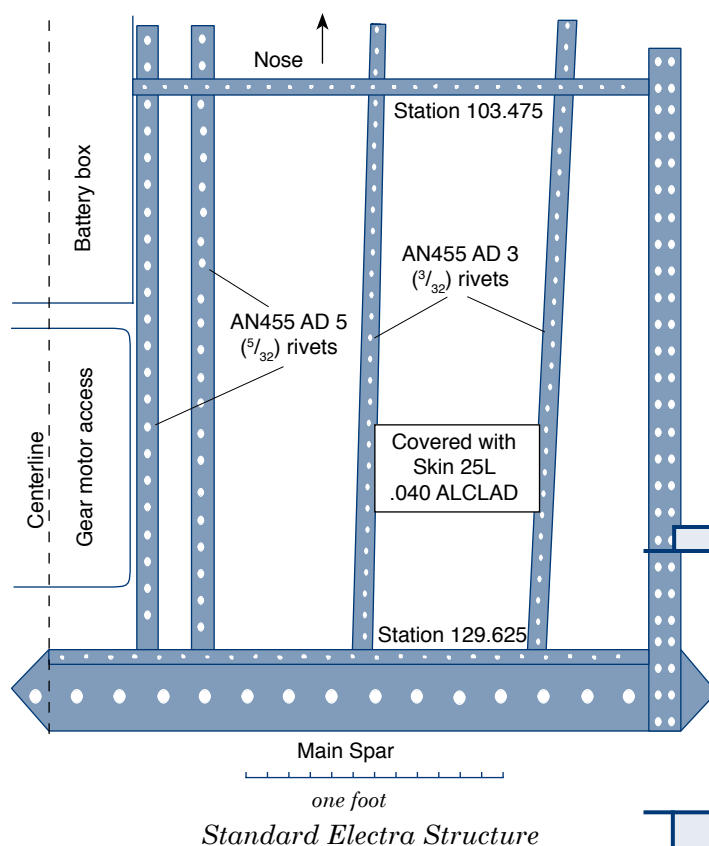
Standard Electra Structure

of 0.032 (rather than 0.040) Alclad and reinforced with two additional longitudinal stiffeners added between the standard stringers, the resulting structure would be an exact match to the sheet found on Nikumaroro.

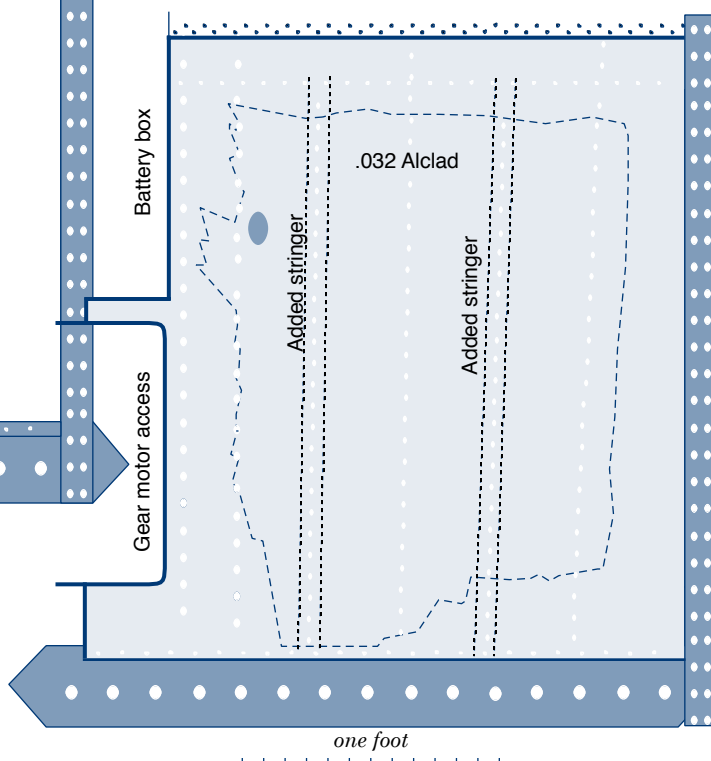
Possible Repair Resulting in Exact Match to Artifact

Pursuing this hypothesis further, we know that the sheet failed due to area loading from the interior side—in other words, it was blown outward with sufficient force to rip the heads off many of the $\frac{3}{32}$ rivets and tear the skin through the larger $\frac{5}{32}$ rivet holes like paper torn through perfo-

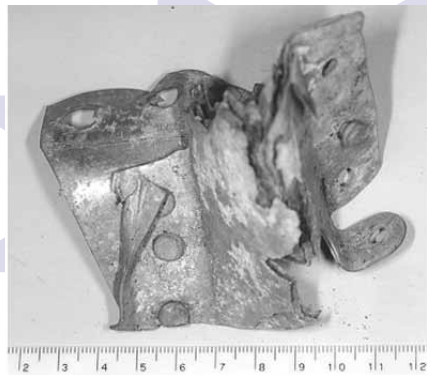
8. Riveted Assembly (TIGHAR Artifact 2-2-V-8)

Description: This assembly was made up of two aluminum alloy members. One member was roughly triangular in shape and appeared to be complete and relatively undamaged. The other member was severely damaged by exfoliation corrosion making it difficult to determine its original shape or configuration. However, there were four identifiable $\frac{5}{32}$ inch diameter rivet

Condition: As mentioned by the NTSB, portions of this artifact exhibited severe exfoliation. There was also evidence of extensive cutting and shearing caused by tools or implements.

Commentary: Like several other artifacts found on the island, this appears to be a scrap left over from local use. It may be related to the Aluminum Plate (Artifact 2-5). The exfoliation seen on the Cut Strip (Artifact 2-3) suggests that it may have at one time been exposed to the same conditions (immersion in salt water?) as the Riveted Assembly.

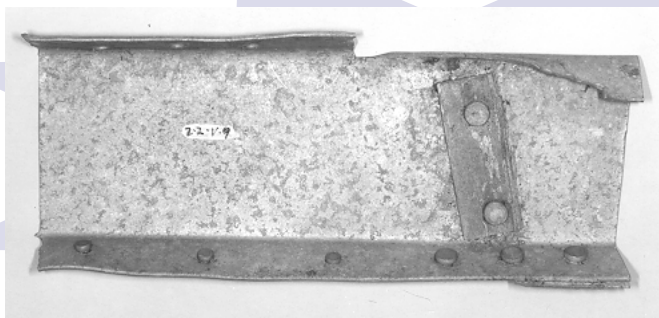
9. Channel Section (TIGHAR Artifact 2-2-V-9 & 10)

Condition: One end of the channel has been transversely saw cut through the entire cross section. The other end also exhibits saw cut marks but only partially through the section thickness. The remaining section thickness was bent and broken at the cut. The bracket piece was severely damaged by exfoliation corrosion.

Commentary: This artifact was once part of an aircraft's internal structure, but no match is apparent to any component in the Lockheed 10. The proportions of the piece suggest that the B-24 is a more likely candidate and the presence of exfoliation corrosion would appear to strengthen that possibility.

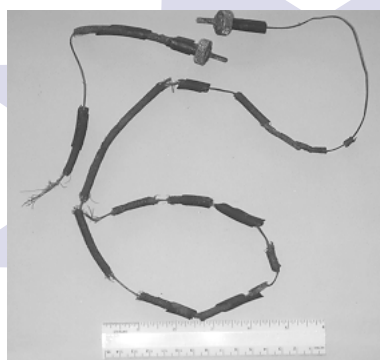
10. Cables (TIGHAR Artifact 2-3-V-1)

Condition: Various components of the cable are missing in many areas, but entire cross-sections survive to permit a full description of the original make-up. The connectors are in remarkably good condition.

Commentary: Specifications for military-approved coaxial cable in 1941 begin with a 12-strand core. It may be that the 10-strand cable found on Nikumaroro is an earlier civilian type. Documentation is being sought. The Earhart aircraft carried Western Electric and (possibly) Bendix receivers.

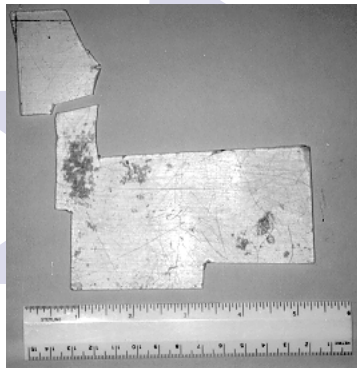
11. Plexiglas (TIGHAR Artifact 2-3-V-2)

Description: This is an irregularly shaped sheet of transparent polymethyl methacrylate (PMMA), tradename Plexiglas. It measures nominally 4.75 inches long by 2.5 inches wide and is $\frac{1}{8}$ inch thick. A second fragment is roughly 1.75 inches long by 1.5 inches wide and fits a fractured edge of the larger piece. Both pieces exhibit a slight but uniform curvature over the surface.

Condition: The convex surface of the sheet exhibits a number of shallow scratches, while the concave surface has only a few. One edge appears to be an original manufactured edge. The others exhibit saw marks. There is no evidence of heat damage. Because PMMA must be heated to at least 90°C to be formed, the curve of the surface on this sheet is probably original.

Commentary: Lockheed engineering drawings show that the material, the curvature, and the thickness of the artifact match those specified for the cabin windows of the Electra. A number of changes were made to the material and thickness specifications for the windows over the production-life of the Model 10 (1934 to 1941). Of particular interest is a change specified for January 15, 1937 at which time the window thickness was reduced from $\frac{5}{32}$ to $\frac{1}{8}$ inch. The date is significant because it was just at that time that the cabin windows in Earhart's airplane were replaced and additional special windows were installed as part of her world flight preparations. The curvature and thickness of the Plexiglas found on Nikumaroro exactly matches Lockheed's specifications for Electra cabin windows at the same time Earhart's new windows were installed. They do not match any window on the B-24.

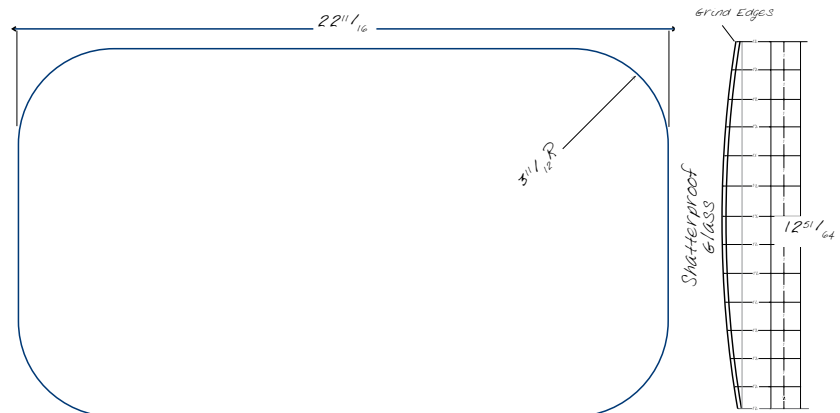
F	SEE CHANGE NOTICE	1-19-37	R.N.G.	NOTES	10	10	
E	THICKNESS $\frac{1}{8}$ WAS $\frac{5}{32}$	1-19-37	S.D.P.	MATERIAL FINISH NO. REQUIRED	PER GRP	PER ACT	
D	SHATTERPROOF WAS PLATE GLASS	2-12-35	L.I.C.				
C	$\frac{1}{8}$ SPAD $\frac{1}{8}$ HRTPO						
B	PLATE GLASS WAS SHATTERPROOF	3-21-36	R.L.S.				
A	CHANGE	DATE	BY	HT/IR

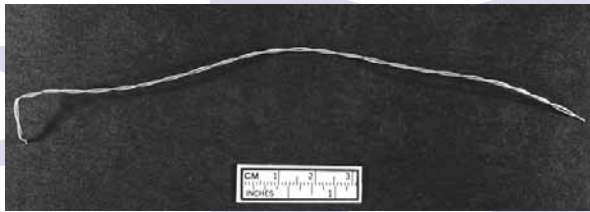
12. Aircraft Safety Wire (TIGHAR Artifact 2-3-V-3)

Description: This is a length of 304 stainless steel wire 6.75 inches long comprised of two strands of .010 inch wire twisted together in a very even left-hand twist with an average pitch of .564 inches. There is a 90 degree bend located approximately .582 inch from one end.

Condition: Both ends of the wire have been cut. There is no evidence of failure from fatigue or high tensile loading. The wire is in excellent condition.

Commentary: Although as innocuous an artifact as could be imagined, this is yet another object found on Nikumaororo which was, at one time, part of an airplane. The only clues to its origin may be its somewhat unusually long tail and the fact that its twist may have been hand-done rather than twirled with special safety wire pliers. Early mechanics prided themselves on the precision of their lock wire work.

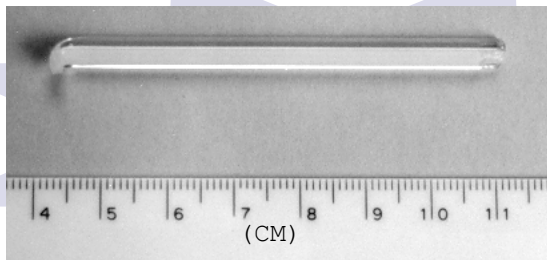
13. Thermometer, broken (TIGHAR Artifact 2-2-G-5)

Condition: The rod is broken at both ends. No trace of markings or gradations are visible on the white band or the rod. The external surface of the glass is smooth and shows no sign of abrasion. There is a trace of foreign material at the straight break and a few flecks have found their way into the central tube to a depth of about 5mm.

Commentary: No match has been found to any specific type of thermometer. The hook at the end is particularly puzzling. Thermometers are easily broken, but this one is broken at both ends. How did that happen? The glass shows no sign of having been tumbled about on the rough coral as one might expect if it had been washed ashore from the lagoon. But if it was simply dropped, where is the rest of it? And how did foreign material get 5mm down into the central tube?

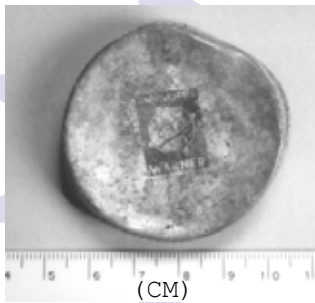
14. Threaded metal cap (TIGHAR Artifact 2-2-G-6)

Condition: Most of the paint has bleached off but corrosion damage to the underlying surface is minimal. The top is very slightly dimpled in several places and its circular shape has been deformed by flattening along one side, with a corresponding bulge opposite. There is a reddish-brown discoloration or stain along part of the edge and top.

Commentary: There are, of course, a number of possible explanations for the bottle cap's presence on the island. However, because Earhart is known to have suffered from stomach trouble during the world flight, and because the cap was used on products contemporaneous to that time, and with so much other evidence pointing to Earhart's presence not only on this island but on this specific part of the island, the artifact deserves a close inspection.

Several observations raise interesting questions. The slight indentations on the top of the cap suggest light tapping with a hard, somewhat pointed instrument. The flattened side indicates either a sharp blow or deliberate compression, perhaps to dislodge a stuck cap from the bottle. But where's the bottle? No glass (except for the thermometer) was found anywhere nearby. The reddish-brown stain is particularly intriguing and merits chemical analysis.

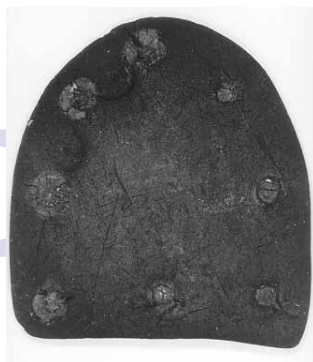
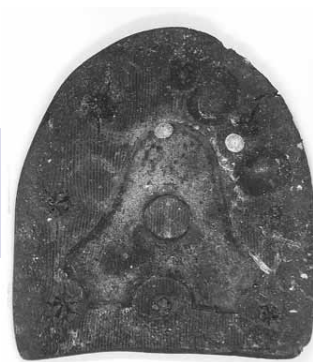
Artifact 2-2-G-7/1, Cat's Paw heel

Description: This is a rubber shoe heel 3 inches long by $2\frac{7}{8}$ inches across its greatest width. It is nominally $\frac{1}{4}$ inch thick and is pierced by 8 ferrous nails. The exterior (bottom) surface is considerably worn. The interior surface exhibits a number of codes and markings molded in at the time of manufacture, plus the hand-written letters RN.

Condition: The rubber is hard and probably somewhat contracted. Remnants of all eight nails are extant but severely oxidized. The washers surrounding the nails are present in six of the holes.

Identification: This is a Cat's Paw replacement heel manufactured in the United States in the mid-1930s for a left shoe of either a large woman's or small man's size. The hand-written RN may be stock coding applied by the repair person.

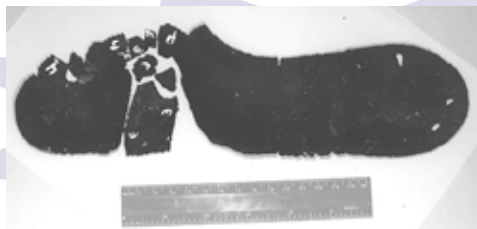
Artifact 2-2-G-7/2 through 5, Sole

Condition: The rubber is hard, brittle and probably somewhat contracted.

Identification: This is the sole of a woman's left shoe of a style known as a blucher oxford. The location of the stitching holes establish the style and the tightness of the stitches (even allowing for contraction) indicate a woman's shoe. The length and width indicate a woman's size $8\frac{1}{2}$ or 9 narrow. The Cat's Paw replacement heel (Artifact 2-2-G-7/1) found with the fragments was almost certainly once attached to this sole.

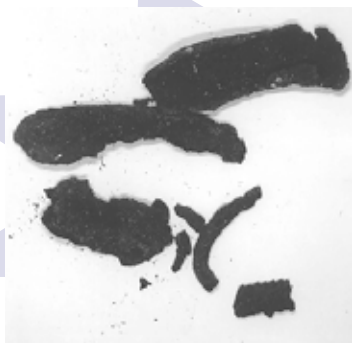
Artifact 2-2-G-7/6 through 8

Condition: The material is hard, brittle and, in some cases, has curled inward along its edges.

Identification: Unknown. These may be pieces of the layered base which goes between the sole and the replaceable part of the heel.

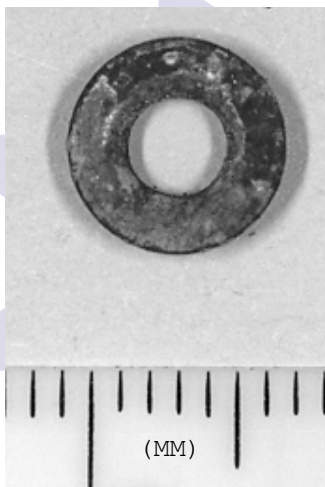
Artifact 2-2-G-7/9, Brass eyelet

Condition: Tarnished but otherwise undamaged.

Identification: Such an eyelet might have many uses but the context in which it was found suggests that it was employed as a shoelace grommet. The aperture is too small to accommodate the laces of a man's shoe but exactly match the usual $\frac{1}{8}$ inch laces for women's shoes.

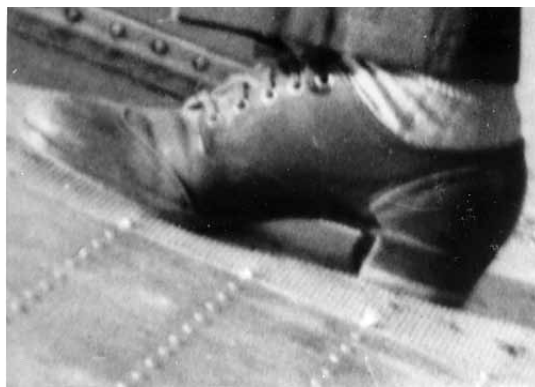
16. Artifact 2-2-G-8, Shoe heel

Description: This is a rubber shoe heel measuring $3\frac{1}{8}$ inches in length by $2\frac{7}{8}$ inches across its greatest width. It is nominally $\frac{3}{16}$ inch thick and is pierced by 8 nail holes in which remnants of the washers are still present. The nails appear to have rusted completely away and one nail did not penetrate all the way through the heel. The exterior (bottom) surface is considerably worn, especially on one side toward the rear. The interior surface exhibits no discernable codes or markings.

Condition: The rubber is hard and exhibits the same degree of degradation seen in 2-2-G-7/1, the Cat's Paw heel.

Identification: This is an original heel, slightly larger and more worn than the replacement heel found in the same area. Re-heeling, by necessity, is done to both shoes of a pair. It seems apparent then, that this heel is from a second pair of shoes.

Commentary: The presence of any shoe in this location would be remarkable. The site is far from any settled part of the island and the hot, hard coral rubble is hardly conducive to barefoot strolling. Rubber shower shoes and an occasional sneaker can be found washed up on the ocean beach, but this location is much too far inland for that explanation. That two pair of shoes (one of them belonging to an American woman) should have been abandoned or lost in this place is odd in the extreme. At the same time, the distribution of the fragments and the absence of the other two shoes suggests at least some scattering from the original point of deposition (assuming all four shoes started out in roughly the same place). Because all of the recovered fragments float, water would seem to be the most logical agent of distribution—specifically, flooding of the lagoon about 200 feet away. Logically then, the shoes were originally deposited somewhere between the point of discovery and the lagoon shore. This also tracks with the old island story of a woman's skeleton with American shoes found under the bushes about five feet from the shore.

The various shoe fragments are most probably from the shoes said to have been found in this location with the bones of a white woman and man in 1938. It is very likely that the shoes, and the bones, belonged to Amelia Earhart and Fred Noonan.
