# A Landing on the Reef

*TIGHAR's working hypothesis is that on July 2, 1937 the Earhart aircraft was landed on the reef-flat at Nikumaroro north of the shipwreck; that the landing left the aircraft intact enough to send radio signals for one or more days; and that the aircraft was subsequently destroyed by wave action and the wreckage sufficiently scattered and obscured by the surf that it was not seen by the U.S. Navy's aerial search one week later on July 9, 1937.*

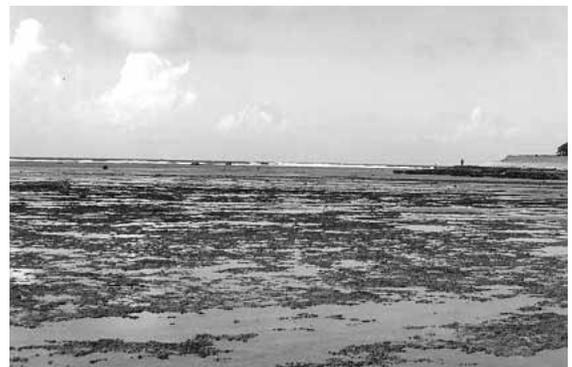
In the photo below the camera is at position "A" looking north along the landable area. The breakers in the distance are approximately 2,000 feet away.

The person standing on the point at “B” is roughly 800 feet away. The perturbations in the reef surface in the foreground average about 4 inches.

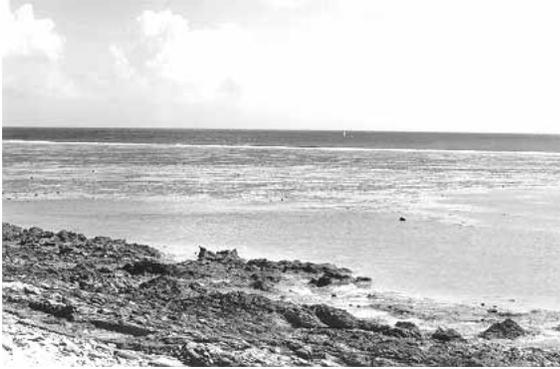
In the photo above left, the camera is at “B” in the diagram, looking westward across the reef-flat.

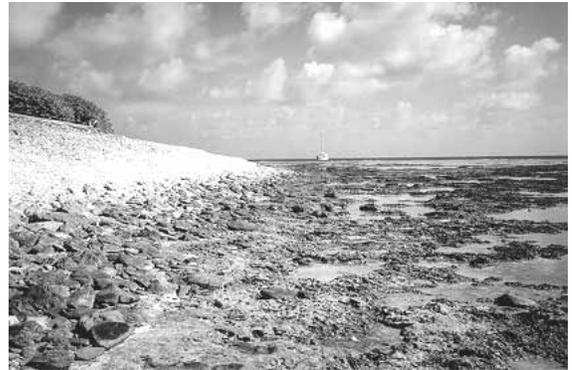
The photo above right looks southwestward and shows the deeply pitted surface of the reef-flat near shore. It shows that while the beach may at first seem to be a more attractive place to land an airplane, closer inspection shows it to be rather steeply sloped and covered with loose coral rubble.

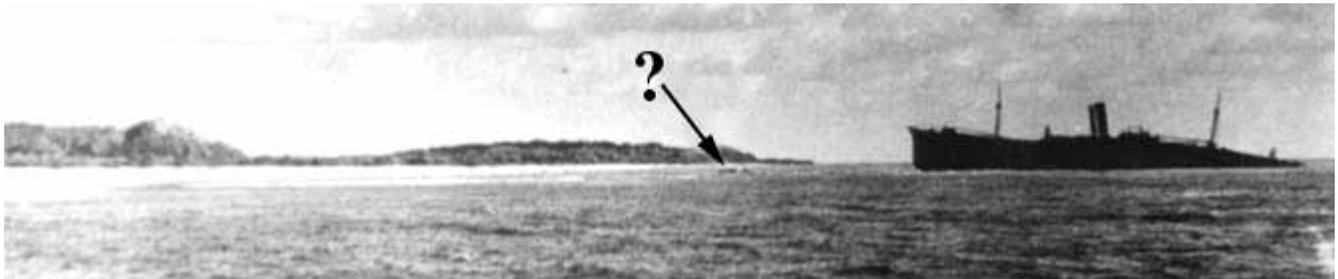
By aligning the relative position of identifiable landmarks in the photo it is possible to determine a line along which the unidentified objects must fall. As shown below, the objects in the 1937 photo are on a line (shown in red) which corresponds with a portion of the “landable” part of the reef. The location means

that the objects in the photo are almost certainly not debris from the shipwreck, the wreckage from which is distributed exclusively in a southeasterly direction. The location does, however, match that marked on a map by Emily Sikuli (“E”) to indicate where she saw airplane wreckage in 1940.
