TIGHAR Tracks

Treasure Map

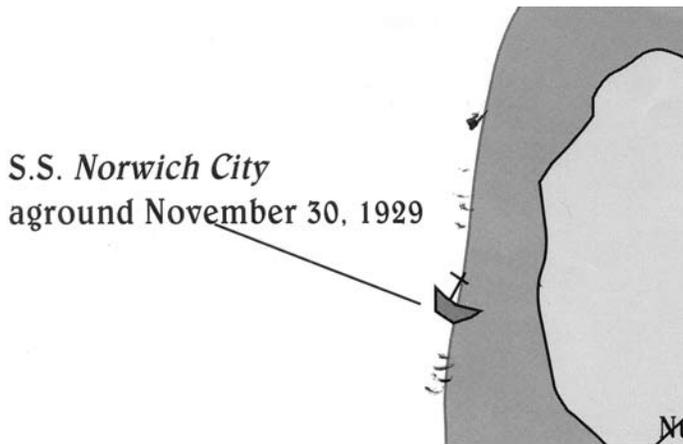
This is the map Emily marked for us during her interview. The darker, larger mark farthest north is her mark. The smaller marks were made to show her where the surf breaks.

Emily was quite specific about what she saw and where she saw it. She spoke of a red, rusty object which she estimated to be about 12 feet long with a large round shape at one end. She said that it was out at the reef edge "where the waves break" and that it was about 300 feet north of the wreck of the S.S. *Norwich City*. The wreckage, she said was in very bad condition and could only be seen at low tide (see marked map next page).

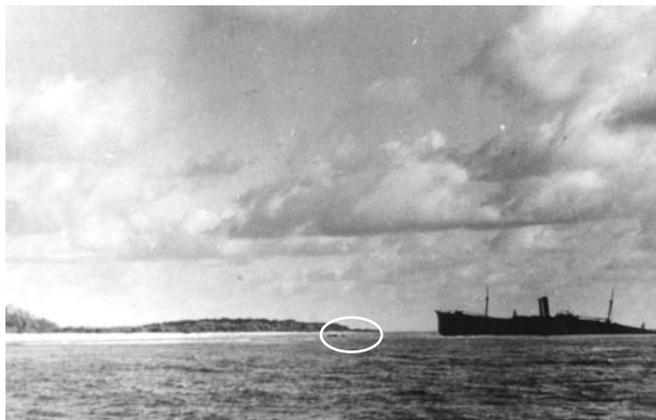
Eric Bevington took this photograph in October 1937. Photo courtesy E. Bevington.

Eric Bevington during a visit to the island in October 1937. There, a few yards ahead of the bow of the *Norwich City*, could be seen some kind of debris on the reef which seemed to match Emily’s description. Another photo, this one taken in 1939 by the New Zealand survey party, showed something on the reef that might be the same feature.

The feature in the Bevington photo was in that same location. Clearly this was not corroboration of Emily’s story.

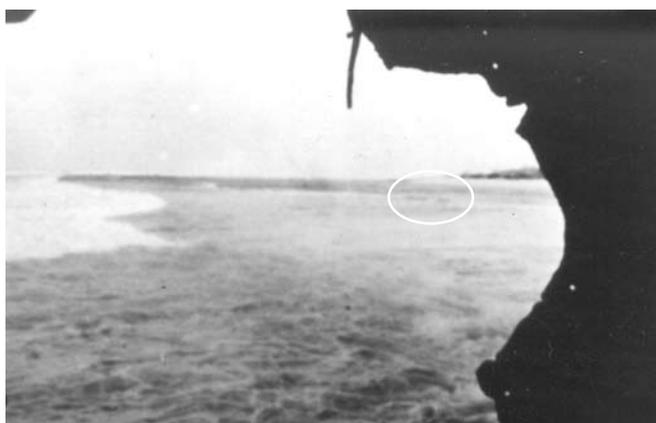
The New Zealand survey party took this photograph in December, 1938. Photo courtesy Wigram Air Force Museum, New Zealand.

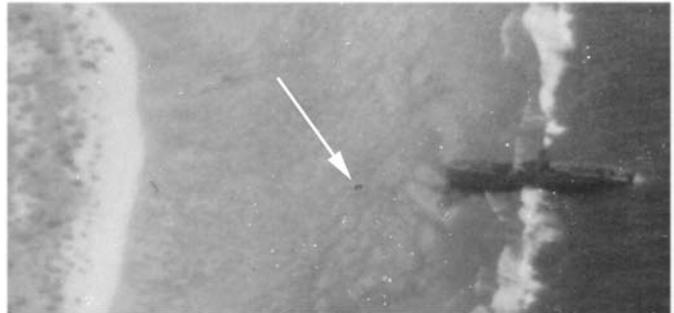
The 1938 aerial photo and the Kiwi detail photo. Photos courtesy Wigram Air Force Museum, New Zealand.

The question of whether the features in the Bevington and New Zealand photos could be Emily’s Object relied upon determining just *where* on the reef the feature was. Jeff Glickman at Photek spotted a chunk of something on the reef not far from the bow of the *Norwich City* in a 1938 aerial photo taken immediately prior to the New Zealand survey. Photos taken by the Kiwis on the ground during that survey show that chunk to be a slab of hull plating from the shipwreck.

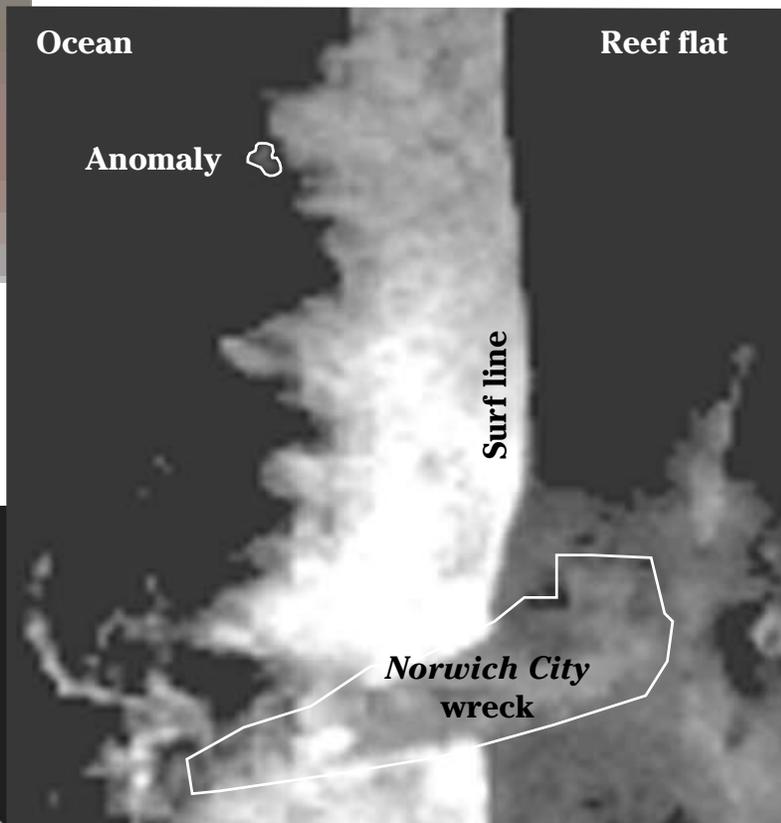
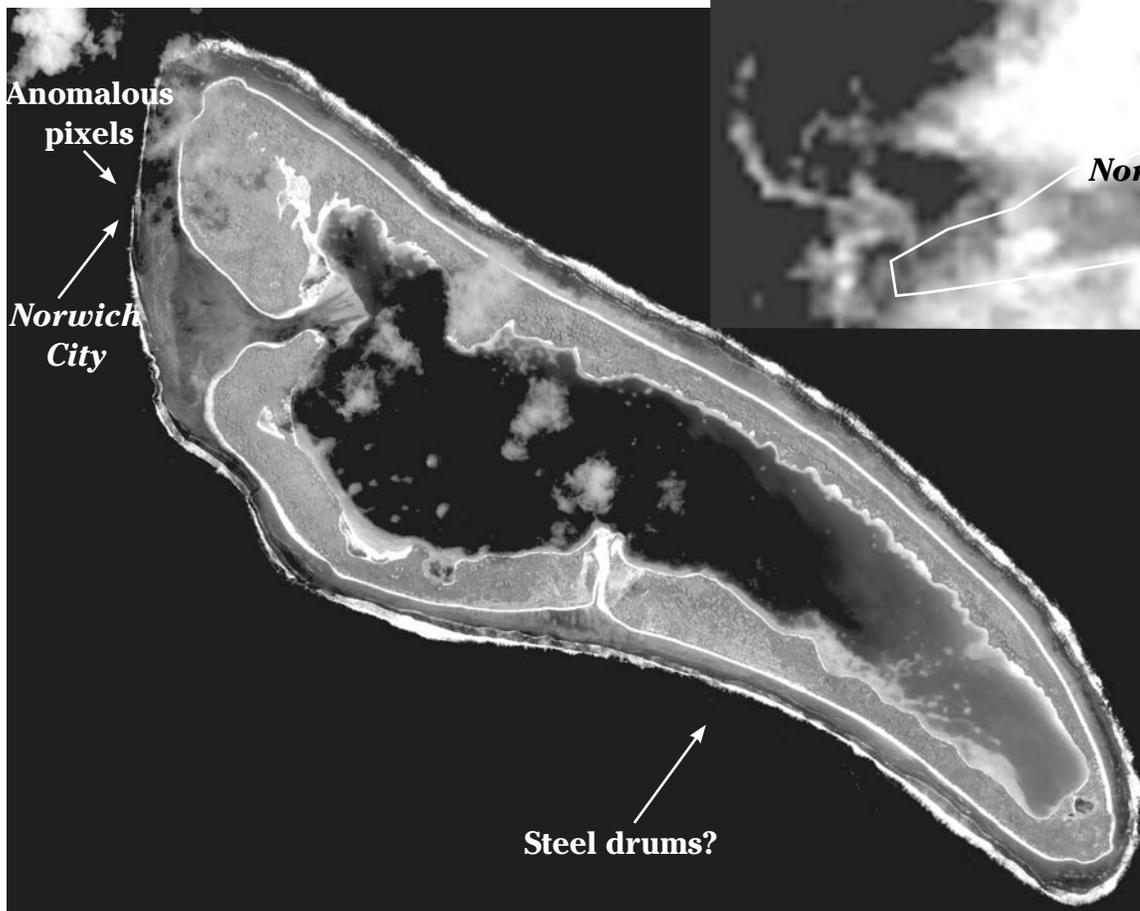
These three images are (above) the four meter resolution color satellite photo; (right) the one meter resolution panchromatic photo; and (below) a reduced image of the entire island, showing where the anomalous pixels are located.

The first photographic clue that Emily’s Object might still be there came on May 11th of this year when Dr. John Pratt (TIGHAR #2373), in looking closely at the color satellite imagery, noticed a couple of anomalous rust-colored pixels at the reef edge about 60 meters (200 feet) north of the shipwreck. They are behind the surf line and were, therefore, under water at the moment the imagery was acquired (see top of page 3).

and it's hard to know if one or two odd pixels represent "noise" in the image or an actual "thing" on the ground. In the color satellite image each pixel is a square four meters (13.1 feet) on each side but its color is influenced by the pixels bordering it, each of which is influenced in turn by other bordering pixels, and so on. On the face of it, two rust-colored pixels would seem to suggest a rust-colored object eight meters (26.2 feet) long and four meters (13.1 feet) wide but that is very deceiving. The object or feature could easily be much

shorter and/or narrower and of sufficient color intensity to dominate the pixels. The color, too, is an average of what the satellite's digital sensor sensed. For example, a four-meter area that was half red and half white would produce a pink pixel, but so would a four-meter pink area. In this case, the particular color of the pixels is unlike any of the known "noise" in the image and unlike anything on shore. The closest similarity is to some parts of the *Norwich City* and a couple of unidentified features in the water off the edge of the reef at the southeast end of the island. This is the same area where barrels of diesel fuel were floated ashore to resupply the U.S. Coast Guard Loran station during World War Two, so it may be that we're seeing steel drums that were holed on the reef edge and sank there.

meter on each side, but again, each pixel is influenced by its neighbors. Although the panchromatic picture presents more detail, it does not penetrate the water nearly as well as the blue/green band of the multispectral image. Looking in the same spot as the maverick pixels in the color image, we see five pixels in the panchromatic image that appear to be distinct from the background and the surf.

The implication is that there is something there that is roughly three meters (10 feet) long and variously one to two meters wide, but again, that can be deceiving. About all we can say is that the feature is present in both images and seems to be larger in the color image than in the black and white—which may suggest that we're seeing more of it in the color image because of the better water penetration.

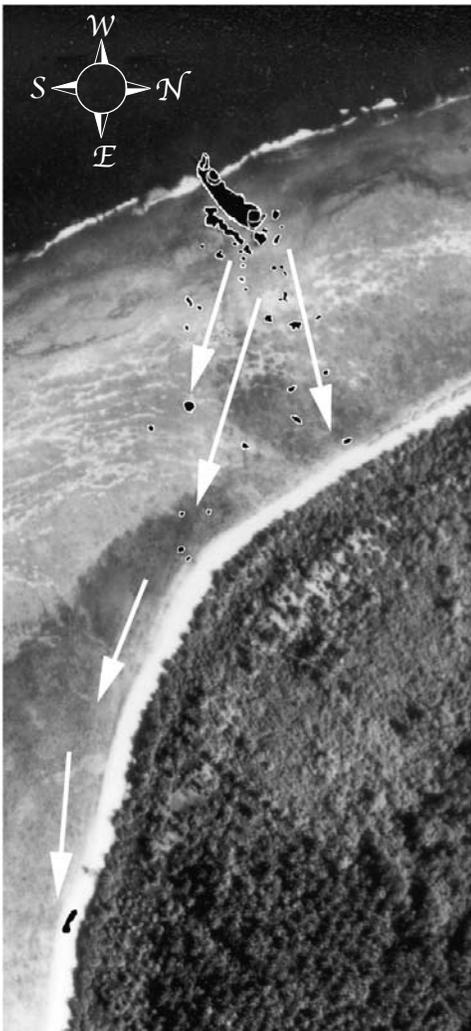
Norwich City debris field in 1985.

Norwich City debris field in 1999.

Another fact that appears obvious from the example of the *Norwich City* is that the ocean is capable of exerting tremendous force against the atoll's western reef. Chunks of the freighter weighing several tons have been moved hundreds of meters by the crashing waves. If Emily's Object was wreckage from the Earhart airplane how could it possibly have remained stationary in such a dynamic environment for three years, let alone still be there now? The only reasonable possibility is that it was jammed in one of the jagged canyons found along the reef edge. Known as "spur and groove" features, these crevasses are typical of coral reef morphology and were originally caused by erosion when the ocean's water level was lower.

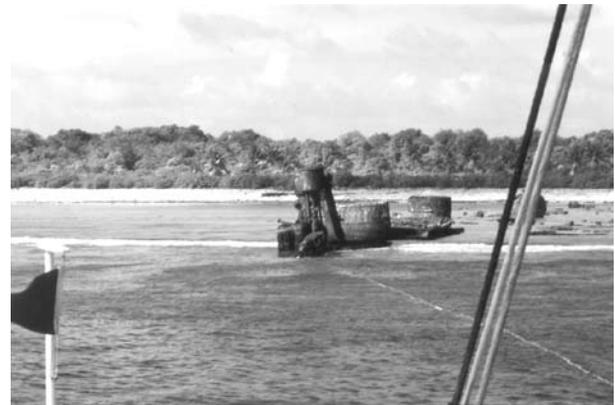
TIGHAR photos show that between 1989 and 1991 this tank moved approximately 100 meters.

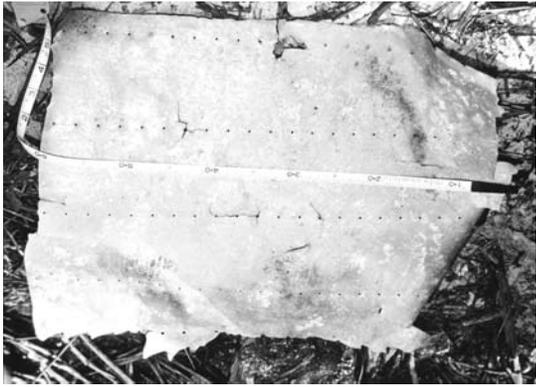
Artifact 2-2-V-1, aluminum aircraft skin, showing damage consistent with having been blown out from an aircraft by water.

Although still of undetermined origin, the section of aluminum airplane skin (Artifact 2-2-V-1) found in 1991 exhibits damage that is consistent with its being torn from an aircraft by powerful surf action. The piece has no finished edges and was literally blown out of a larger section of aluminum sheet from the inside out with such force that the heads popped off the rivets. The interior surfaces exhibit none of the pitting that is normally left by an explosion and one edge clearly failed from fatigue after being cycled back and forth at least twice. The artifact was found on the island's southwestern shore in the debris washed up by a violent storm. In order for a section of skin to fail in this way, the airframe to which it is attached must be held relatively immobile.

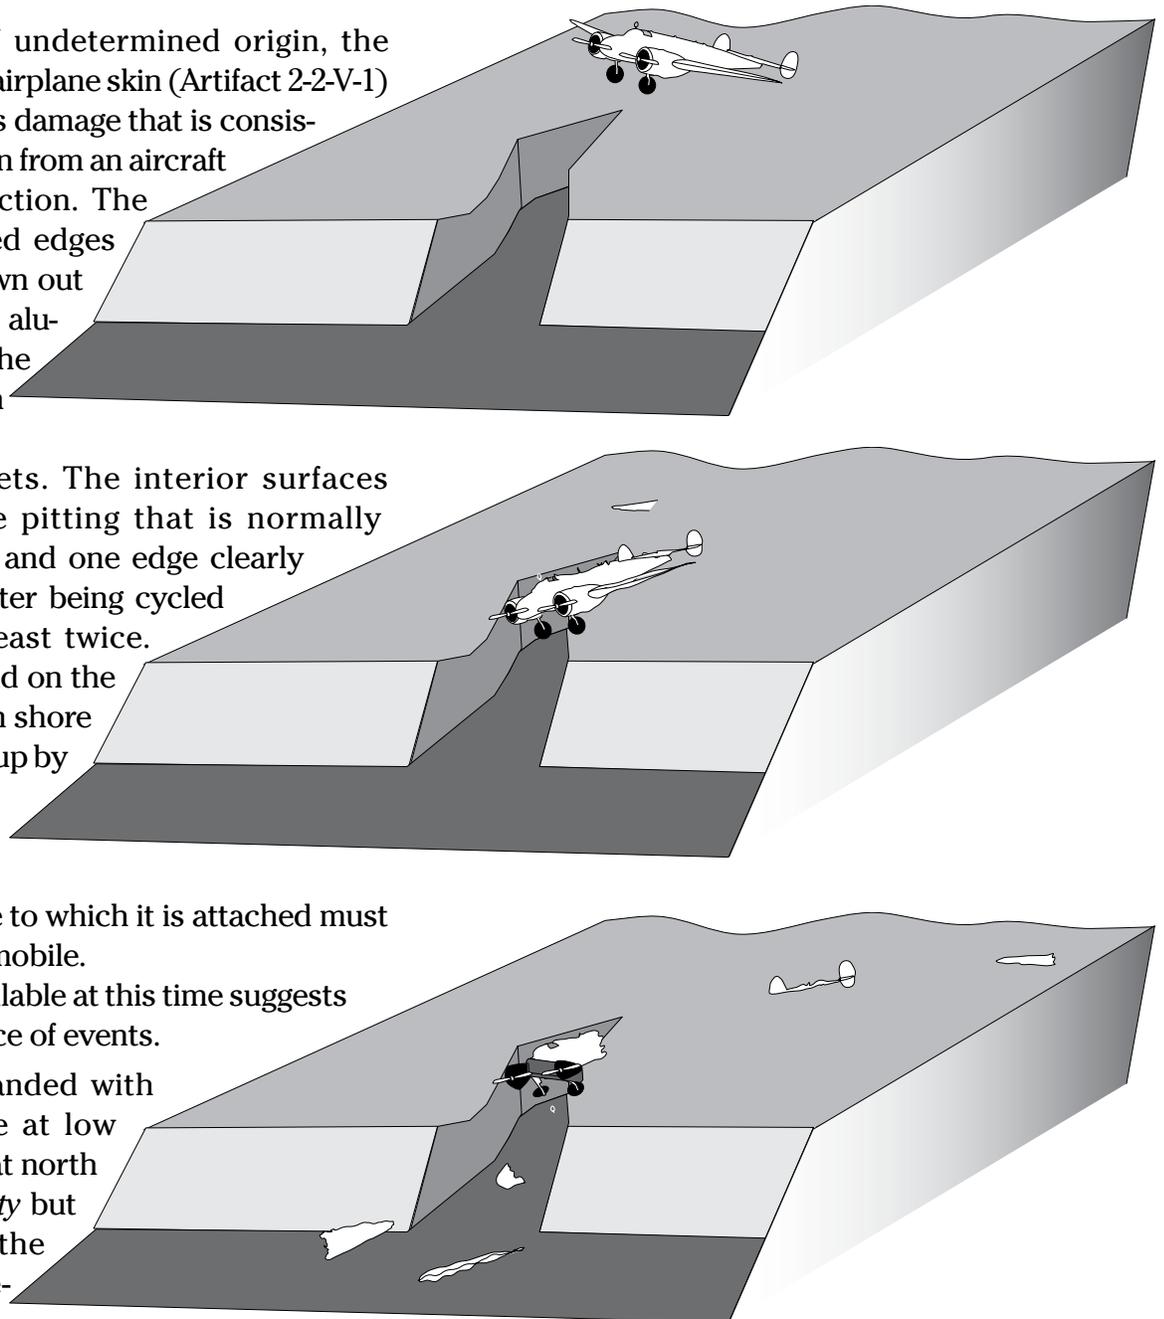
1. The aircraft is landed with minimal damage at low tide on the reef flat north of the *Norwich City* but irregularities in the reef surface prevent the airplane from being taxied

2. On or about July 5th increasing swells and rising surf on the reef force the crew to abandon the aircraft and seek shelter ashore. The waves wash the buoyant *Electra* back and forth until it falls into a groove feature near the reef edge and becomes jammed there.
3. Held immobile by the coral, the *Lockheed* is quickly ripped apart by the crashing surf. Some

parts are pulled out and over the steep reef slope while others are scattered shoreward across the reef flat. The massive main beam, with engines and landing gear attached at each end, remains wedged in the reef groove.
