TIGHAR Tracks

Mysteries of the Seven Site

The Seven Site is an obscure patch of nearly impenetrable bush on one forgotten corner of an abandoned island in the middle of a vast ocean. It may be the place where Amelia Earhart lived for a time as a forlorn and desperate castaway. It may be the place where she died. If it is, we may be able to prove it – but we need your help.

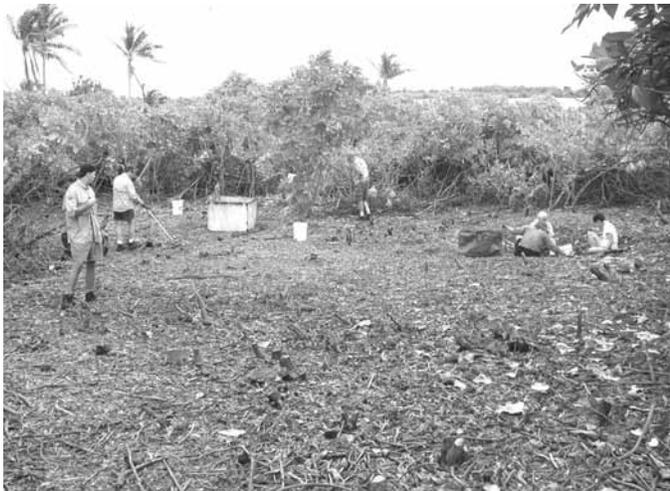
This was the Seven Site on Day 8 (September 5, 2001) of the Niku III Expedition. The TIGHAR team was doing a final cleanup after a solid week of backbreaking clearing in hundred-degree heat. We were hoping that the archaeological work that could now begin would justify the investment of time and sweat. We were not disappointed.

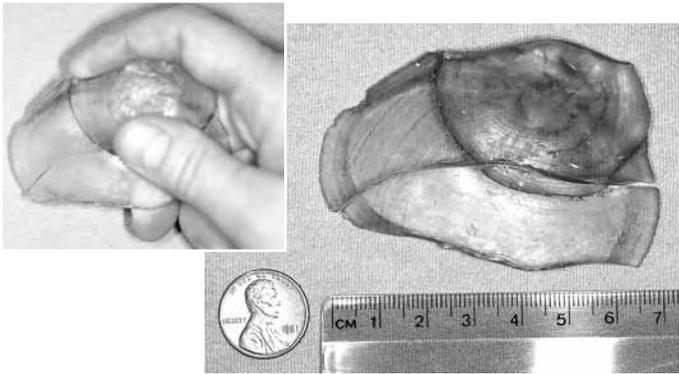
Artifact 2-6-S-21a is a shard of broken glass which appears to be from the top of an old-fashioned glass ball fishnet float. No other piece of glass from the float was found. Whether by coincidence or design, the shard fits comfortably in the hand while presenting a very sharp cutting edge. The edge will be examined by an expert in ancient tools to determine whether there are indications that the surface has been used for cutting.

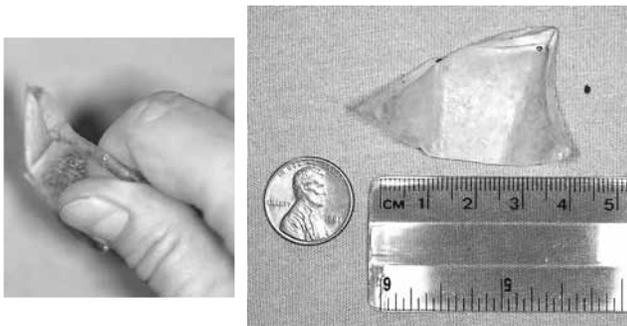
Artifact 2-6-S-21b is a shard of broken glass which was apparently once part of a small hexagonal bottle. It was found immediately adjacent to Artifact 2-6-S-21a and no other similar piece of glass was found anywhere. This piece also can be held safely and used as a sharp tool. Its edge will also be examined for evidence of wear.

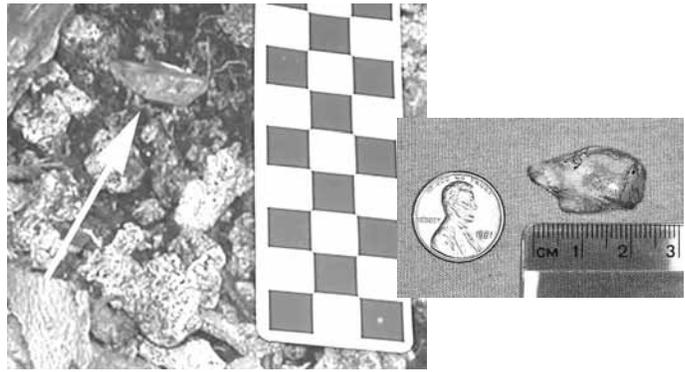
Artifact 2-6-S-16 is a small piece of glass, found by itself and theoretically useful as a tool. The “point”, however, is quite dull. Perhaps expert examination can determine whether that is natural or the result of use.

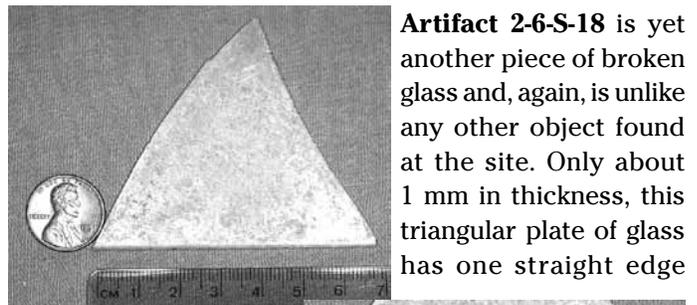
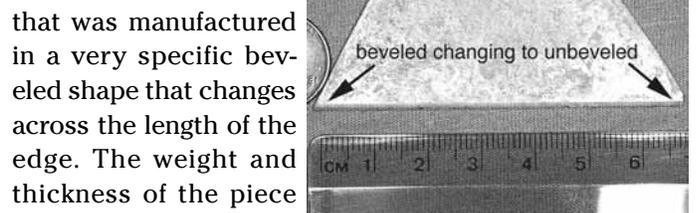
Artifact 2-6-S-18 is yet another piece of broken glass and, again, is unlike any other object found at the site. Only about 1 mm in thickness, this triangular plate of glass has one straight edge

that was manufactured in a very specific beveled shape that changes across the length of the edge. The weight and thickness of the piece and the straight but complex beveled edge suggest that it may have once covered the rectangular face of an instrument of some kind. Unlike the glass of the artifacts described above, it is difficult to imagine this object as being part of something that had floated ashore.

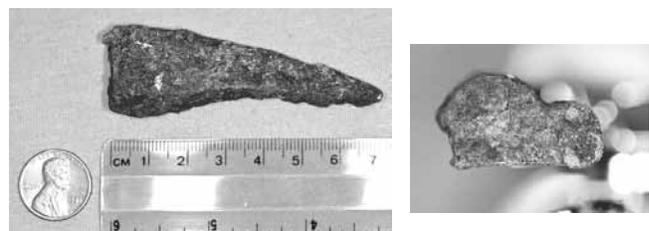
Artifact 2-6-S-12 is interesting because it is the only “chunky” ferrous object found at the site. There is badly rusted corrugated metal siding or roofing material and there are various rusted-to-pieces ferrous containers in the area, but the weight and condition of this artifact seems much more in character with the wreckage of the S.S. *Norwich City* at the other end of the island. Its shape suggests that it may have once been part of a circular iron cover or lid but this broken fragment has obvious potential utility as a prying tool.

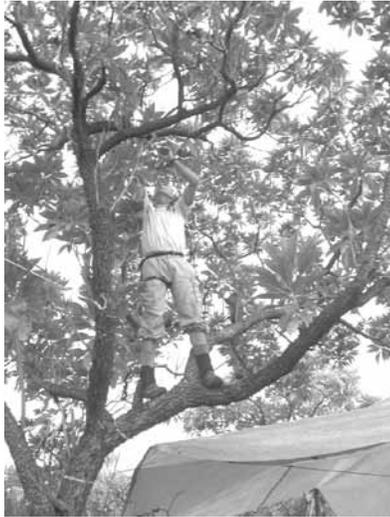
Gallagher, in his October 17, 1940 telegram to the Secretary of the Western Pacific High Commission, says, "Body had obviously been lying under a "ren" tree and remains of fire, turtle and dead birds appear to indicate life." Ren trees (*Tournefortia argentia*) are quite common

on Nikumaroro, so that is not much help, but for what it's worth there is now a rather large ren tree right in the middle of the Seven Site. Near the base of that tree, and at several other discreet locations nearby, we excavated numerous bird, turtle and fish bones some of which showed clear signs of having been in a fire.

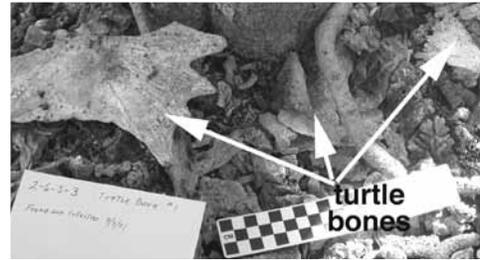
Literally hundreds of bones were collected from meticulously excavated archaeological "units" (gridded areas). These will be examined by faunal experts to determine the size, number, and species of the animals and fish consumed at the site. Any information about methods of preparation or cooking will also be noted. If, for example, we find that the bones of deep ocean fish are present, that would argue against the fish being caught by a castaway. If, on the other hand, the bones represent fish that, although perhaps easy to catch on the reef or in the lagoon shallows, are not favored by Pacific islanders, that would argue for a castaway.

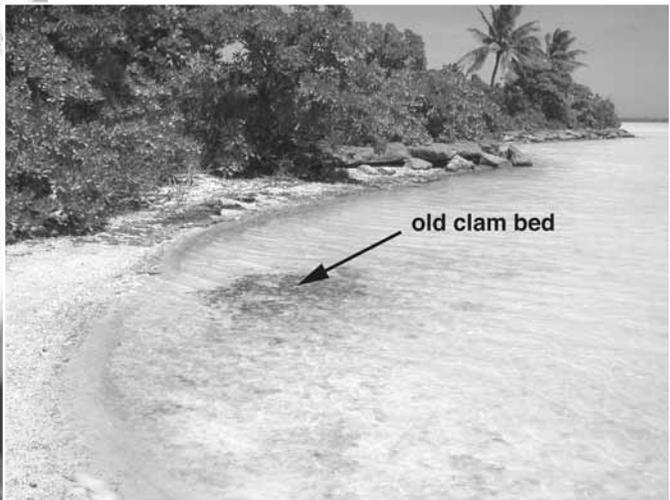
In retracing the trail on the ground, matching the 1938 aerial photo to current satellite photography, we found that the route follows the easiest path in terms of terrain and vegetation between the two points.

In light of those observations it is very difficult to see the feature in the 1938 aerial photo as anything but a man-made trail connecting an exploitable food source with an occupied campsite where the food was consumed. Other apparent 1938 trails lead into the buka forest where birds abound and to the ocean shore where turtles come ashore to lay their eggs.

One of the apparent trails leads from the part of the Seven Site where the clam shells were found, through the buka forest, to a specific point on the shore of the lagoon, where there was once a clam bed. It's the only place along the shoreline on that part of the island where evidence of a former clam bed has been found.

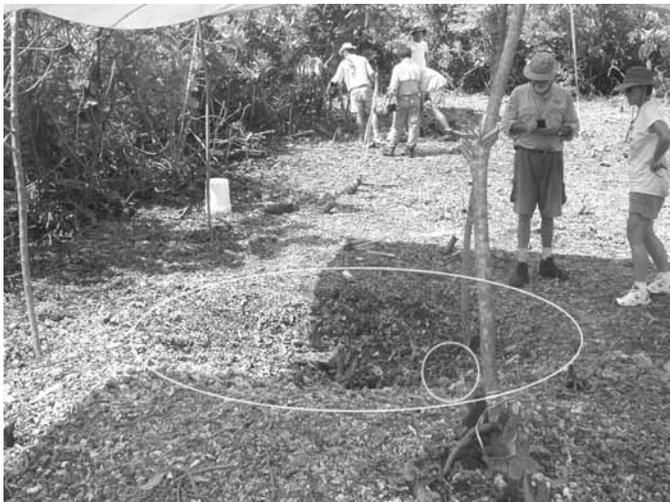
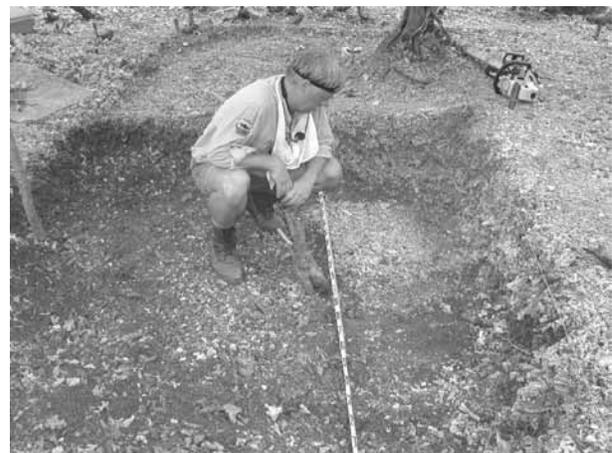
As we excavated the hole it became apparent that its original shape fit the "skull hole" hypothesis very nicely. It appears that there were two holes – an original

The fourth question we asked of the Seven Site was whether the hole that we noticed when we first found the site in 1996 might be where the work party buried the skull that was later exhumed by Gallagher. We reasoned that a careful excavation of the hole might provide clues to its purpose and, if it was really the "skull hole",

hole of fairly small proportions, and a subsequent larger hole that was not centered over the original one. Unfortunately, no teeth were found but neither can we

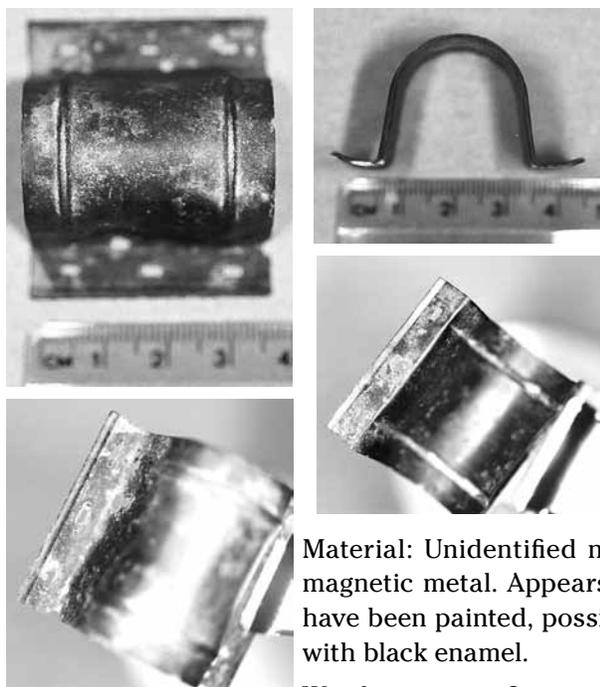
ARTIFACT NUMBER: 2-6-S-43

Material: Unidentified non-magnetic metal. Appears to have been painted, possibly with black enamel.

Weight: approx. .2 oz.

Condition: Excellent. Some small holes. The metal is still “springy.” No part of the object appears to exhibit wear except some minor upward plastic deformation in the outside edges of the three small rectangular holes in each of the flanges.

Speculation: This appears to be a spring clip used to hold a replaceable cylindrical object securely in place against a flat surface. The strength and springiness

of the metal suggests that it may be a non-magnetic type of stainless steel. The three rectangular holes in each side of the flange may have fit over pins to prevent longitudinal movement of the clip while the raised edges of the flanges may have fit under a lip to prevent lateral movement.

Could this be a clip to hold an accessory (such as an inverting eyepiece) securely in a sextant box? In his telegram to the resident commissioner of September 23, 1940, Gallagher says the sextant that was once in the box he found was “probably painted over with black enamel.”

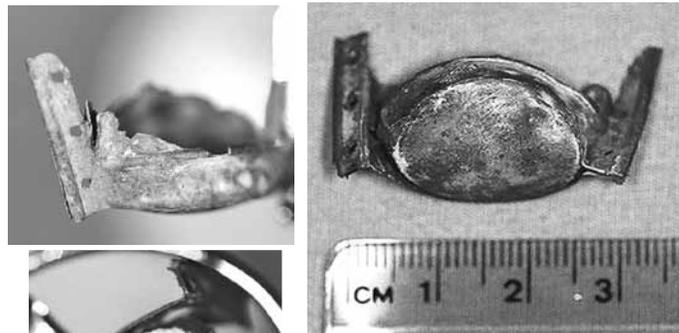
ARTIFACT NUMBER: 2-6-S-21F

Material: Lightweight magnetic metal. No indication of paint but the metal seems to exhibit a faintly gold

color.

Weight: approx. .1 oz.

Condition: Good. Broken and somewhat deformed. No rust.

Speculation: This appears to be a complex, highly specialized component from some kind of lightweight technology.

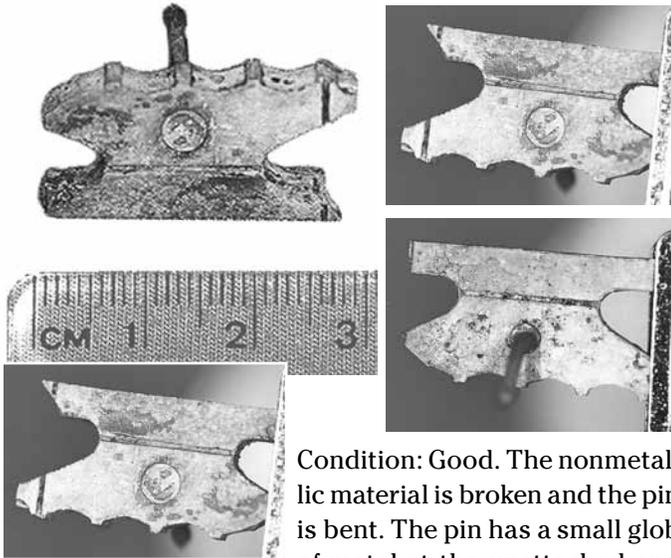
ARTIFACT NUMBER: 2-6-S-32

Material: Unknown non-metallic porcelain-like material with a magnetic metal pin set in it.

Weight: approx. .1 oz.

Condition: Good. The nonmetallic material is broken and the pin is bent. The pin has a small glob of metal at the unattached end possibly indicating that it was welded or soldered to something.

Speculation: This appears to be an internal component from some piece of lightweight technology. The scallops may be detents for a rotating cam that was part of some kind of variable adjustment.

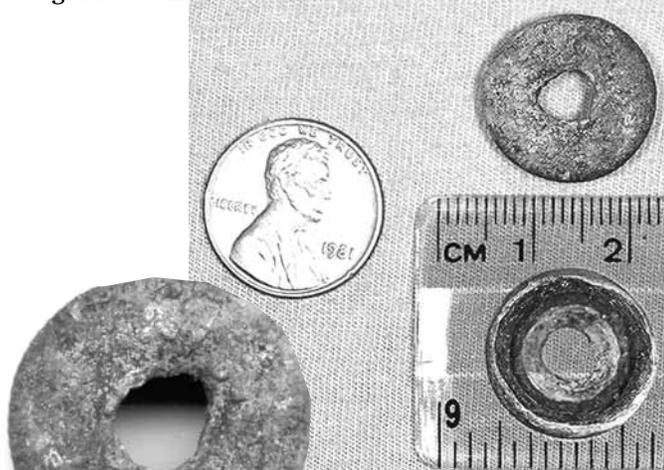
ARTIFACT NUMBER: 2-6-S-45

Material: Non-magnetic silver-colored metal beneath rust-colored exterior. The exterior edge has small grooves and there are letters (worn and, so far, illeg-

ible) on the upper surface which may include patent information. There is a separate internal channel around the interior surface.

Weight: approx. .2 oz.

Condition: Good. Bent and broken.

Speculation: This appears to be a knurled adjustment knob. There may have been a separate, smaller concentric knob that turned a disk that rotated within the internal channel. This suggests a knob for making coarse and fine adjustments to some kind of small instrument or machine. If we can decipher the letters on the exterior surface we might be able to make a positive identification.

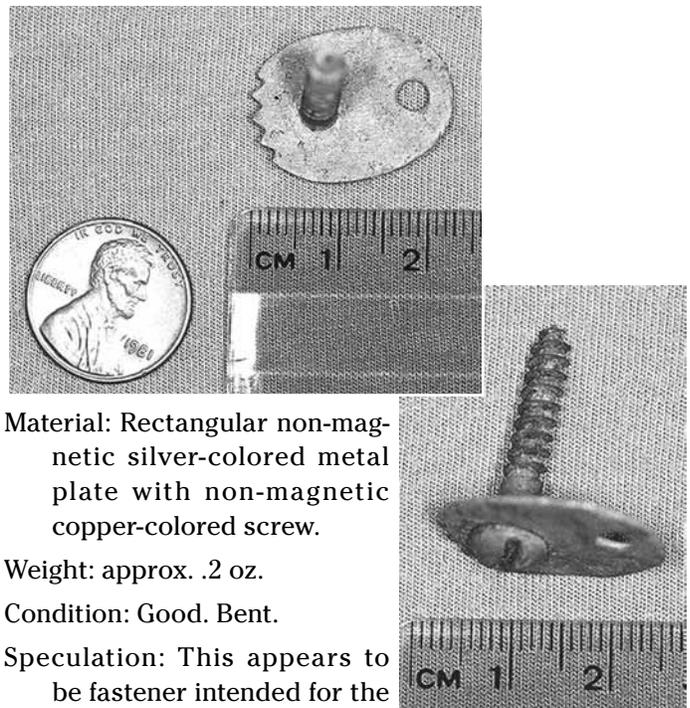
ARTIFACT NUMBER: 2-6-S-03B

Material: Rectangular non-magnetic silver-colored metal plate with non-magnetic copper-colored screw.

Weight: approx. .2 oz.

Condition: Good. Bent.

Speculation: This appears to be fastener intended for the same purpose as 2-6-S-03a

but of slightly different design and somewhat heavier construction. In this case the surface to which the

plate was attached seems to have rotated ninety degrees with sufficient force to bend the plate.

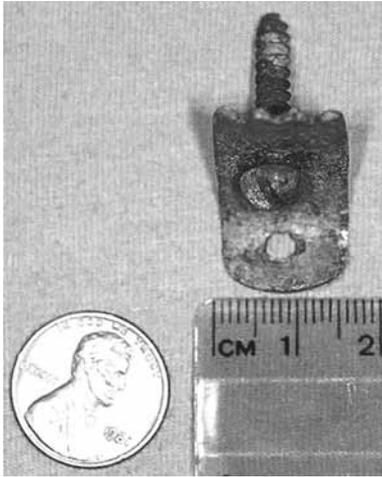
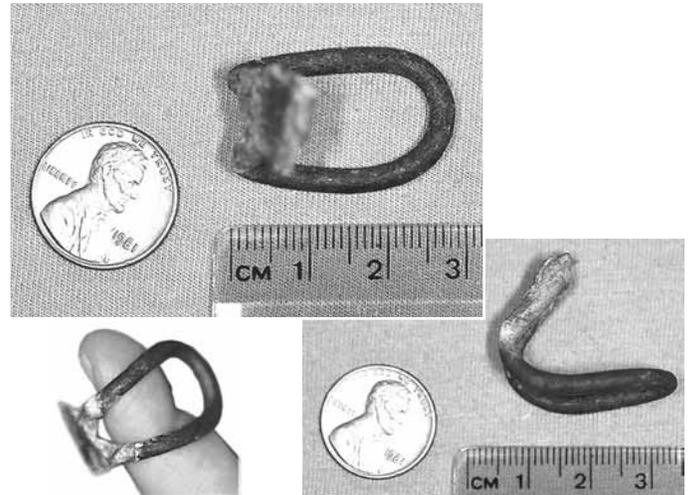
ARTIFACT NUMBER: 2-6-S-46

Material: Looped heavy duty non-magnetic wire that was once welded (?) to another non-magnetic metal surface.

Weight: approx. 3 oz.

Condition: Good.

Speculation: This may have been the handle of a small metal cup. If so, the metal to which the handle was attached failed in compression at the bottom edge and in tension at the top edge – as if the cup was being used as a digging tool.
