TIGHAR TRACKS

THE JOURNAL OF THE INTERNATIONAL GROUP FOR HISTORIC AIRCRAFT RECOVERY

NEW DOTS,

NEW CONNECTIONS

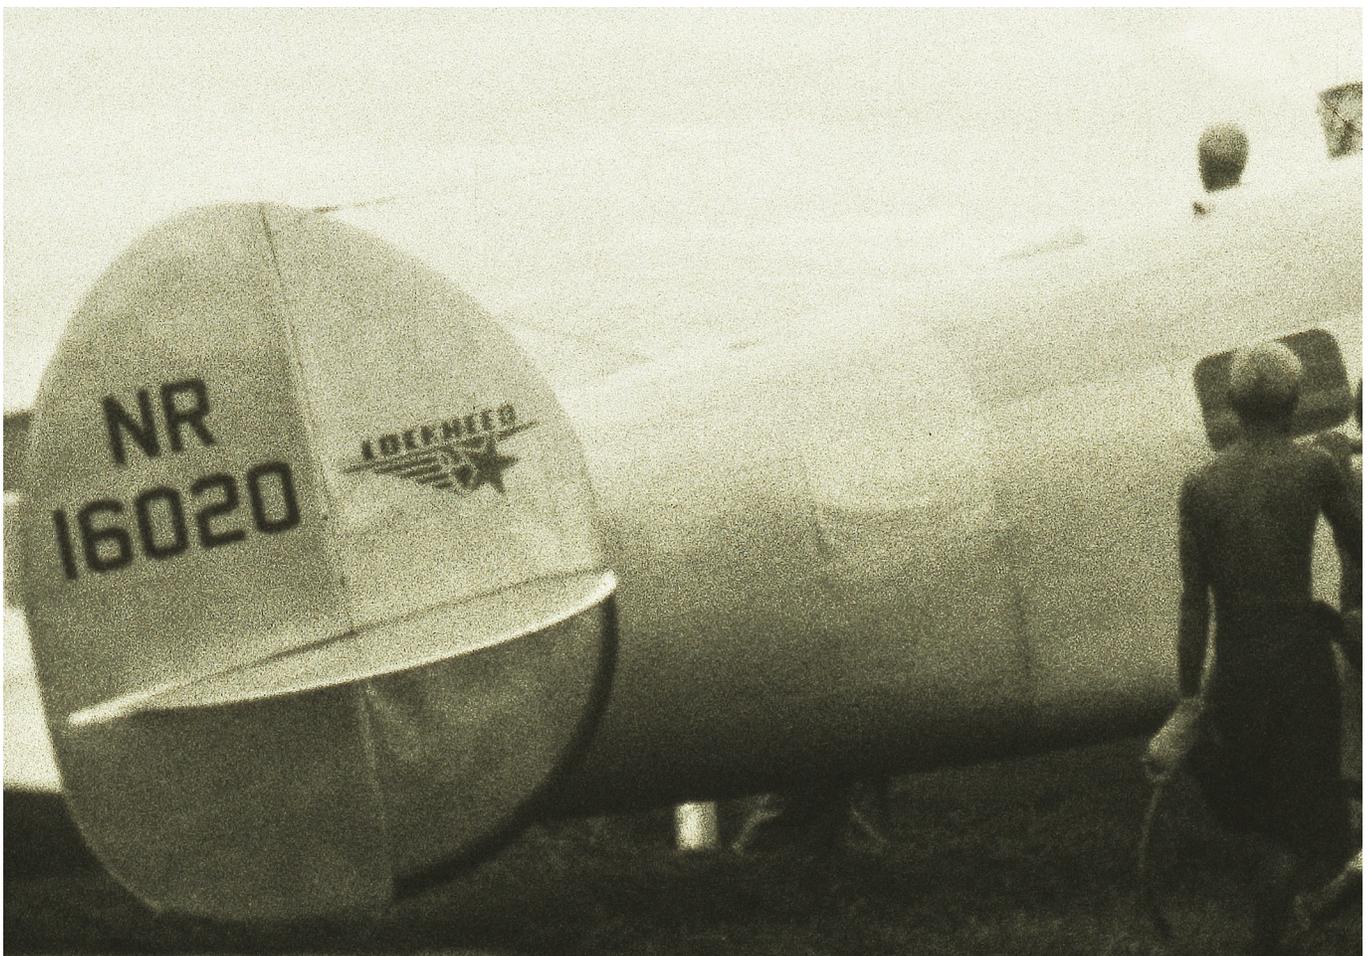
Meanwhile, it is now apparent that bits of information once seen as incidental and unrelated, are connected and consequential. Deformation of the patch visible in the new imagery is indicative of stresses that trace back to the installation of the window it replaced and, ultimately, to the original construction of the airframe.

CAUSE AND EFFECT

1. The Model 10, like most all-metal aircraft, is of semi-monocoque construction. Aluminum skins are riveted to circumferential formers and longitudinal stringers which distribute the aerodynamic loads.

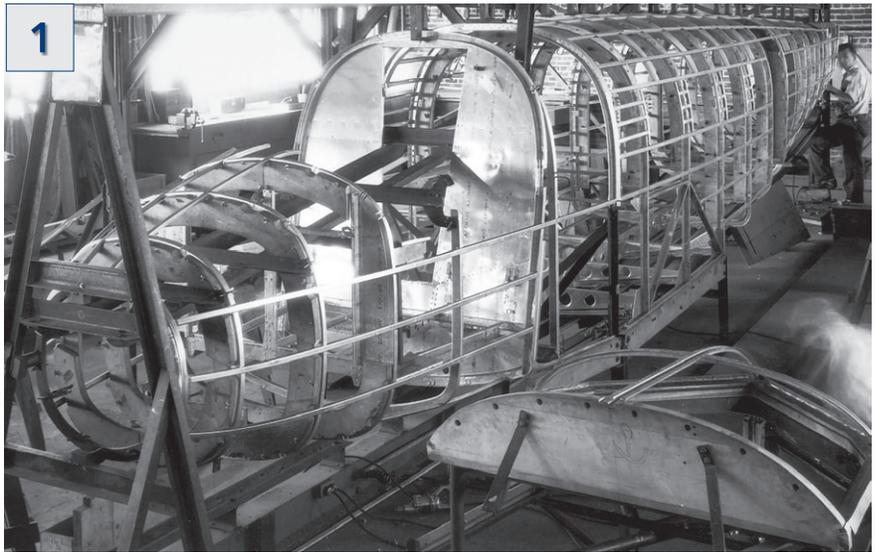
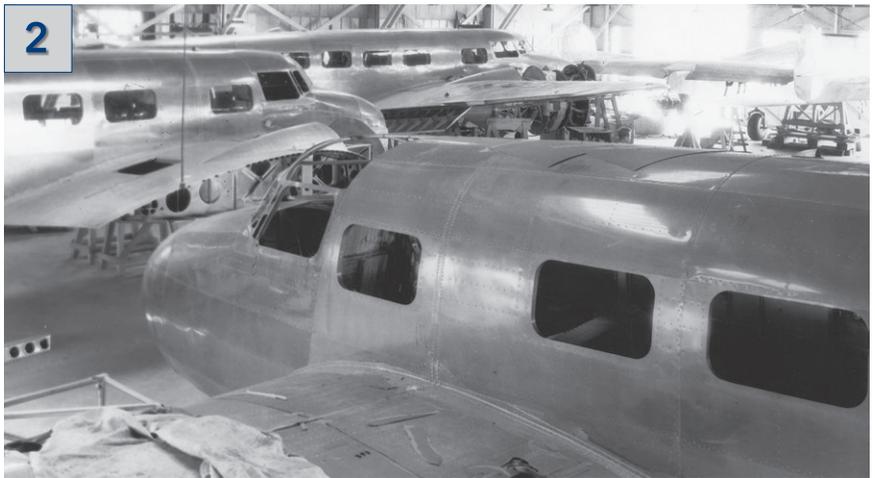
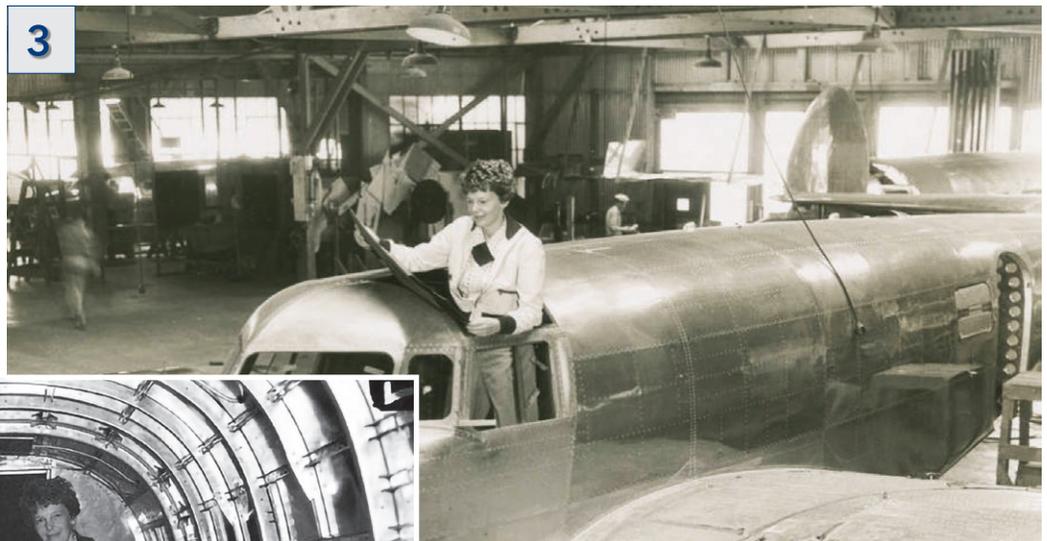
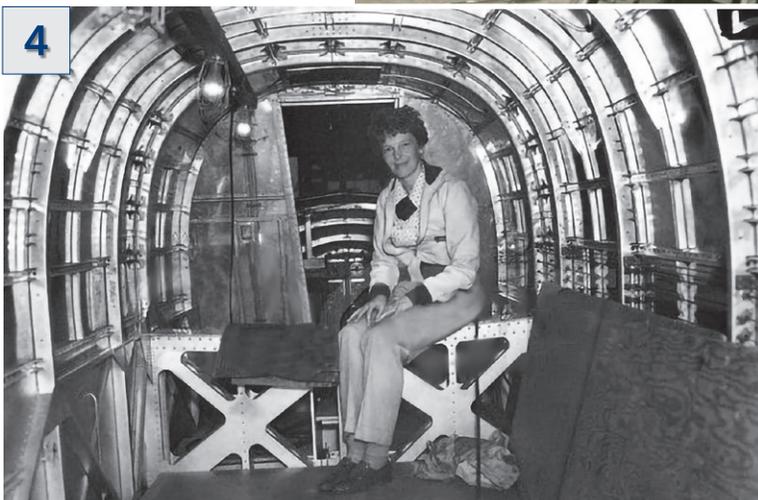
3 & 4. Holes for doors and windows weaken the structure, so Lockheed made Earhart's 10E Special stronger by eliminating four of the five passenger windows

on each side of the cabin, and leaving the normally-removed stringer in place for the one remaining window on each side.

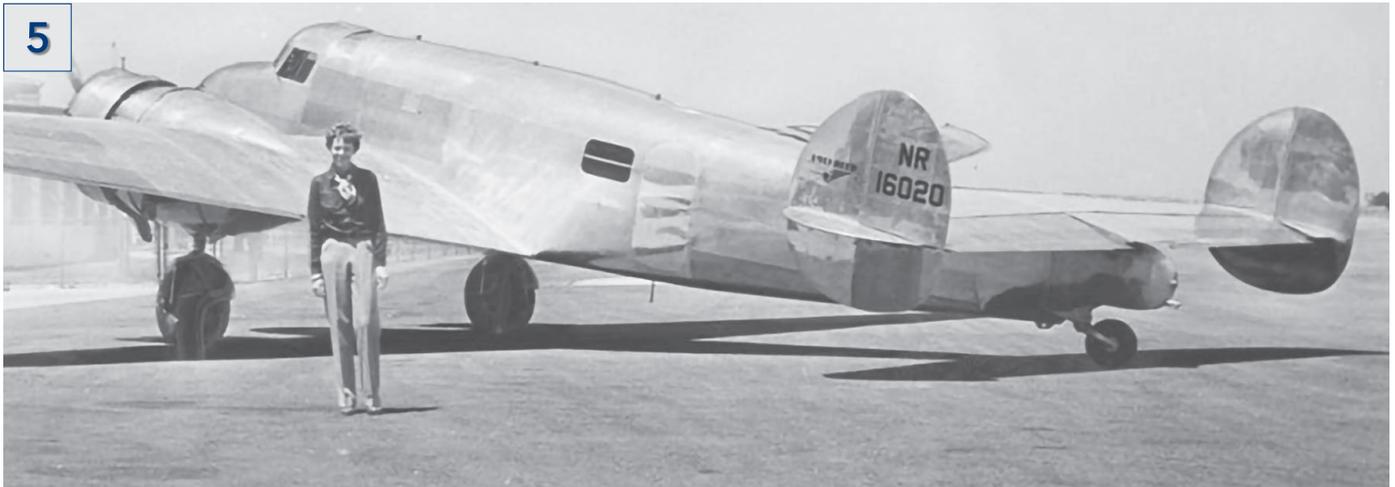
5 & 6. As delivered in July 1936, Earhart's Model 10E Special featured an immensely strong fuselage structure interrupted only by the solid cabin door standard on all Electras.

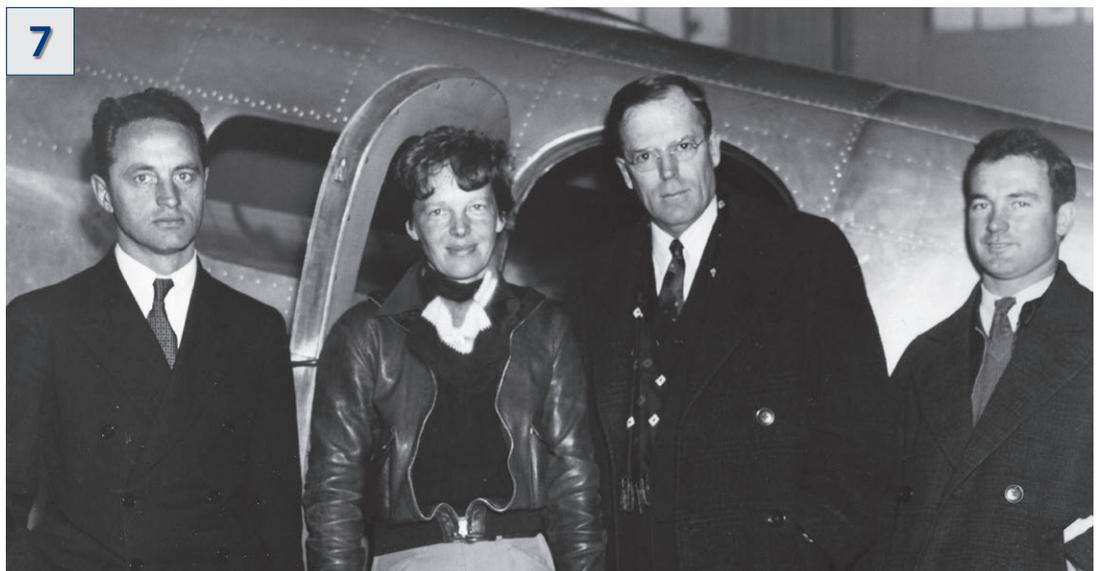
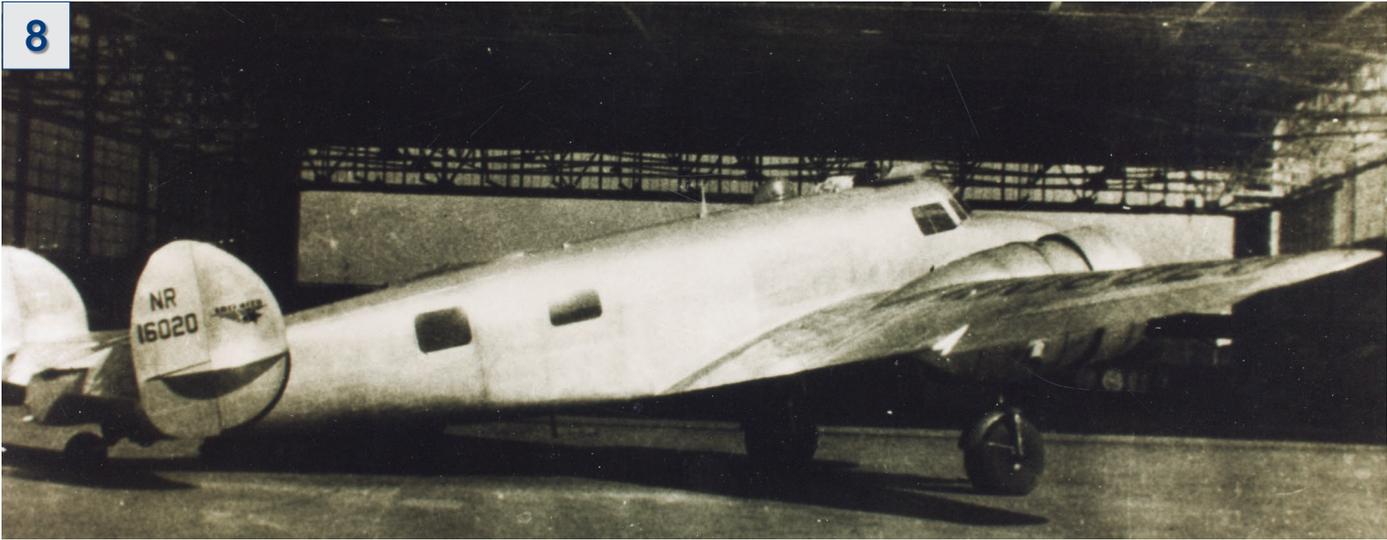
7. On December 28, 1936 the Bureau of Air Commerce approved the construction of a runway on Howland Island, and preparations for Earhart's world flight moved into high gear. For the long Pacific legs, Amelia had chosen sea captain Harry Manning to be her navigator. Although experienced at nautical navigation, Manning had never done celestial sightings from an aircraft. To provide him with better visibility for observations, changes were made to the Electra. By early February, when Amelia, Manning (left), her husband George Putnam (center), and mechanic Ruckins "Bo" McKneeley (right) arrived in New York to announce that Amelia would begin the world flight in March, the window stringers had been cut out and a new window installed in the cabin door.

8. Of greater consequence was the addition of a large window on the right-hand side of the fuselage in what would normally be the lavatory compartment.

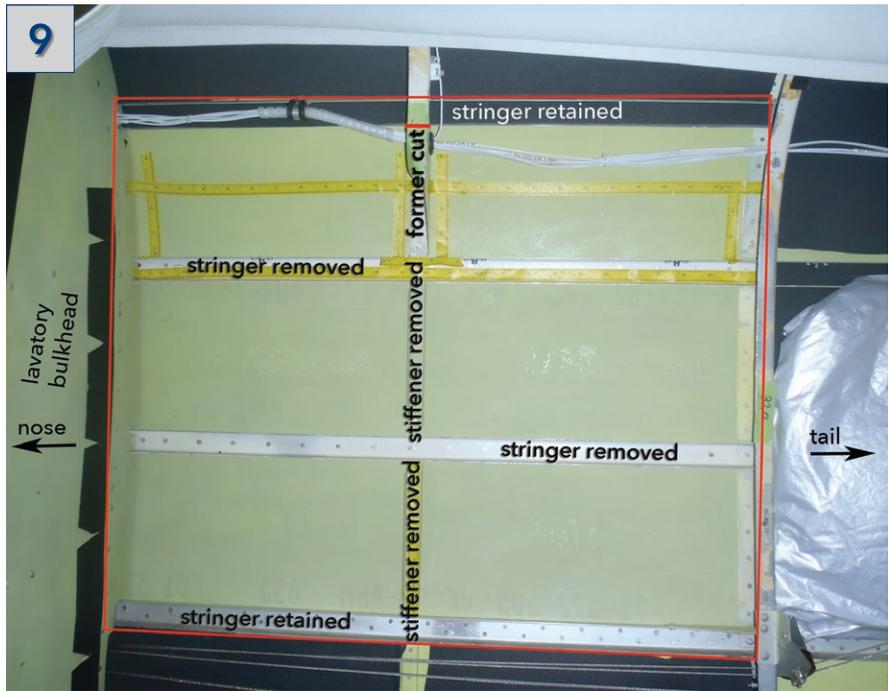
9. This is the interior wall of a Lockheed Model 10 in the area where the new window was installed. Making a hole for the window meant removing a large section of load-bearing skin (outlined in red), cutting a circumferential former, losing two vertical stiffeners, and cutting out sections of two stringers. The effect was to weaken the ability of the fuselage to withstand vertical loads. There was no Bureau of Air

Commerce approval for cutting away these structures and no government inspection of the work. Had there been an inspection it's likely that the aircraft's license category would have been reduced to Experimental, thus cancelling the world flight.

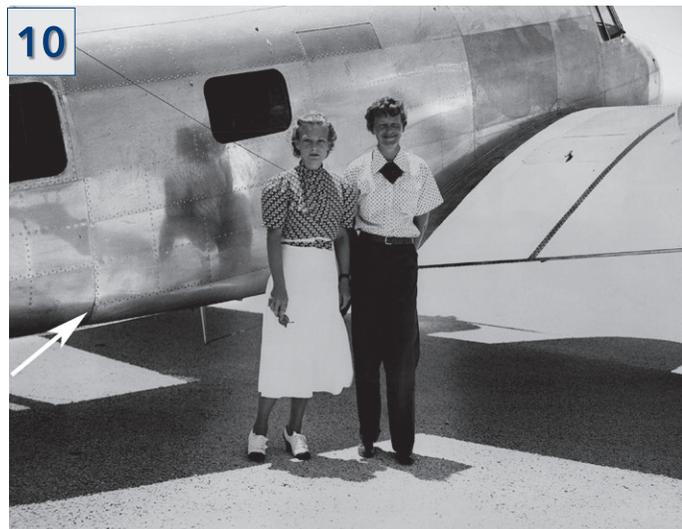
10. Despite the ill-advised modifications, the fuselage held up well, even through the groundloop accident in Hawai'i which ended the first world flight attempt and led to Manning's departure from the project. On May 23, 1937, when Earhart, Putnam, Fred Noonan, and Bo McKneeley arrived in Miami for the start of her second world flight attempt, Amelia landed at the wrong airport. Realizing her mistake, she immediately took off and flew the short distance to the correct field where the press eagerly

awaited her arrival. Embarrassed and rattled, she botched the landing and dropped the airplane in so hard that, according to a reporter for the Miami Herald, “you could hear the screech of metal all over the airport.” McKneeley was so concerned that he put the aircraft in the hangar to inspect the landing gear for damage. None was found, but a photo taken several days later shows that the “screech of metal” was the upward flexing of the weakened empennage (tail section) resulting in a slight separation of the fuselage skins at the base of the bulkhead just forward of the large window.

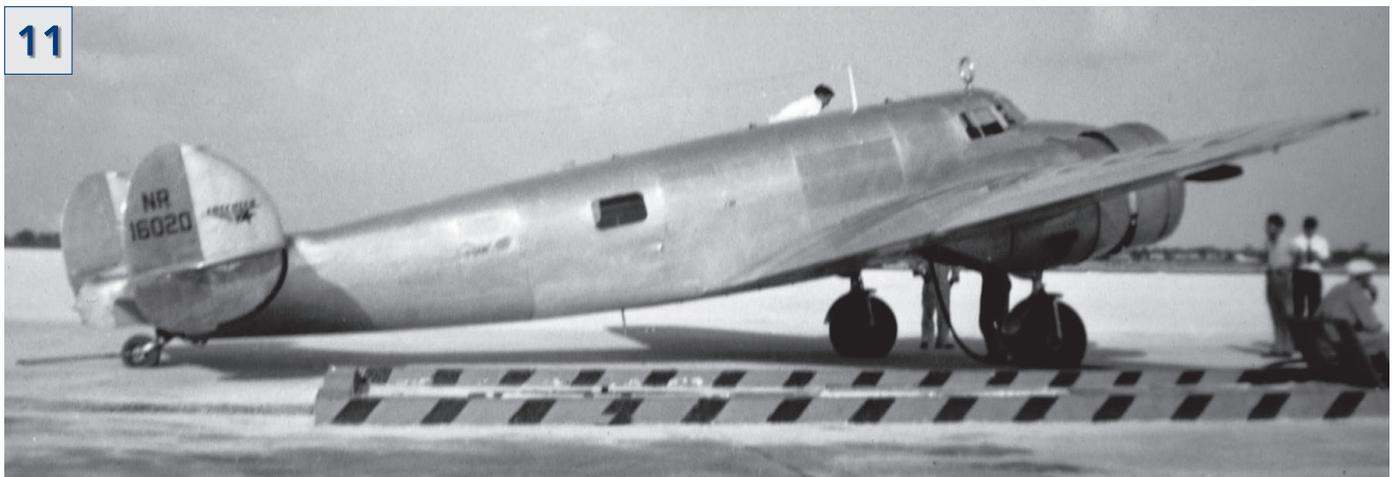
11. It’s likely that the same flexing also cracked the window, which was replaced with the shiny aluminum patch seen in this photo taken the day before Earhart and Noonan left Miami on June 1, 1937 – but installing the patch merely covered the hole. It did not restore the structural integrity of the empennage.

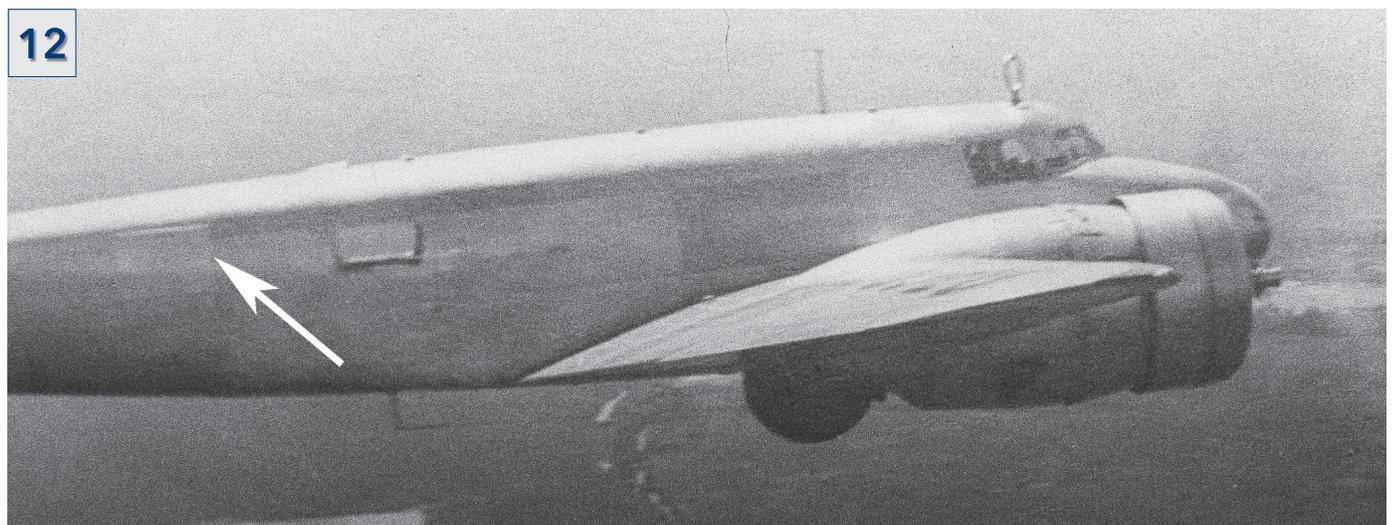
12. In this air-to-air photo taken over Java about three weeks later, the patch is less shiny but appears smooth and intact.

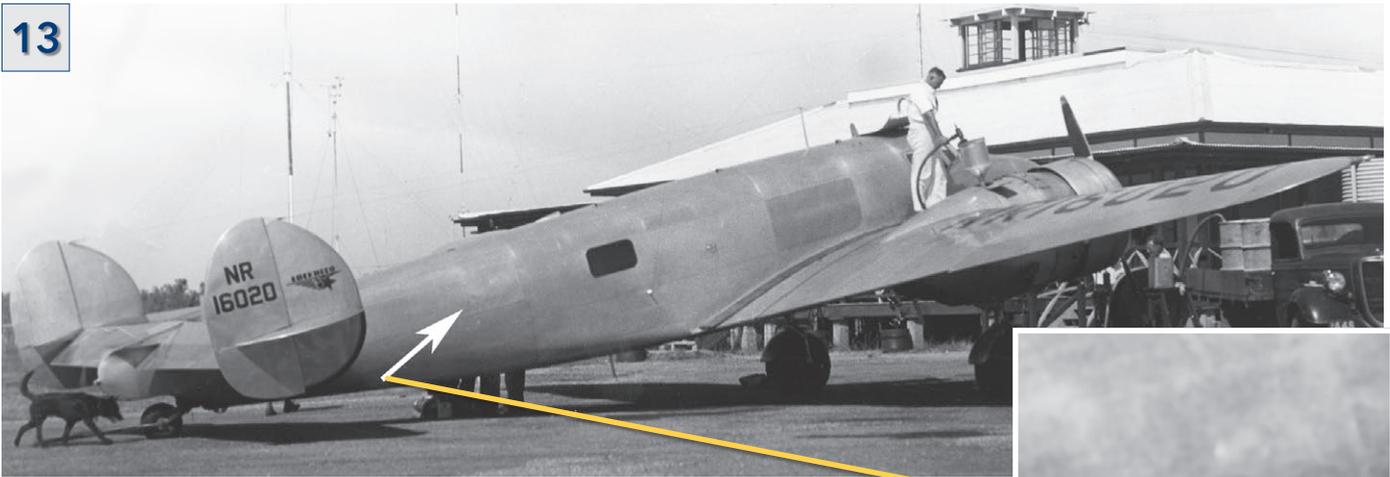
13

13. A problem with the patch is first evident in a photo taken on June 28, when the aircraft was in Darwin, Australia being fueled for the next day's flight to Lae, New Guinea. The metal has begun to buckle in the lower left-hand corner of the patch.

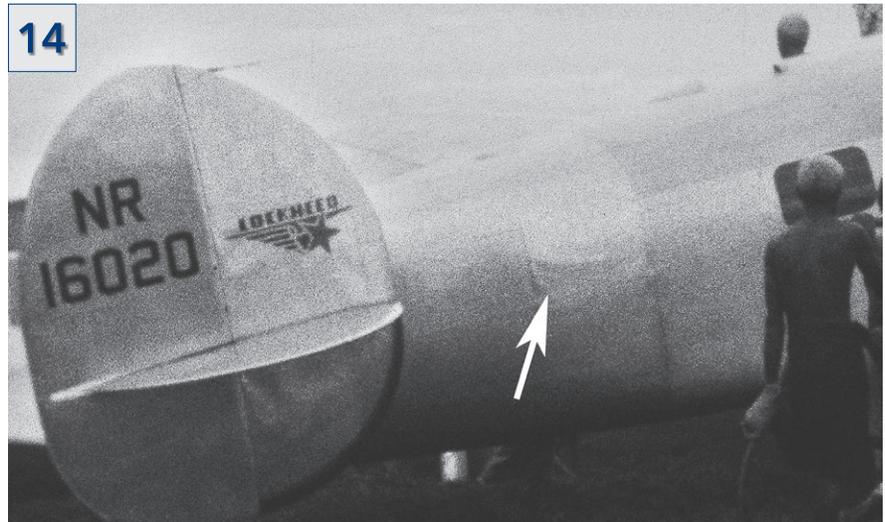
14

14. By the time the aircraft was being fueled in Lae on July 1, the problem had grown worse. In the raw imagery from the recently acquired film, it is apparent that vertical flexing of the empennage has caused the buckling to increase along the bottom edge where the patch was anchored to a particularly heavy stringer which, in the original structure, featured a double row of staggered rivets. "Super-resolution" analysis of the newly acquired film should reveal more detail of how the patch was riveted to the aircraft.

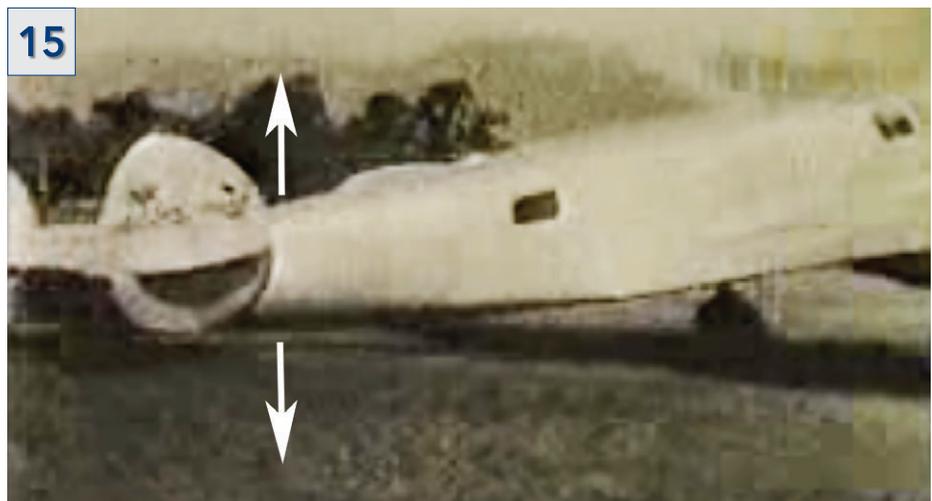
15

15. Image resolution in the film of Earhart's departure for Howland Island the next day is too poor to see the patch, but the unprecedented weight of the fuel load and the long taxi to the far end of the airstrip put increased flexing loads on the empennage as the tailwheel bounced along the unpaved surface. The buckling and stress on the lower edge of the patch could only have grown worse.

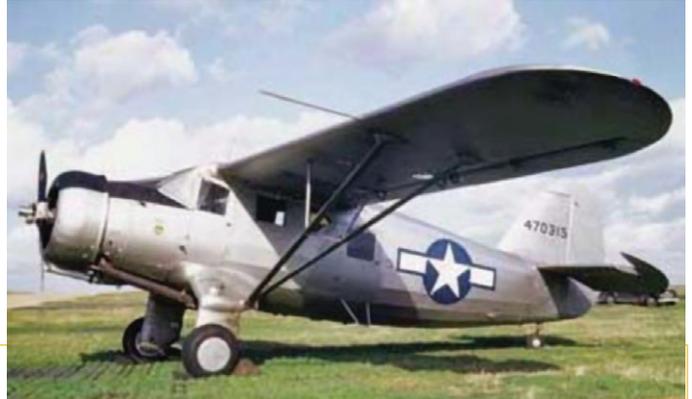
The C-64 Norseman was a radial-engine, high-wing monoplane with fixed landing gear and a large door on the left side of the fuselage. There were other radial engine, high-wing light aircraft types that served with the USAAF, but none had a large door on the left side of the fuselage.

His description of the aircraft's configuration matches the Miller aircraft.

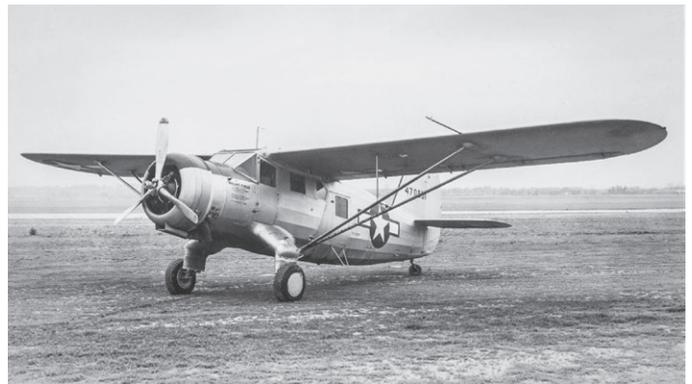
The fisherman remembers a three-bladed propeller. The Miller aircraft had a two-bladed prop, but there are photos of later C-64s with three-blades.

All C-64s serving in England had two-bladed propellers. A three-bladed prop was tested on a C-64 at Wright Field in 1945 and found to be more efficient than the two-blade. Some C-64s were subsequently modified, but the Miller aircraft in 1944 cannot have had a three-blade prop.

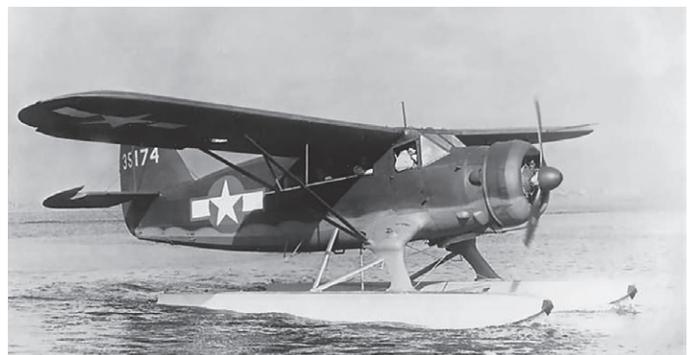
The fisherman remembers a "big round nut" on the propeller hub. The Miller aircraft almost certainly had no such feature but there is at least one photo of a C-64 with a spinner on the hub and what appears to be a three-bladed prop.

None of the photos of Norsemen in military or civilian service show anything on the prop hub. There is only one known photo of a Norseman with a "big round nut" on the prop. The aircraft, C-64 43-5174 was kept at the Noorduyn factory for 23 months for flight tests including various float and landing gear configurations.

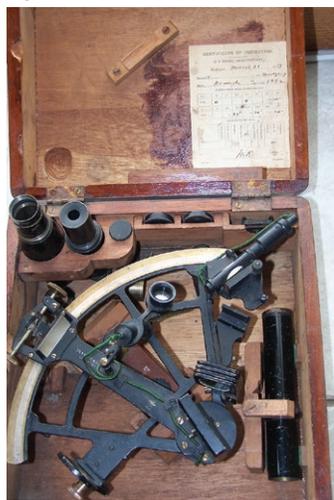
Brandis sextants were delivered in a wooden box with the matching maker's number stenciled on the inside. The Naval Observatory pasted a certificate on the inside of the lid and sometimes stamped the N.O. number into the wood.

TIGHAR research established that the numbers identify the sextant in question as a Brandis Navy Surveying Sextant. The 3500 is the Brandis "maker's number" and the 1542 is the "N.O. number" assigned by the U.S. Naval Observatory when the sextant was initially calibrated.
