# *TIGHAR TRACKS*

THE JOURNAL OF THE INTERNATIONAL GROUP FOR HISTORIC AIRCRAFT RECOVERY

# WHAT HAPPENED TO THE PLANE?

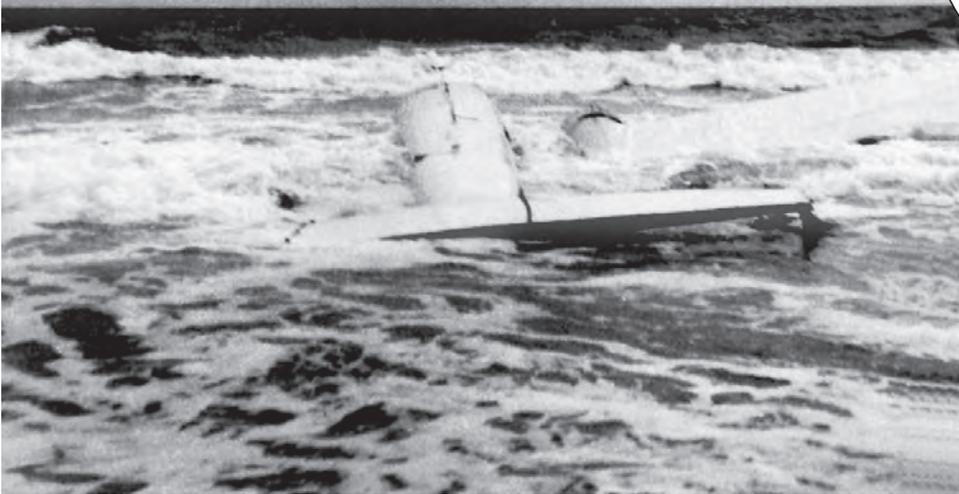
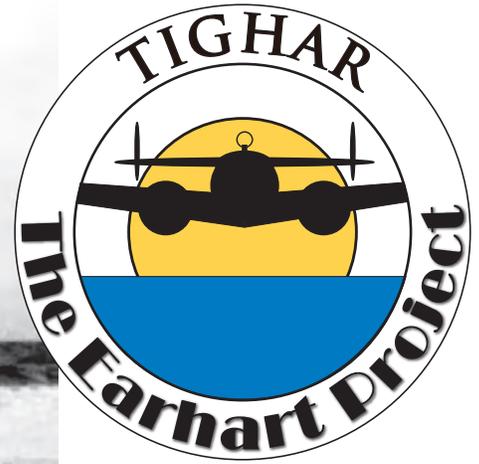
*A Lockheed 10E that ditched off Cape Cod in 1967 floated for seven minutes.*

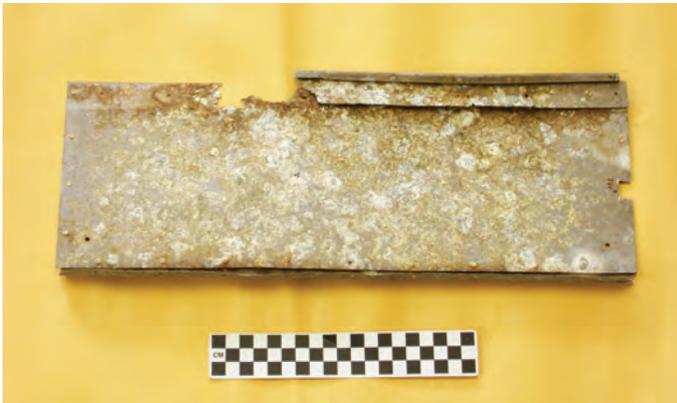
*Interior aircraft component found in 1989, believed to have been an insulated heat shield to protect the fuselage fuel tanks and lines from cabin heater ducts in NR16020.*

The second hypothesis is less palatable but better supported. Our first indication the plane broke up came as early as our first expedition to Nikumaroro in 1989 from scraps of re-purposed aluminum aircraft components found in the abandoned village. Structures that looked like they might be from Earhart's Electra clearly came from the inside of an aircraft. The discovery in 1991 of a torn section of aluminum aircraft skin, washed ashore by a recent storm, further pointed to an aircraft that had been severely damaged.

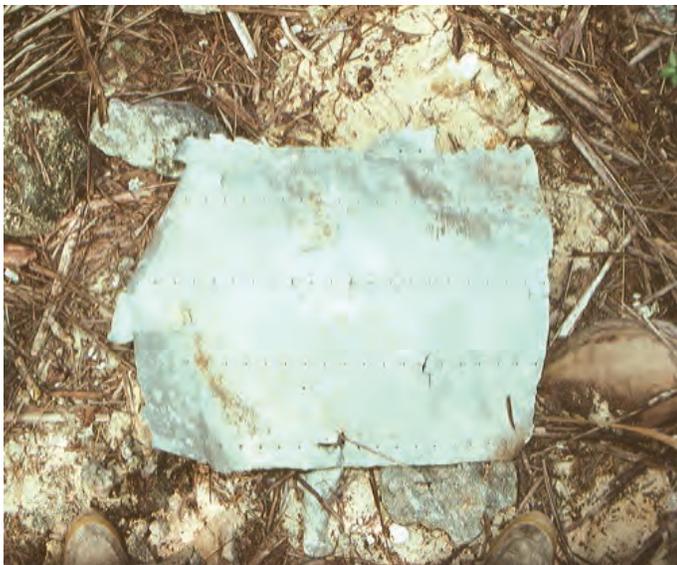
*Section of torn aircraft skin found in 1991.*

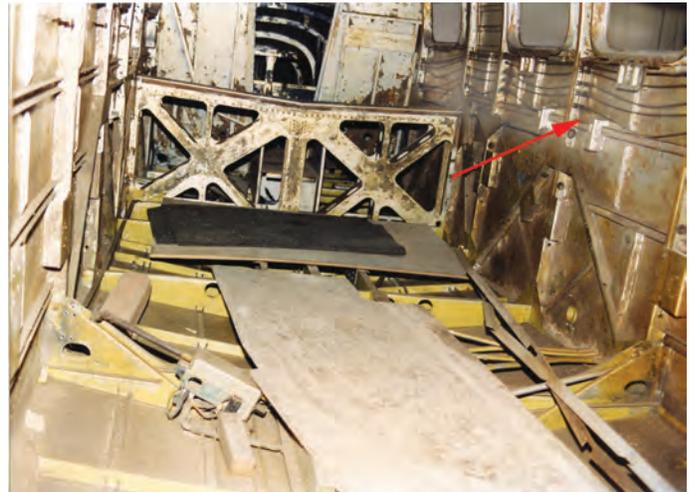
*Control cables in an Electra under restoration.*

The first Gilbertese work party arrived at Nikumaroro in December 1938. If there was an airplane wreck there it could only be NR16020. The ailerons on an Electra are operated by cables in the wings. The rudders and elevator are controlled with cables that run from the cockpit along the length of the starboard cabin wall to the tail. For control cables to be salvageable, they would have to be exposed and accessible.

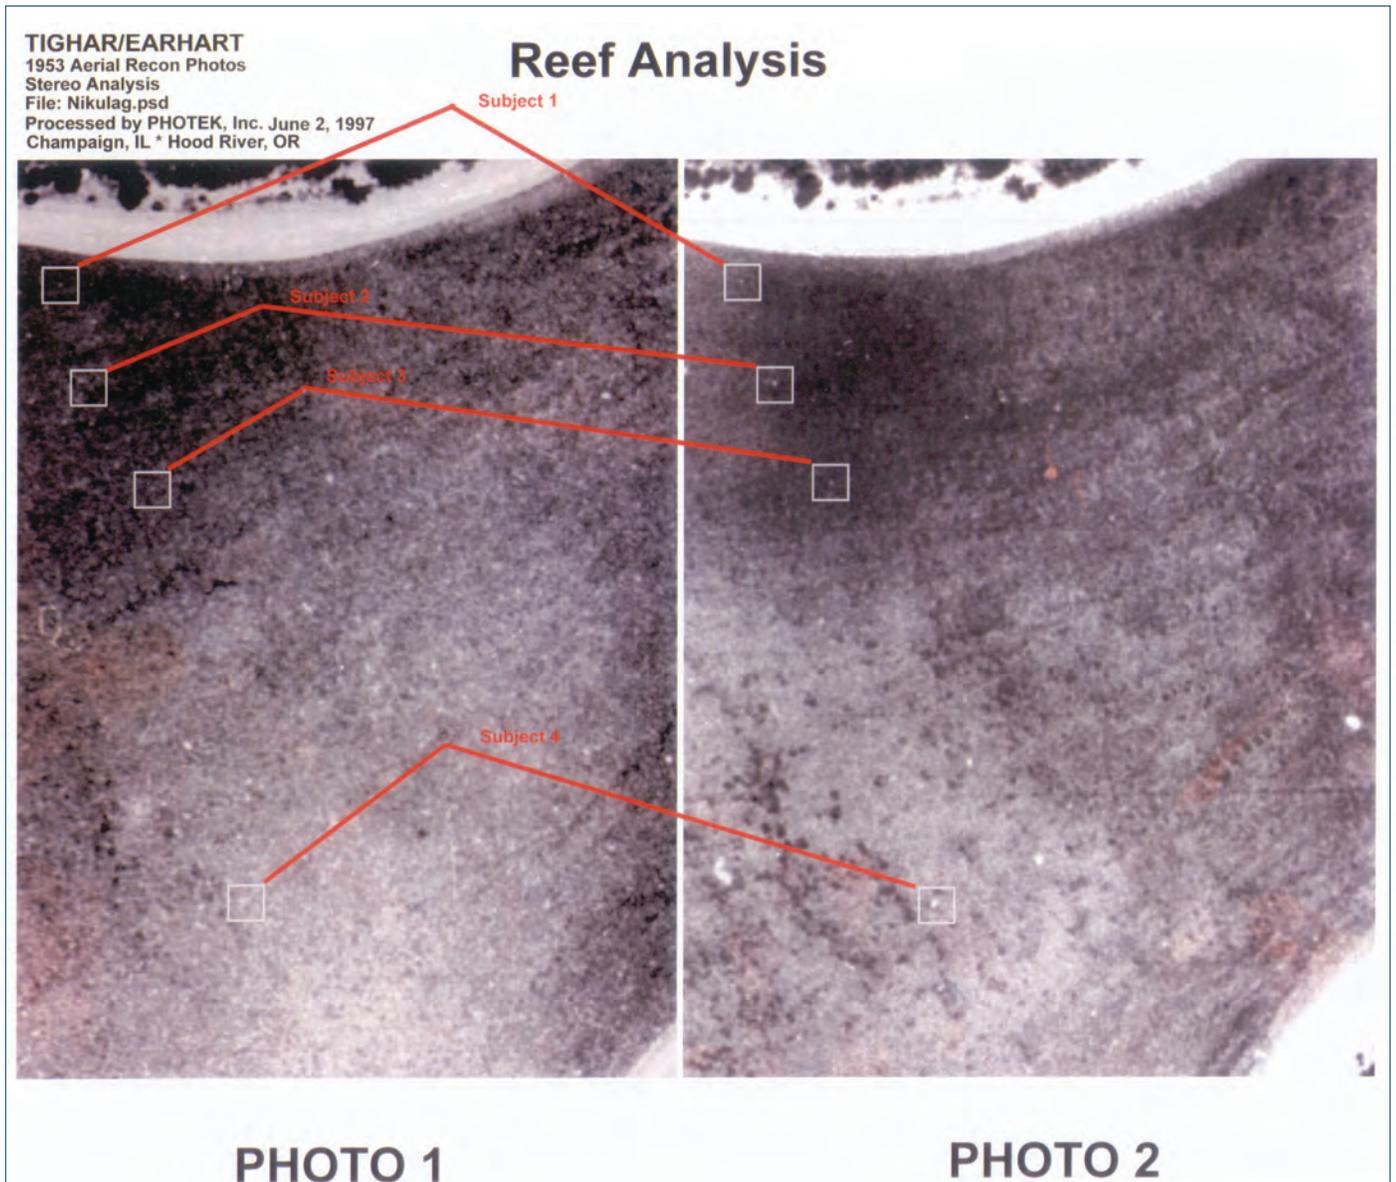
*Four large pieces of light-colored metal are visible in shallow water on the reef flat near the mouth of the main lagoon passage in aerial mapping photos taken in 1953. Their presence in two separate photos confirms they are not dust specks or flaws in the film. The shiny reflective quality of the objects indicates they are metal. Debris from the shipwreck is not reflective.*

Later that year, Tapania's recollections were corroborated with photographic evidence when forensic analysis of aerial mapping photos taken in 1953 showed what appeared to be light-colored metal debris in the area she described.

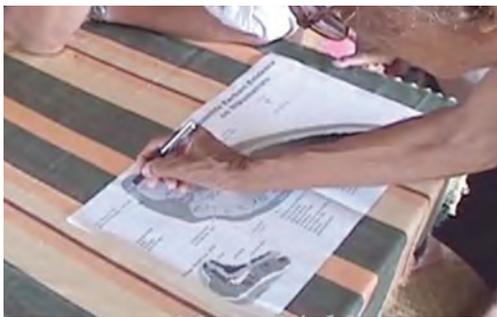
Emily marks the spot where she saw aircraft wreckage on the reef.

In a videotaped interview a few days later she told of seeing what her father told her was airplane wreckage on the reef edge north of the shipwreck near "where the waves break." On a map, she marked a spot north of the shipwreck.

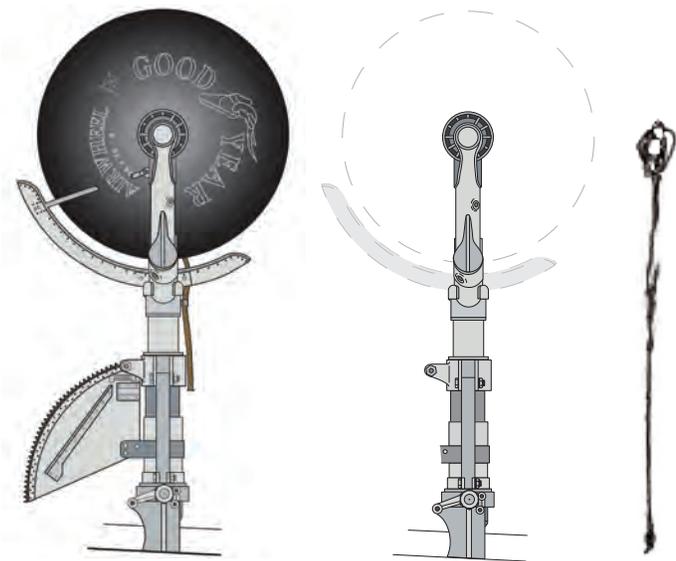
Lockheed Assembly 40650 is the main landing gear for the Model 10 Electra.

The landing gear strut and fork, minus the tire and aluminum fender, resemble Emily’s sketch.

There is a component of a Lockheed Model 10 that fits Emily’s description. Landing Gear Assembly 40650, minus the tire, worm gear, and lightweight aluminum fender, viewed from the side, bears a resemblance to Emily’s crude sketch.

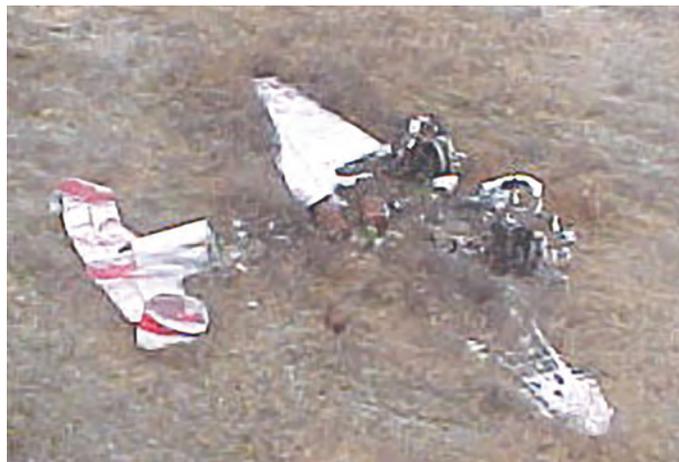
Lockheed 10A c/n 1005 flipped and burned during a forced landing in the 1970s. These photos were taken shortly afterward.

Photos of the wreck of an Electra that flipped inverted and burned during a forced landing in northern Canada, illustrate what Emily might have seen. Emily sketched the object she saw as a vertical line. For the strut and fork of an Electra on the reef edge to be visible to an observer some distance away, it would have to be sticking up. For that to be true, the aircraft must be on its back and the gear still attached to the aircraft’s massive Main Beam, as it is in the photo of the Canadian wreck. The “frame” Emily referred to may be the Main Beam.

The Main Beam was the core structure of the Lockheed Model 10 and ran from engine to engine. The landing gear was attached to the heavy nacelle ribs that were part of the Main Beam.

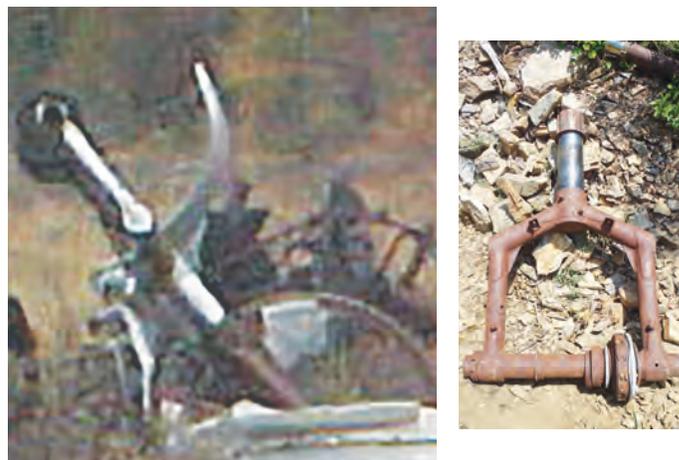
The tire of the starboard landing gear burned in the fire. The landing gear strut and fork, seen edge-on in this photo, minus the aluminum fender, bear a striking resemblance to Emily’s sketch.

The Electra landing gear struts and forks were made of SAE 4130 Chrome Molybdenum steel. In the photo of the Canadian wreck, the steel is still shiny but the forks of an Electra that crashed in Idaho in 1936 (right) are red with rust. There is no sign of the wheel and tire.

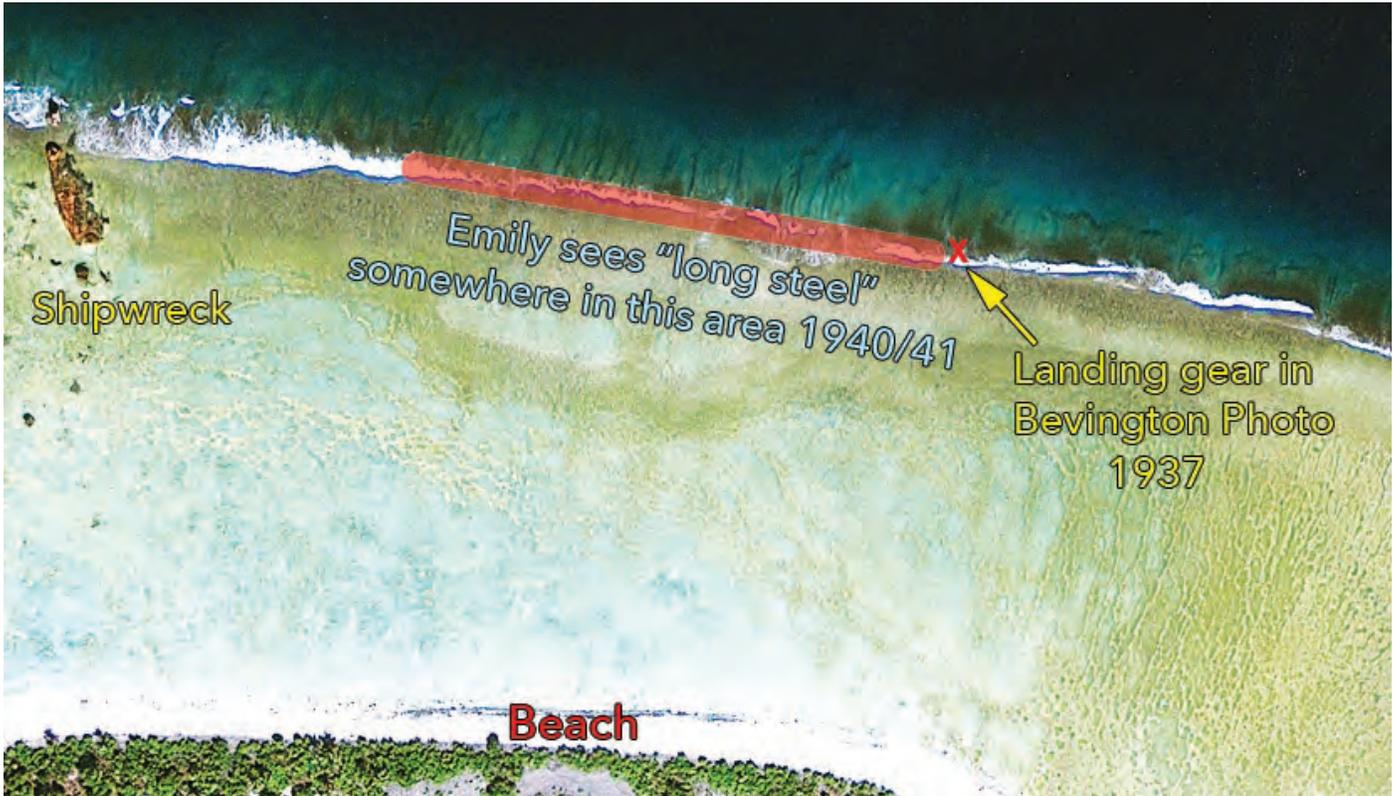
*Emily places the wreckage she saw somewhere in the area indicated in this aerial photo taken at low tide in 2007.*

Emily estimated the length of the “long steel” to be about four arm spans, or roughly twelve feet, but an Electra strut and fork assembly are only four and a half feet long. The photos below show what the reef edge looks like from the beach. Without anything to provide scale, it would be difficult for Emily to judge the size of what she saw.

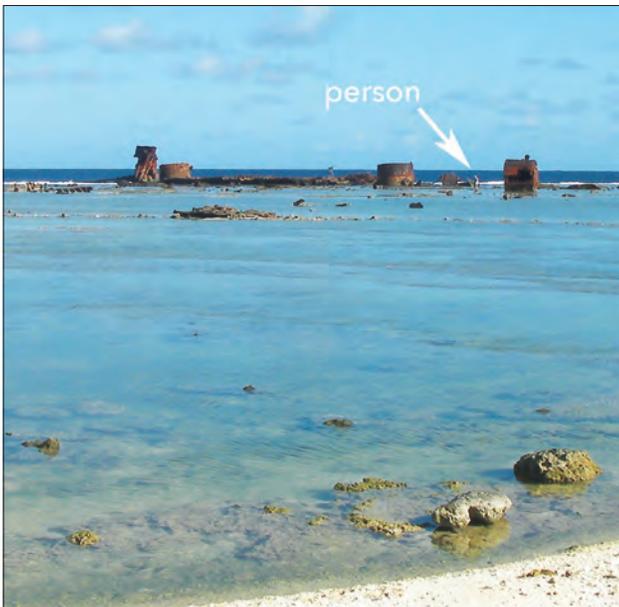
*The Norwich City wreckage seen from the beach at high tide in 1997.*

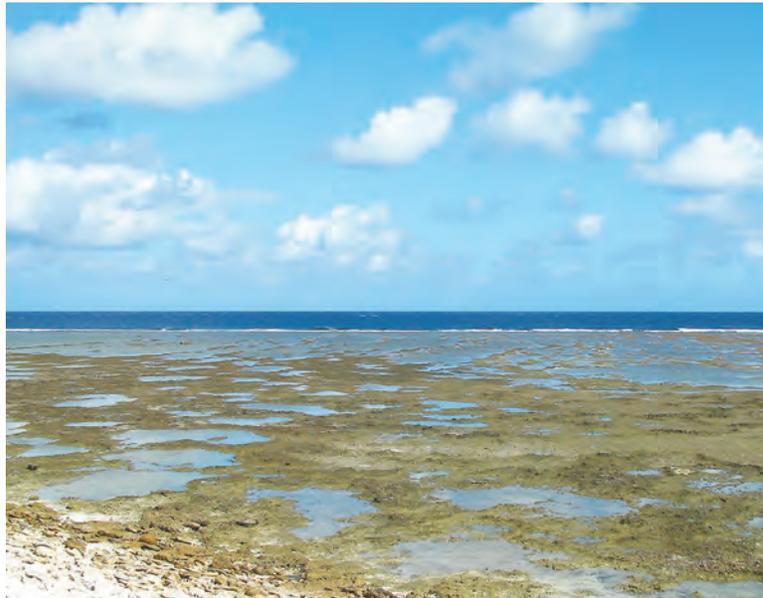
*The reef seen from beach in the area Emily described.*

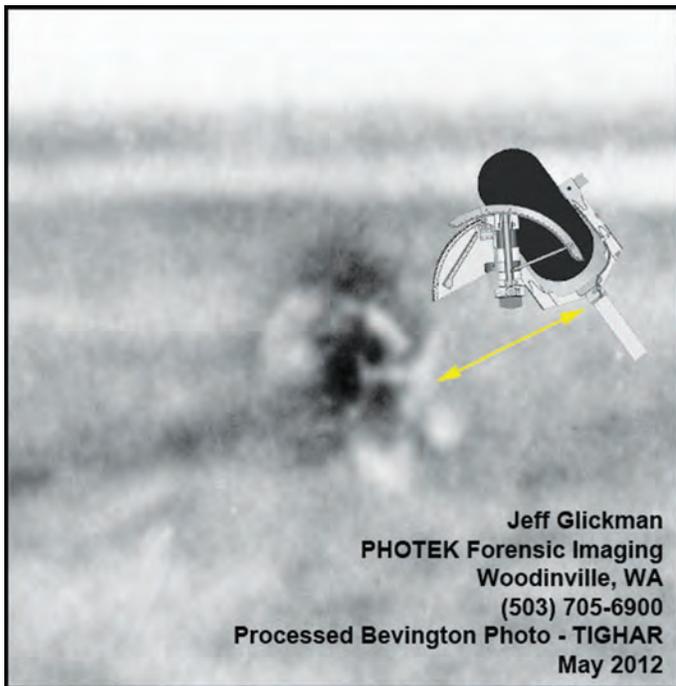
*Landing gear wreckage in the October 1937 Bevington Photo.*

In the landing gear wreckage seen in the Bevington Photo the fork has separated from the shaft of the oleo strut, as it did in the Luke Field accident.

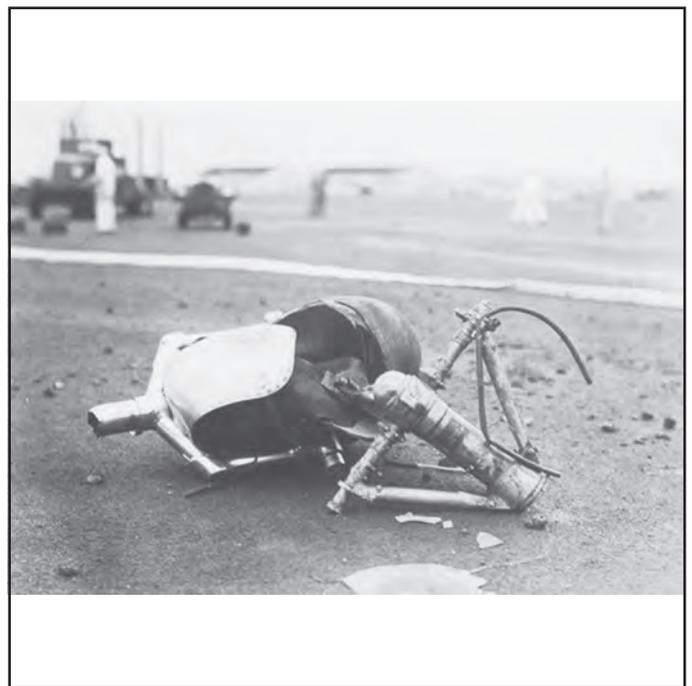
*Landing gear wreckage in the March 1937 Luke Field accident*

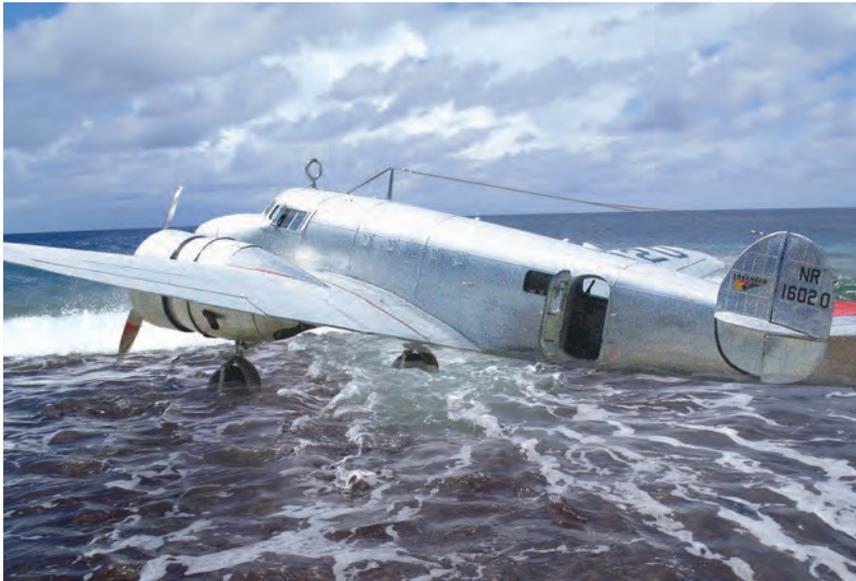
## July 2-7, 1937

NR16020 is intact and on its wheels near the reef edge.

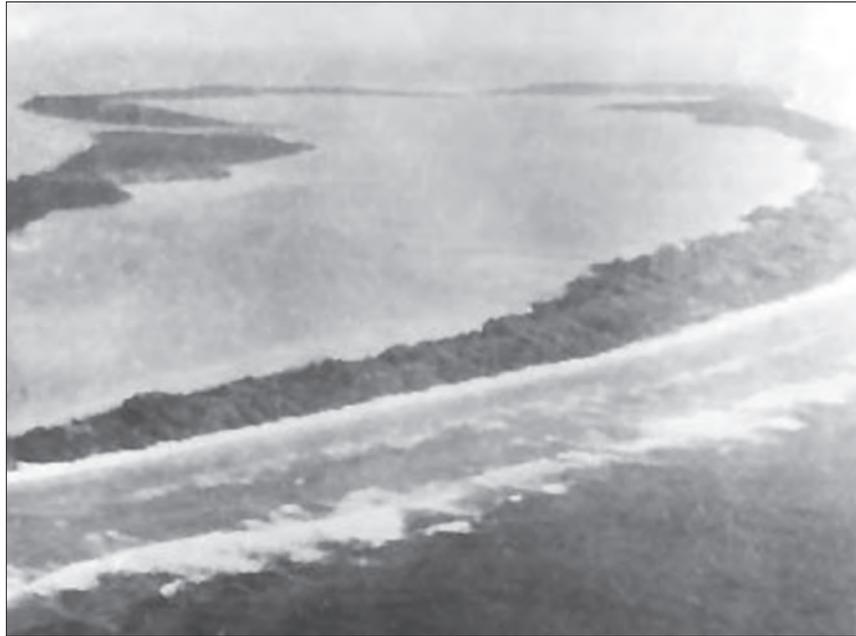
**July 9, 1937**

The tide is high and the surf is rough when search planes from USS *Colorado* arrive. The crews do not recognize the reef flat as a possible landing area, and the landing gear wreckage is hidden by the surf as is the sunken *Electra* in the shallow water just past the reef edge.

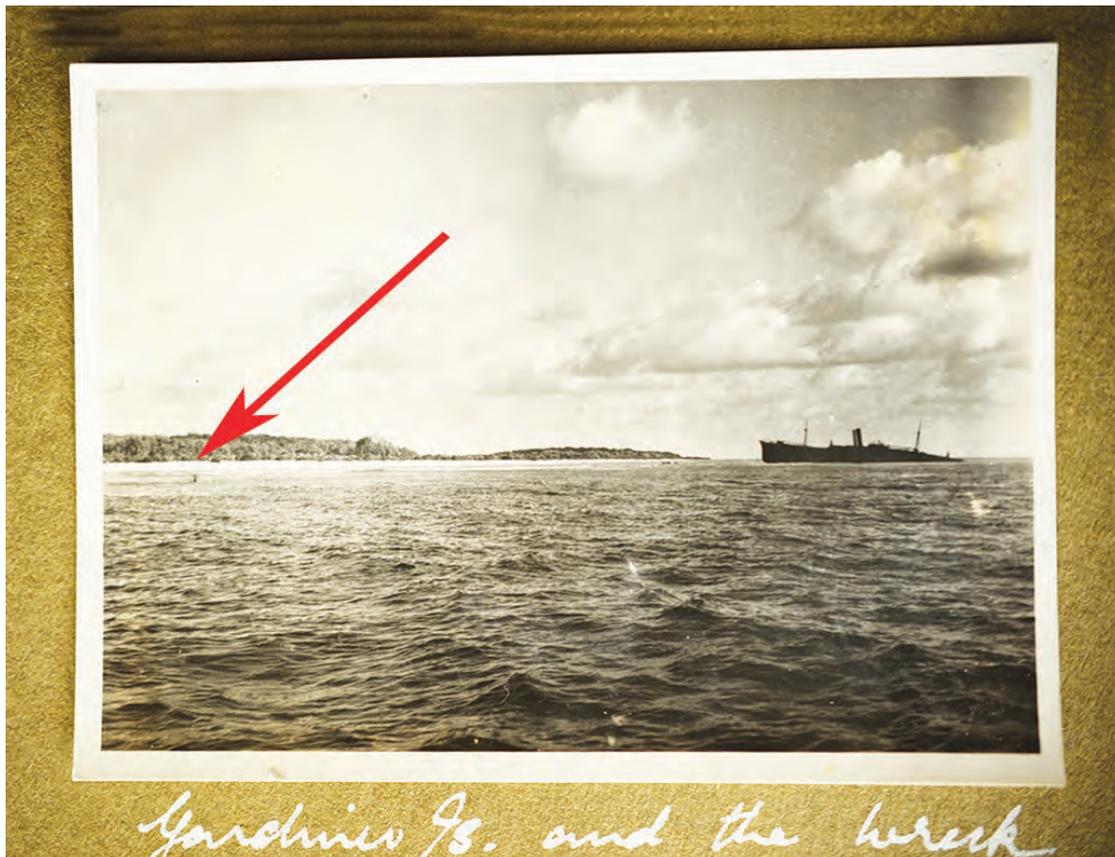
**October 13, 1937**

The situation is unchanged when the British Maude/Bevington expedition departs Nikumaroro after three days of evaluating the island for future settlement. The sea is calm and the tide is low. The landing gear wreckage is visible, but unnoticed, in a photograph of the island's northwest shoreline taken by Bevington.

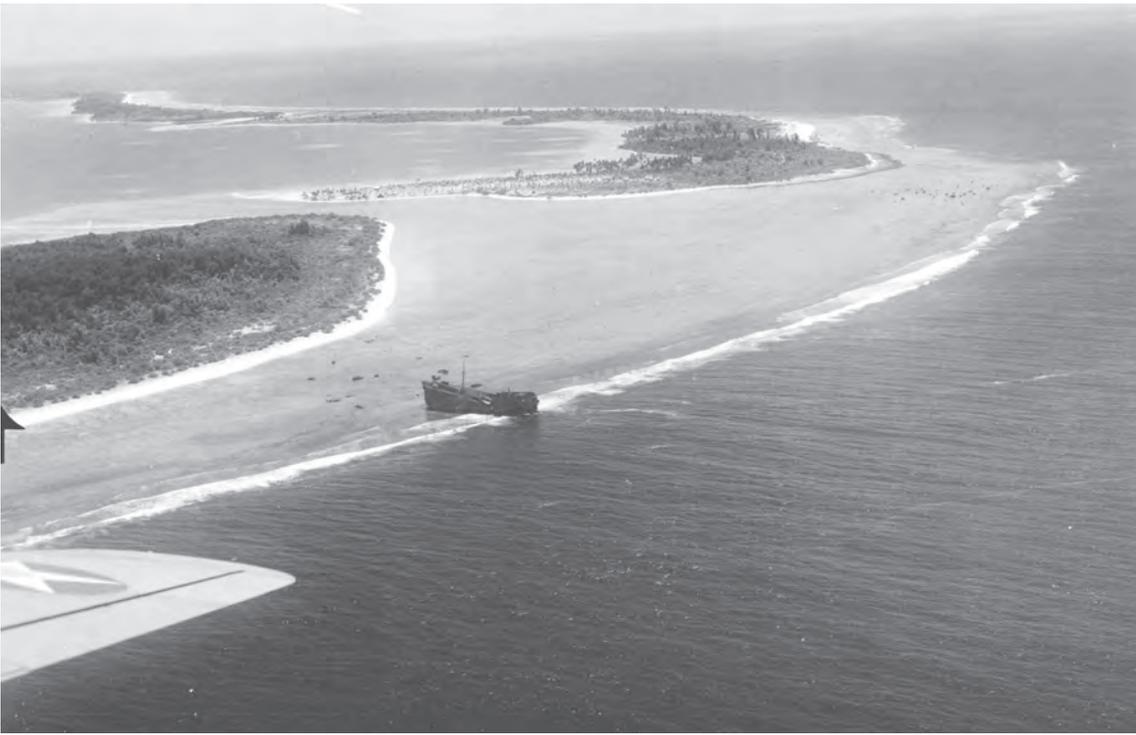
*January 27, 1942,  
USAAF airdrop of  
supplies. The stern  
half of SS Norwich  
City has broken off.  
The colonial village is  
the cleared area across  
the passage into the  
lagoon.*

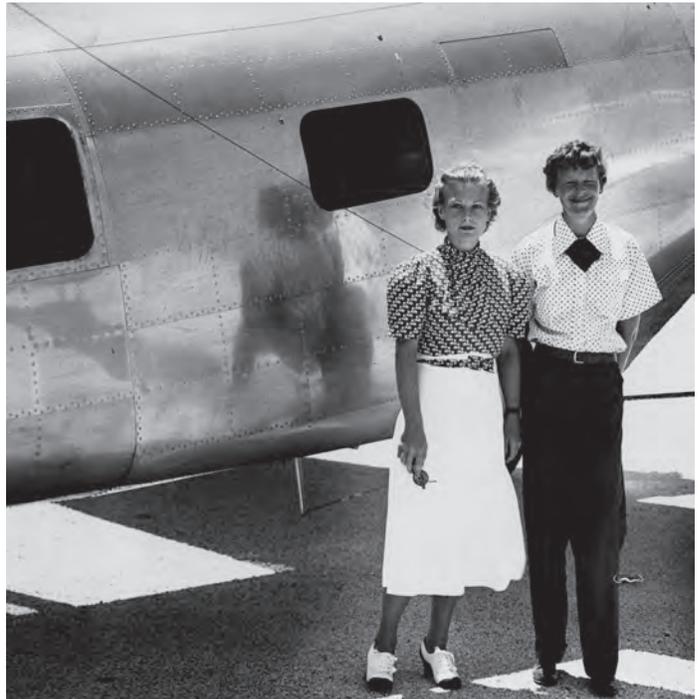
*When Earhart and Noonan taxied out to depart for San Juan, Puerto Rico early on the morning of Tuesday, June 1, the window had been removed and the hole covered with a plain aluminum patch.*

**EVER SINCE 2012** when we first developed the hypothesis that Artifact 2-2-V-1 is the patch installed on Earhart's Electra to cover the hole left by the removal of the special navigator's window, we've struggled to find photos of the patch with sufficient resolution to compare details of the rivet pattern on artifact to the patch on the airplane. Most photos of the Electra were taken of the left side of the airplane because people tended to congregate around the cabin door. The patch was on the seldom-photographed right side of the plane.

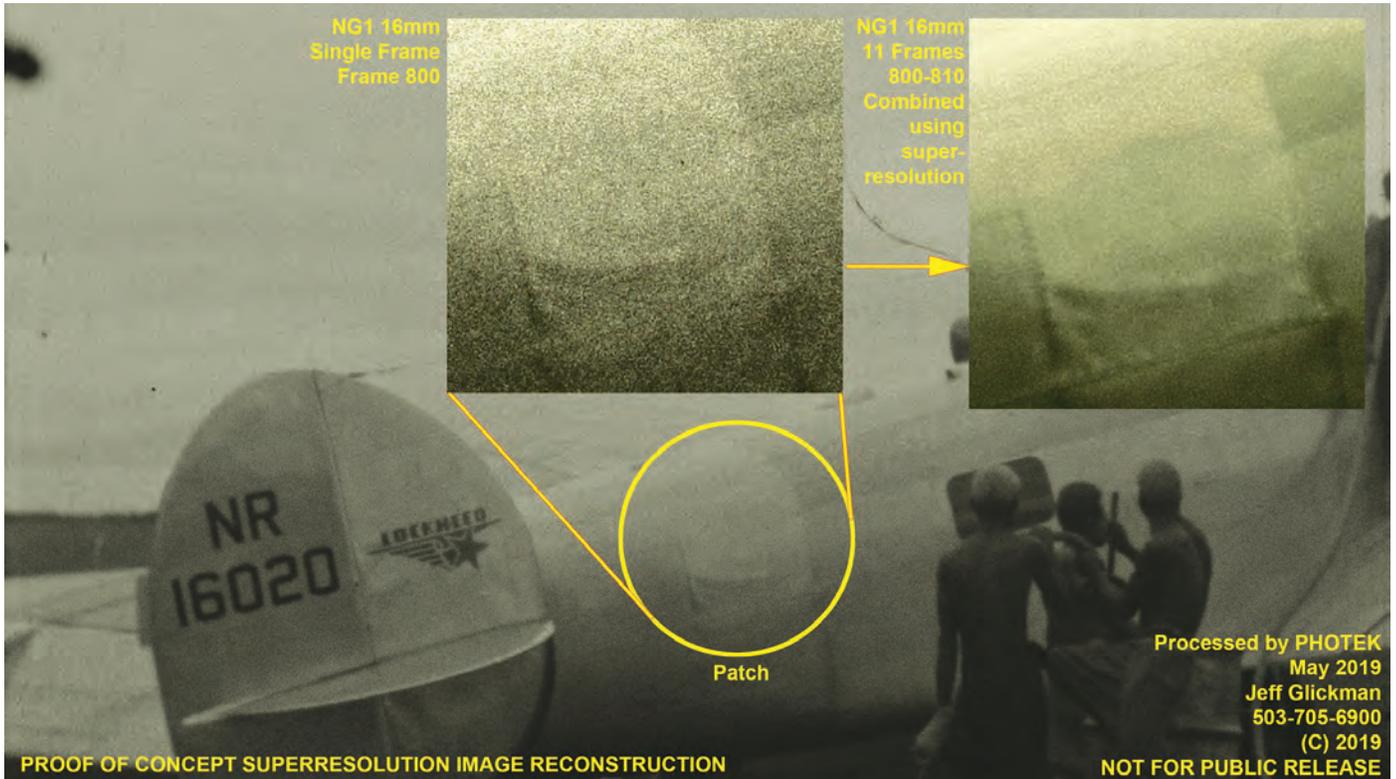
*Processed frame from 16mm film shot in Lae on July 1, 1937.*

Before these new photos came to light, the best images we had were from digitized frames of a 16mm film shot in Lae on July 1, 1937, obtained by TIGHAR in 2019 at great expense after many years of negotiations. Forensic imaging expert Jeff Glickman has spent three years applying a variety of cutting-edge techniques to the digitized frames and has succeeded in greatly improving the clarity of the images, but sufficient resolution to conclusively compare the rivet lines remains an elusive goal.

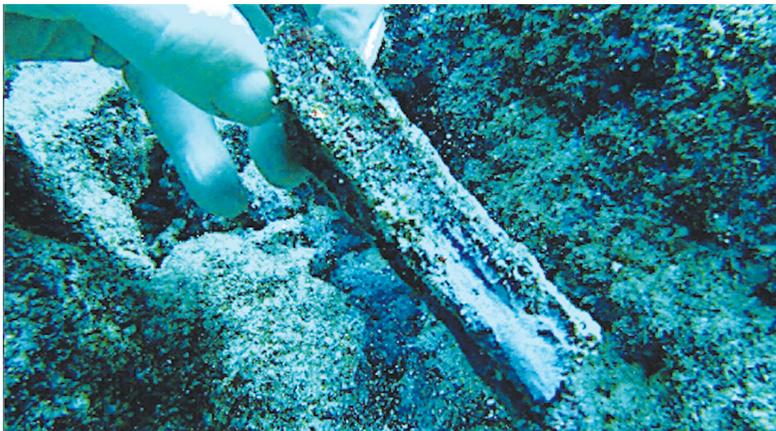
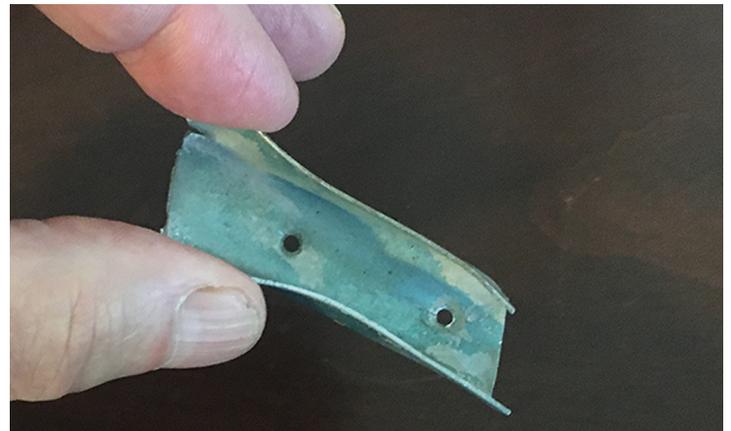
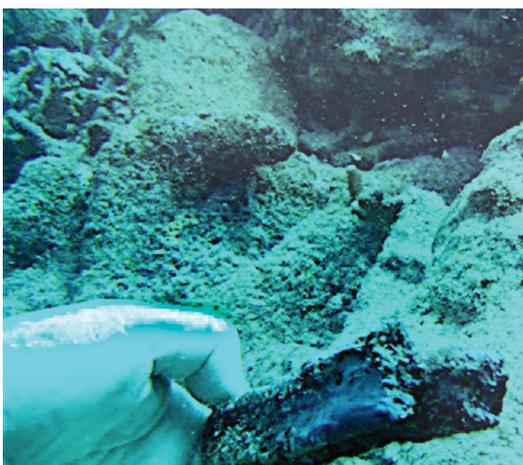
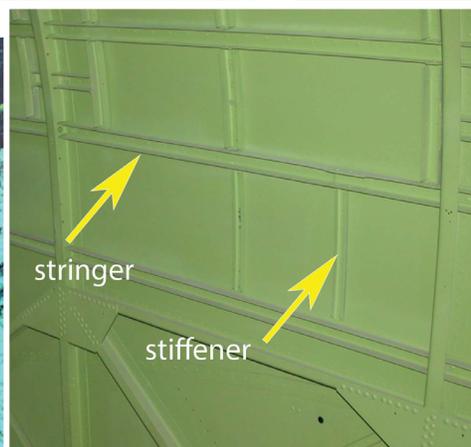
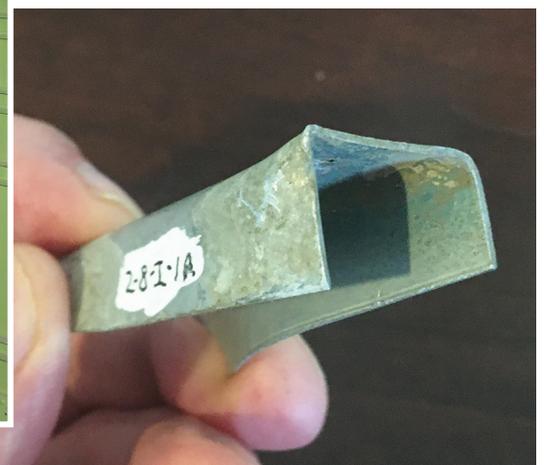
Comparison of screen captures from the short video he took with a piece of damaged stringer from an Electra that crashed in Idaho, bears out his original impression. It could be piece of stringer or possibly a stiffener.
