Biomedical, Materials Science and Mechanical Engineering Analysis 1-800-MSA-MSA1

July 23, 2014

Forensic Evaluation of Video Footage from the TIGHAR 2010 Nikumaroro Expedition – Supplemental Report 3

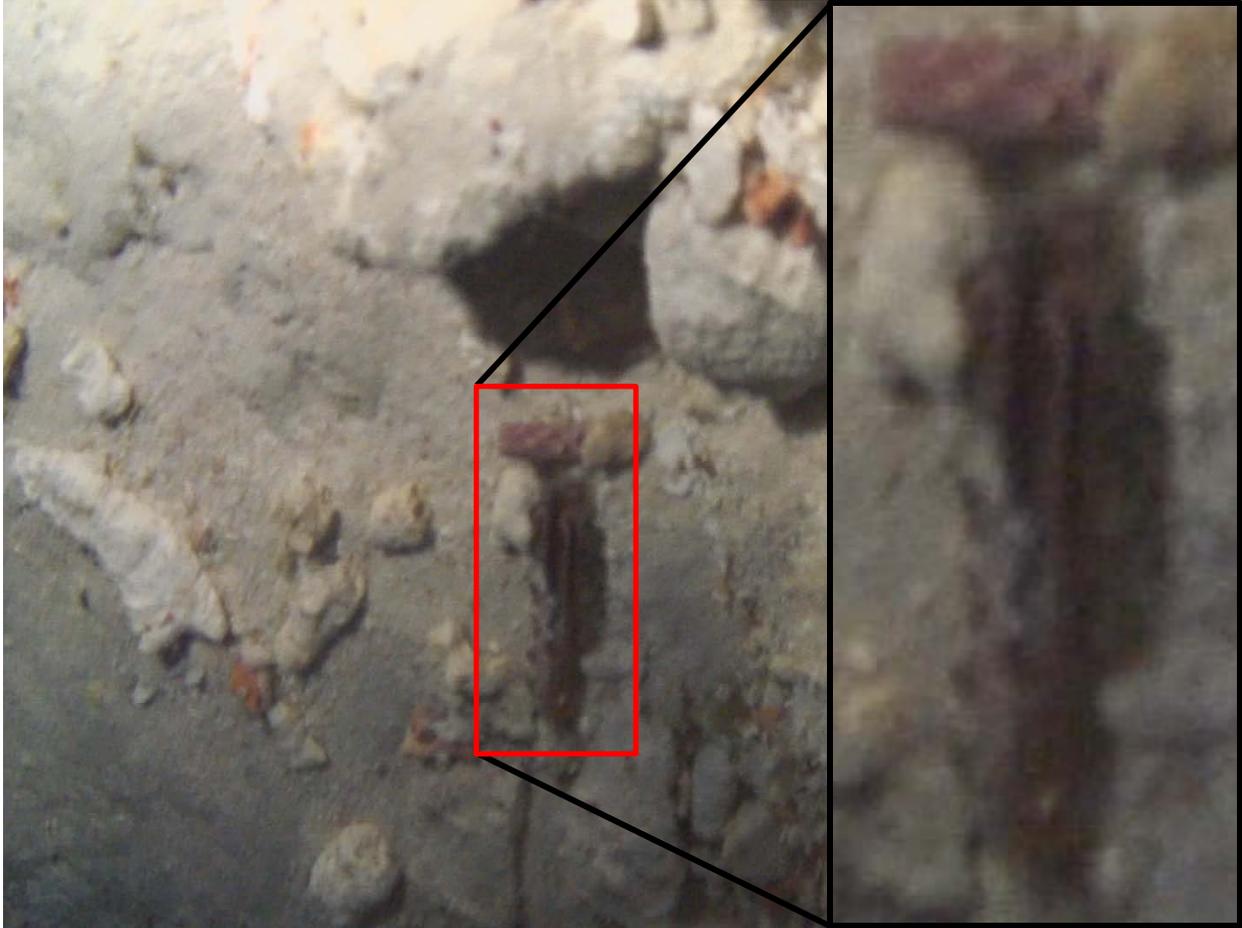
Figure 1: Screenshot at timestamp 13:43:48:24 in the 2010 HD video titled “ROV OPS_0010134 0012XO.mov”.

This is a supplement to my prior supplemental report, which was dated June 4, 2014. At timestamp 13:43:48:24 in the 2010 HD video titled “ROV OPS_0010134 0012XO.mov”, an object of potentially unnatural origin was observed (Figure 1). A series of repeating, staggered features on a rectangular object sits adjacent, and perpendicular to a second rectangular object. This second rectangular object contains parallel features on both long edges of the object. Approximately halfway down this second object, one of the long sides exhibits repeating, staggered features similar to the top, horizontal object. These features bear a resemblance to the window slide rail in the cockpit of the Lockheed Electra 10E aircraft (Figure 2 and Figure 4), prompting further analysis.

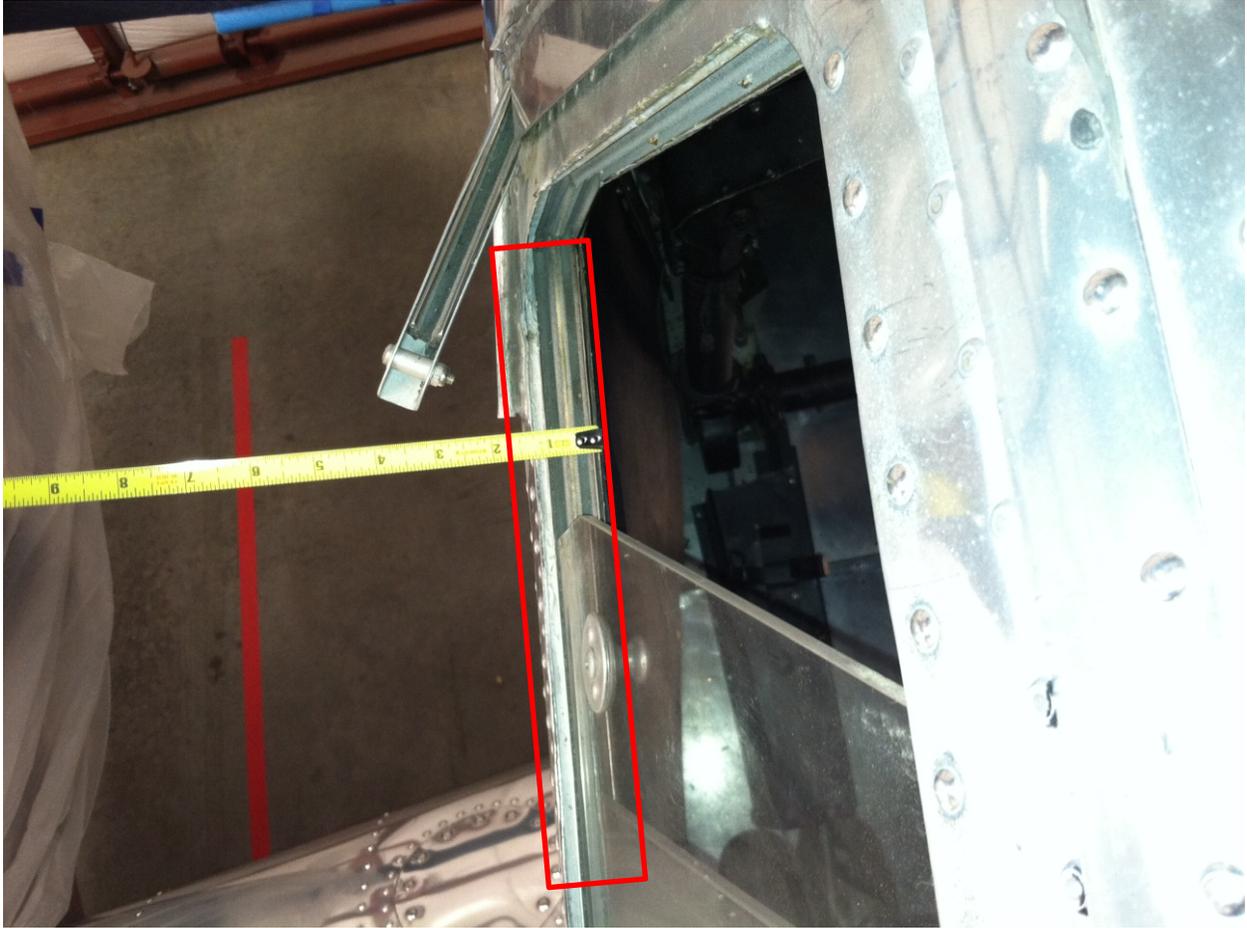
Figure 4: Top-down view of the window slide rail is indicated. This is the rail in which the window travels.

A 3D CAD model of the window rail was created using measurements taken from the transformed image and another photograph of the window slide rail (Figure 4). From the rover image, the estimated centers of the repeated, staggered shapes were drawn. The CAD model was overlaid in perspective view over the rover image in order to perform a numerical comparison between the CAD model and the object seen in the rover video.

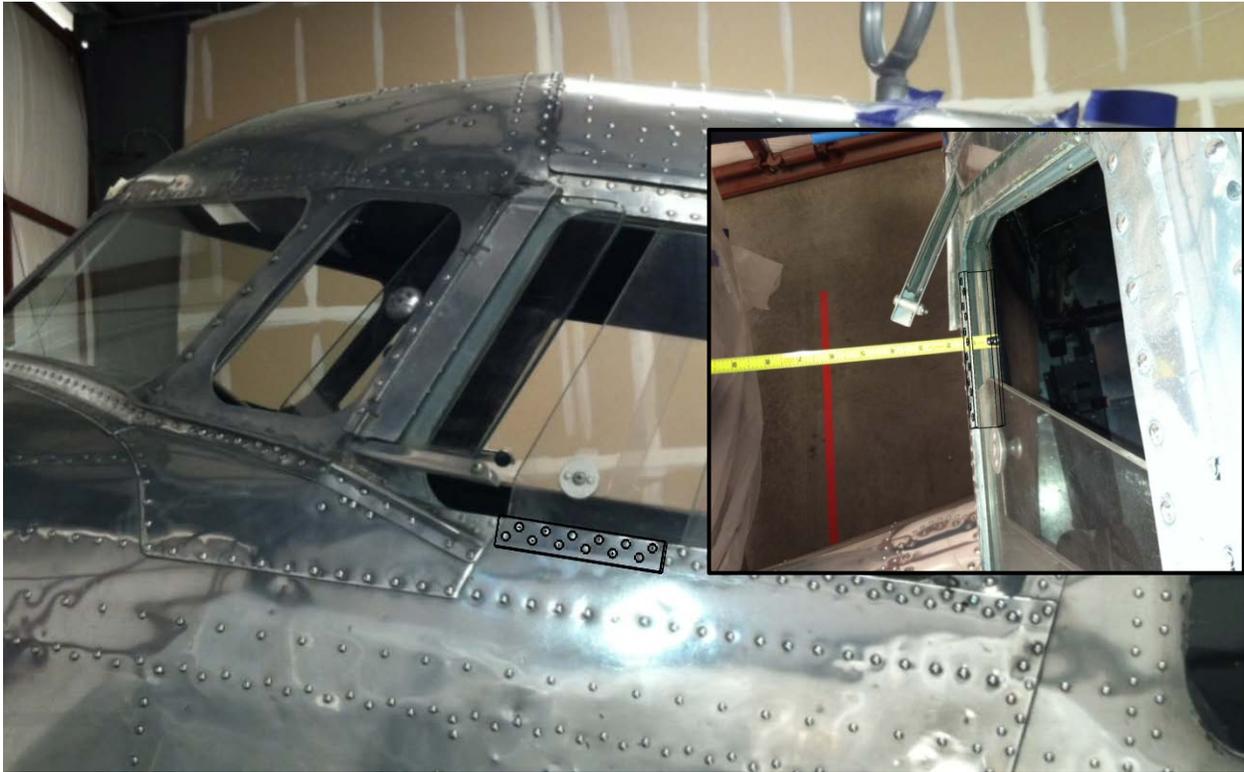
Figure 6: The 3D CAD model is shown overlaid on photographs of a Lockheed Electra 10E.

The 3D CAD model was visually fit to objects in the rover image, while maintaining the CAD model on approximately the same plane during each fit. After fitting, the rover image was replaced with an identical image, but with the centers of the staggered, repeating features of the horizontal object highlighted, and the parallel edge features of the vertical object highlighted.
