The Wreck Photo

We asked, “Is This Earhart’s Electra?” and offered a prediction:

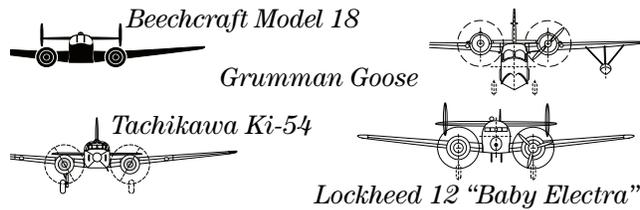
Of these, the Beech, and Lockheed 12 have windshields that are inconsistent with the photo and the long nose of the Goose has a hatch that is not present in the photo. The Tachikawa seems a better candidate but structural information is harder to come by. Research continues.

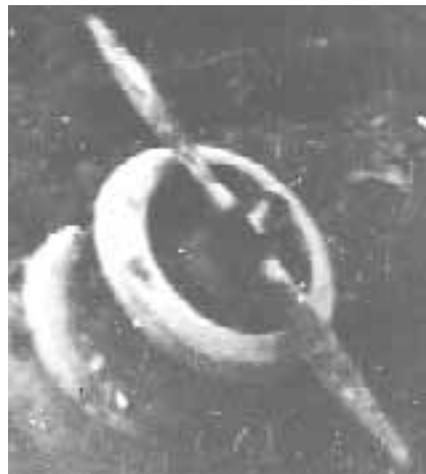
Perhaps the most important quantification of the airplane in the photo centers upon the relative proportions of the propeller and the cowling of the left-hand engine. Because we have nothing in the photo of known dimension, it is not possible to

establish a definitive scale. However, it is possible to establish whether or not the proportions measurable in the photo are right for various types of aircraft. We naturally decided to start with the Lockheed Model 10.
