# DADOS GALORE

TIGHAR'S first expedition to Nikumaroro in 1989 brought back an artifact we thought at the time might be a cover to some sort of aluminum box. It was originally assigned artifact number 2-18 and later, under an expanded cataloging system, became Artifact 2-1-V-18. The materials and the nature of the construction suggested an aviation origin but nobody we talked to recognized it as any known part of an airplane.

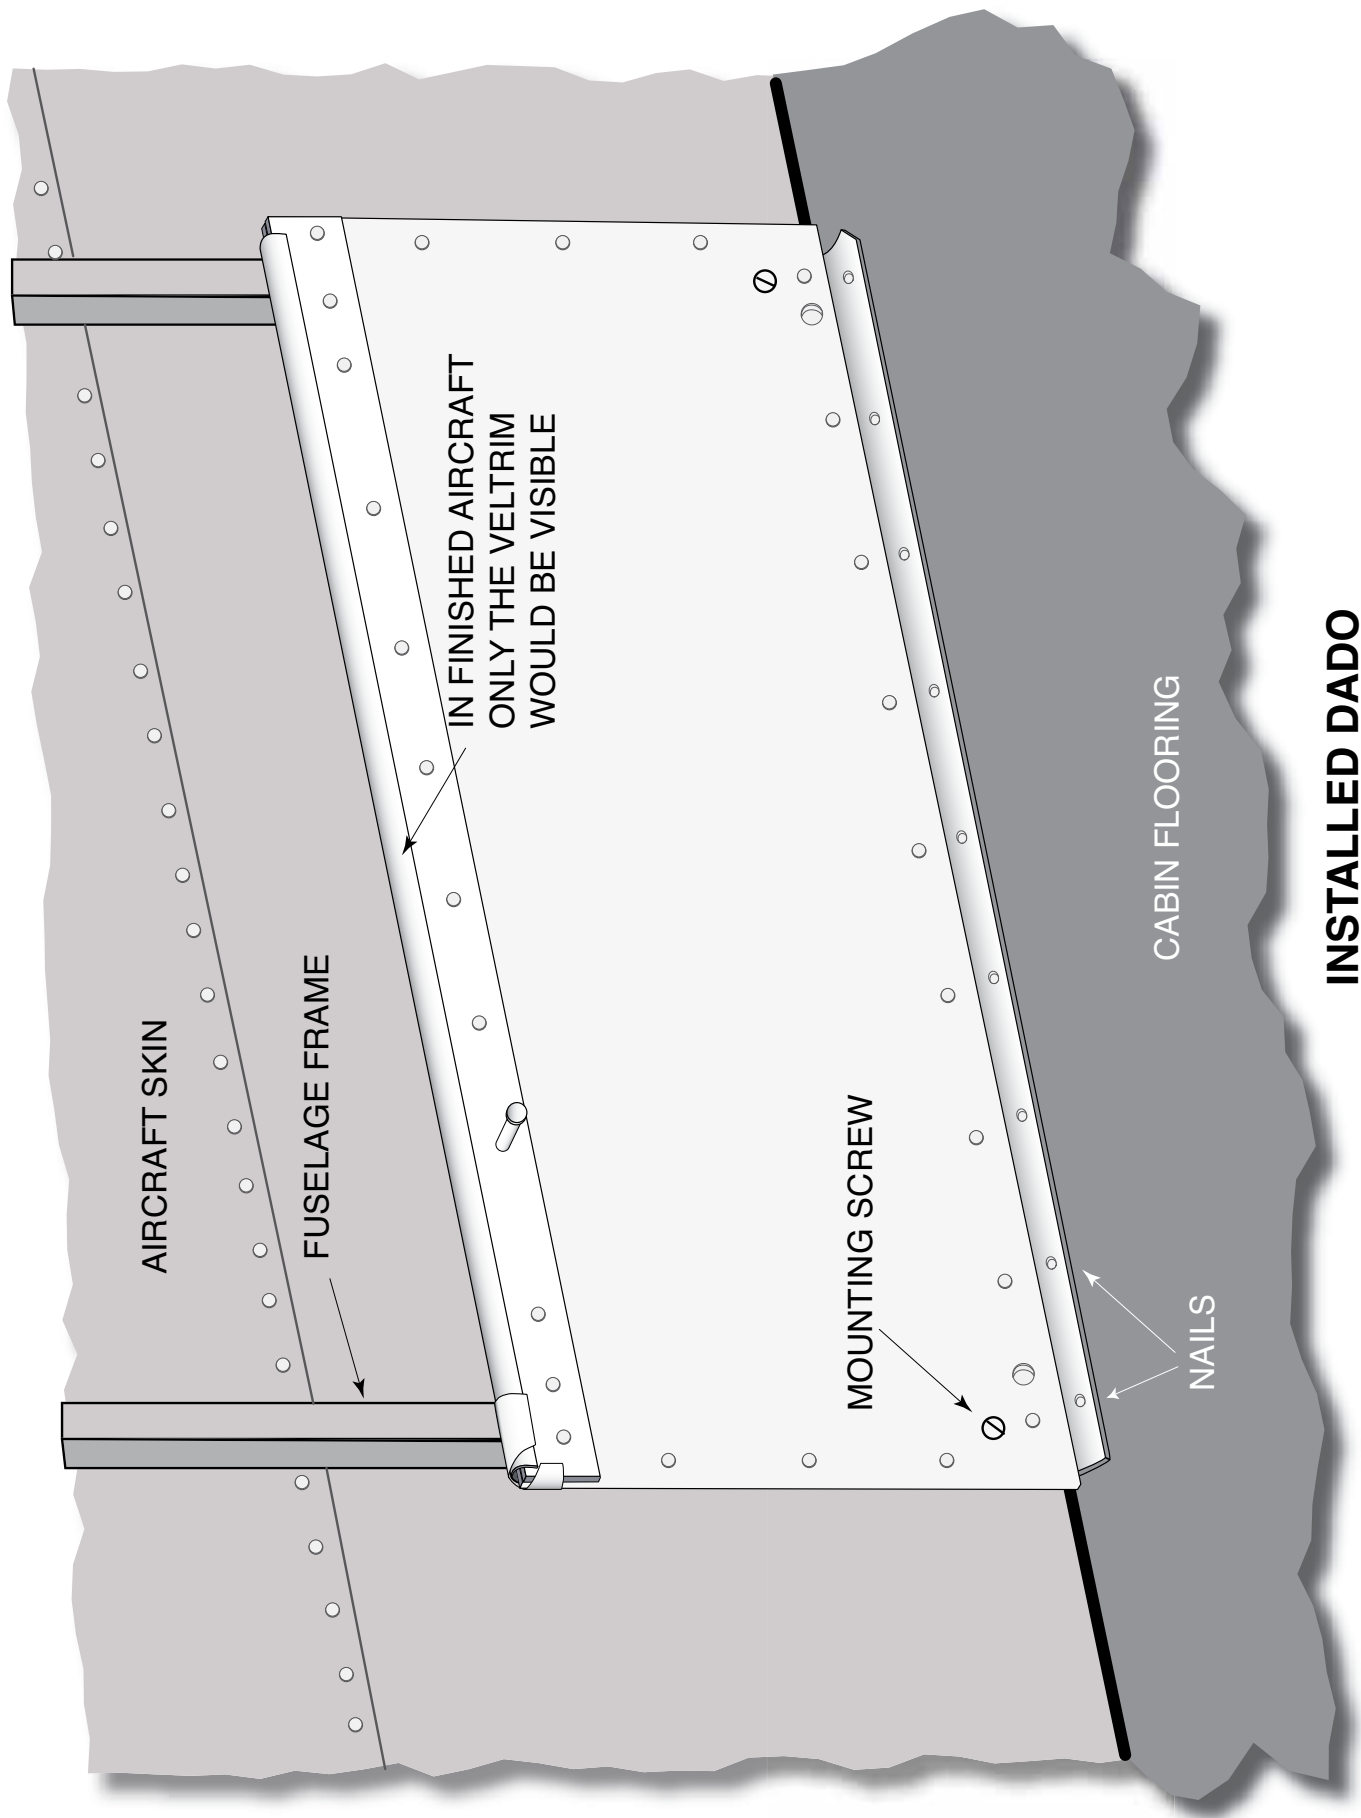
**INSTALLED DADO**

A dado (pronounced DAY-doh) serves as a juncture between the floor and the fabric-covered interior wall of the cabin, providing protection against kicks and bumps. Artifact 2-1-V-18 was anchored to the floor by means of a right-angle flange. The holes in the flange are not a standard rivet size and the bottom of the flange exhibits what appear to be pry marks immediately adjacent to the holes, leading us to conclude that this particular dado was probably nailed to a wooden floor. The Lockheed Model 10 had a wooden floor.

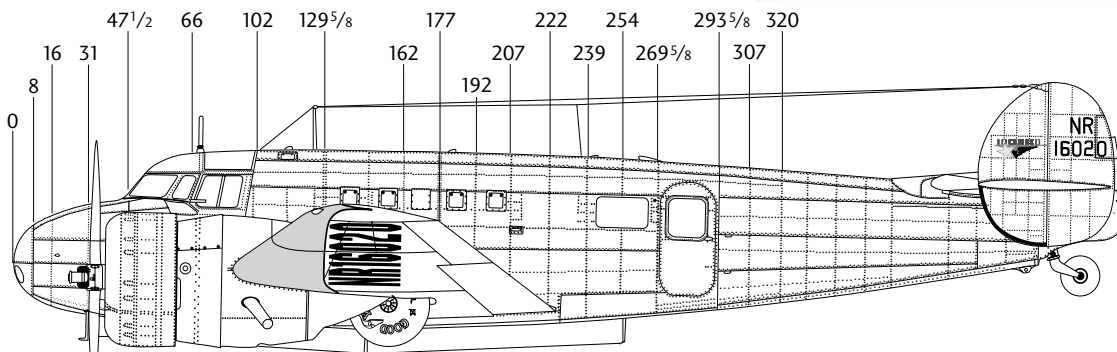
*In the Lockheed Model 10, circumferential frames and bulkheads, known as “stations,” are numbered in inches rearward from the nose of the aircraft. Station #222, for example, is 222 inches from the tip of the nose. Note that most of the stations are 15 inches apart.*

stressed-aluminum aircraft is a matter of scale and strength. The smaller the aircraft, and the greater the required rigidity, the tighter the spacing. The nominal spacing of frames in the Lockheed Electra is 15 inches. That, of course, does not mean that the dado must have come from a Lockheed Electra, but it does suggest that it came from an aircraft of that general size, and it supports the earlier statement that dados were used in “cabin-class twins.”

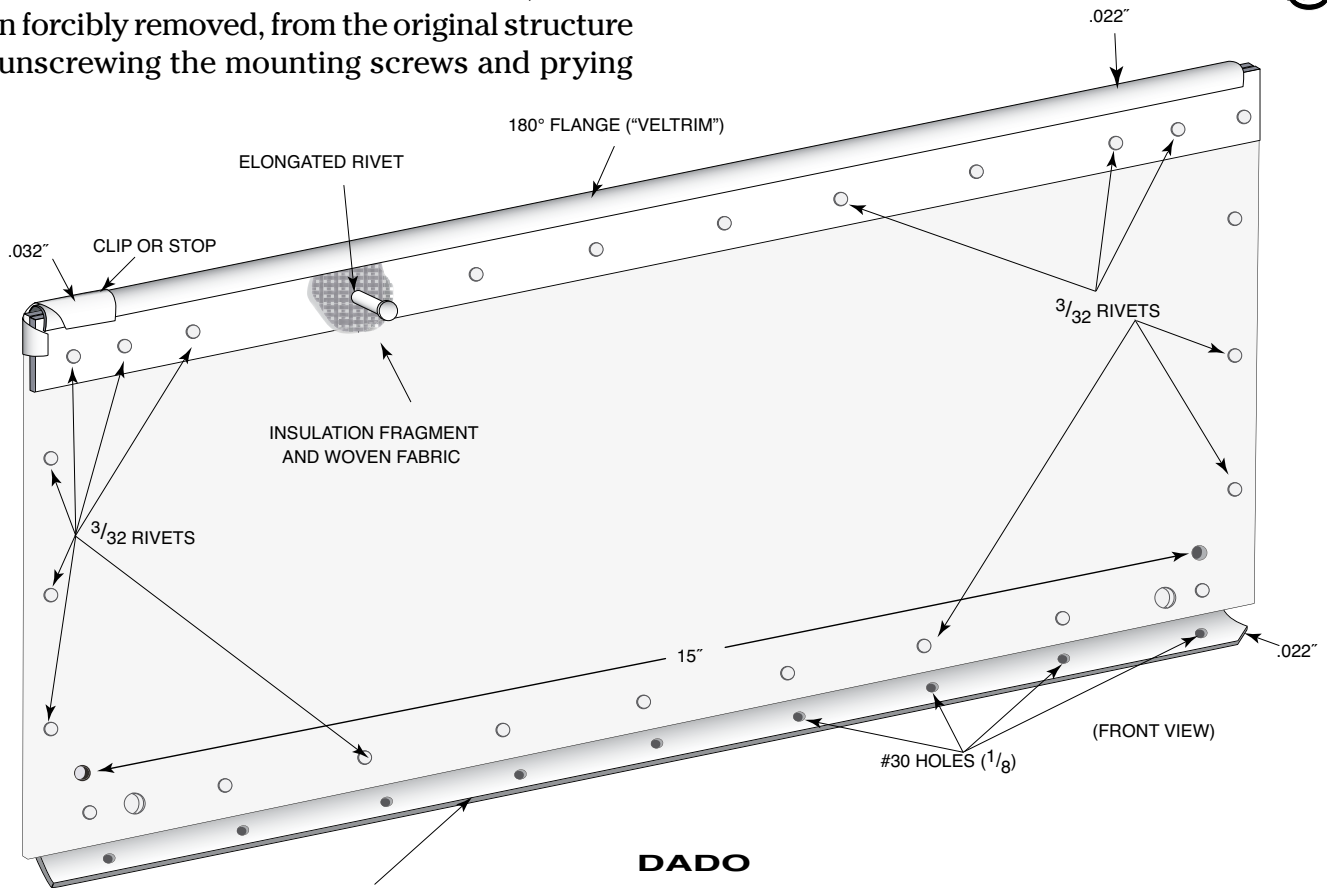
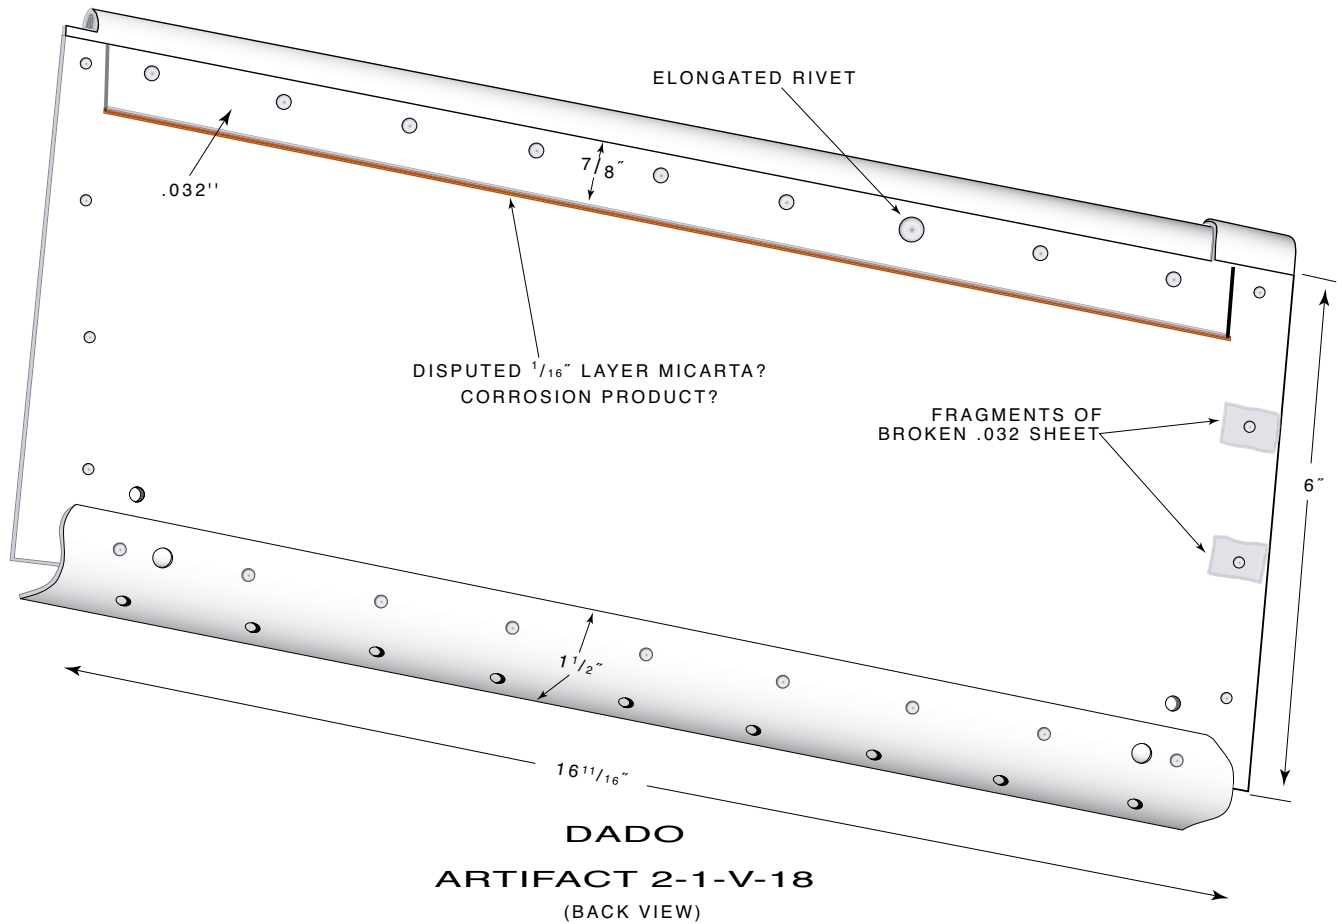
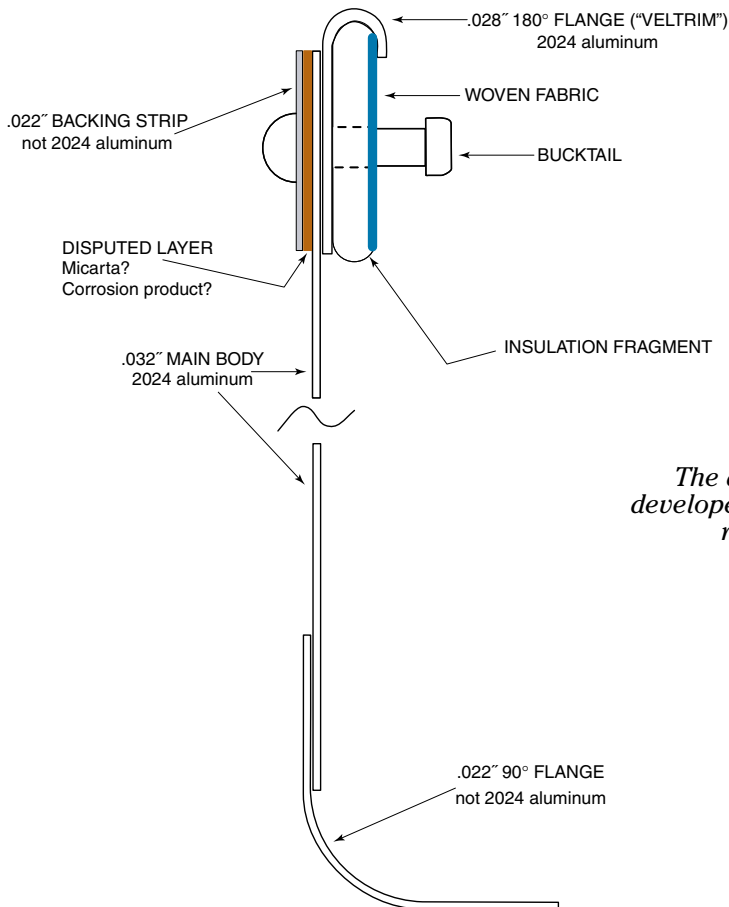
**CROSS-SECTION AT ELONGATED RIVET**

Along the top edge of Artifact 2-1-V-18 was an elongated rivet at the base of which was a small surviving fragment of the original insulation and woven fabric that once covered the entire surface that faced the interior of the cabin. The mottled appearance of the surface may have been caused by residue from the adhesive used

On the type of dado recovered from Nikumaroro the insulation and fabric that covered the face was tucked up under a 1/4 inch 180° flange known as a "veltrim." When installed in a finished aircraft the only visible part of the dado is the thin line of the veltrim.

*The drawings on these pages and on page 4 were developed from drawings made by Frank Lombardo, and represent Dado 2-1-V-18 as found in 1989.*
