Back To Square One for 2-2-V-1

Artifact 2-2-V-1.

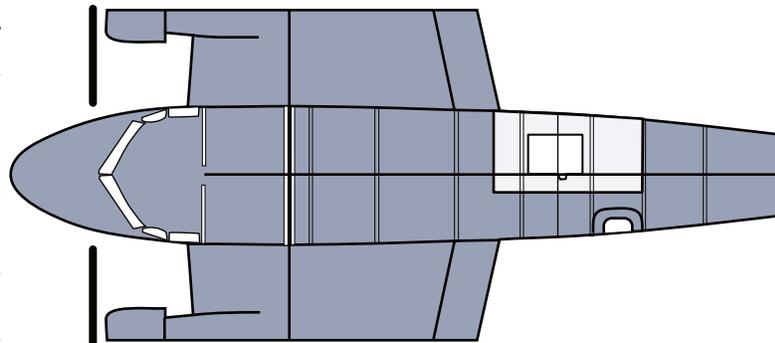
Our first candidate for a point of origin was an area under the aft cabin. The match seemed pretty good: .032 Alclad aluminum, four rows of AN455 AD 3/3 rivets converging at a rate of 1/4 inch over the length of the sheet, a

bordering line of #5 rivets, no crossing line of rivets, even a failure pattern that suggested that the sheet tore around an antenna mast that was on Earhart's Electra. The fit wasn't perfect. The rivet pitch (space between individual rivets) was 1 inch on the artifact rather than the 1.5 inches on the airplane, and the space between lines of rivets was an inch or less narrower on the artifact than on the airplane. Still, the match was far closer than we had seen on any other type of aircraft and we thought those variations might not be unreasonable on an airplane as extensively repaired as Earhart's. Our critics disagreed—vehemently. They pointed out that the distances between the lines of rivets are dictated by the airplane's stringers, which are not likely to change. And the antenna wasn't where we had thought it was. No cigar.

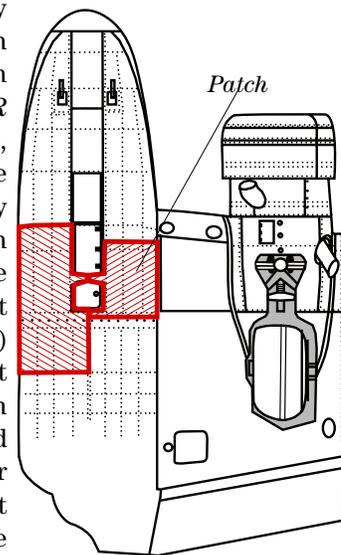
Our next possibility was farther forward on the belly. As detailed in "Finding A Fit" (*TIGHAR Tracks* Vol. 12, Nos 2 & 3), we had reasoned that the torn sheet of metal "may be from a repair patch installed on the underside of the Earhart aircraft on the left hand (pilot's) side of the airplane just forward of the main beam (wing spar)." Lockheed repair orders called for the metal sheet in that area (Skin 25L) not to be completely replaced but

for new aluminum to be installed "from a point 9 1/2 inches aft of the slanting bulkhead to main

beam—rivet new skin in place with a double row of rivets similar to joint in slanting bulkhead." If the ordered repair had been carried out using .032 rather than the .040 Alclad, and if two stiffeners had been added to compensate

for the slightly thinner metal (a not-unreasonable possibility), we would have something that looked exactly like 2-2-V-1.
