The Earhart Electra Part Two:

Around the World

Part One of TIGHAR's documentation of the evolution of the Earhart Electra ("A Star is Born," TIGHAR Tracks Vol. 11 No. 2) traced the airplane's development from its construction in the spring of 1936 through a Bureau of Air Commerce inspection performed in November of that year. This second installment chronicles the modifications made in preparation for the first world flight attempt which ended with an accident in Hawaii on March 20, 1937. Part Two also details the changes made during and after the extensive repairs which preceded Earhart's second attempt to circle the globe, and describes the newly confirmed unintended alteration to the Lockheed's configuration in New Guinea which precipitated its loss. Like Part One, Part Two deals only with the aircraft's external features. Part Three, to appear in TIGHAR Tracks Vol. 11 No. 4, will address the more difficult question of the cockpit and cabin layout as well as the radio equipment at the time of the airplane's disappearance.

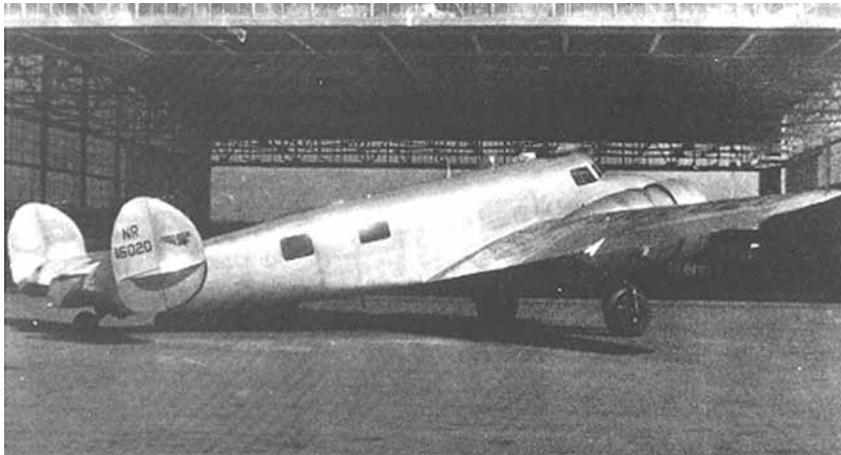
JUST WHEN WORK WAS BEGUN TO MODIFY THE Electra specifically for the world flight is not clear, but by the time the photo above was taken at Burbank in February, 1937, a larger-than-standard window had been installed in the starboard side of the fuselage just aft of Station 293 and the aircraft's registration number had been amended to reflect the international NR designation (approved the previous September). Other

photos from this time show that the cabin door had also acquired a window. The airplane still carried the original trailing wire antenna installation (visible as a white protrusion from the tip of the empennage) and the faired housing of the Hooven/Bendix radio compass loop antenna (evident just forward of the dorsal antenna mast). At this time only one of the two belly antennas previously on the airplane is in evidence.

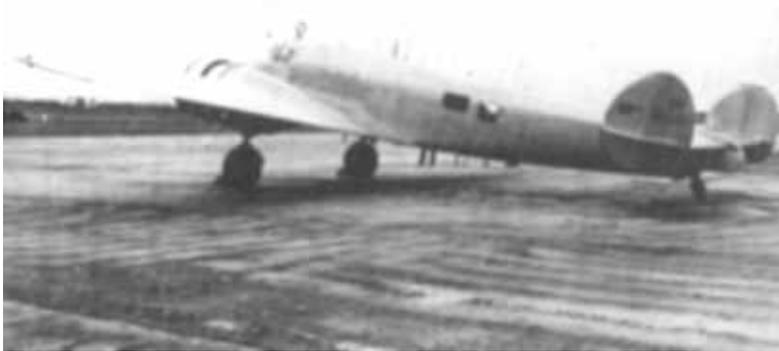
BY EARLY MARCH, THE SECOND BELLY ANTENNA had returned and the trailing wire had been removed from the tail and relocated. The new installation deployed the wire through a mast extending from the belly at a point just forward of the cabin door. The ball-shaped object at the end of the mast is the weight at the end of the wire. More apparent was the replacement of the Hooven/Bendix radio compass antenna with a more conventional open loop mounted over the cockpit. This also appears to be a Bendix product, possibly a Type MN-5, which was manually rotated and considerably lighter in weight (although higher in drag) than the more advanced automated unit it replaced. A further modification to the fuel system has caused a fifth filler port to be added to the side of the fuselage forward of the

other four, and the third (and now middle) filler port has been sealed off. It is at about this time that orange paint with a black border is added to the leading edge of the wings and on the top of the horizontal stabilizer.

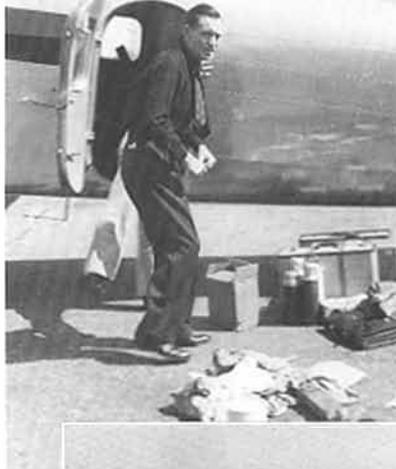
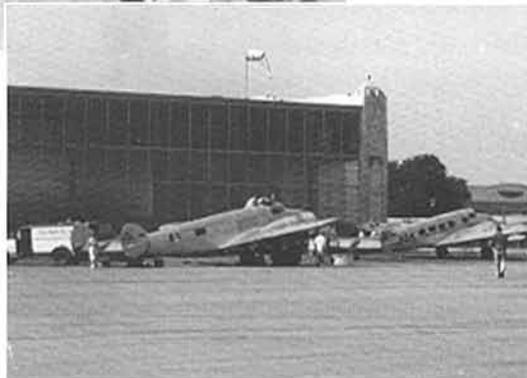
THE REPAIRS WERE SIGNED off on May 19 and the very next day, with no fanfare, Earhart began her second world flight attempt under the pretext of a cross-country test flight. A young photographer named Dustin Carter happened to be at Burbank that morning and took the only known pictures of the preparations for departure. (A grant from John T. Johnson, TIGHAR #0939C, made it possible for TIGHAR to acquire the original negatives from Carter's widow in 1991.) Bureau of Air Commerce records confirm that the airplane at this time had a new right wing, a mostly new belly, and incorporated a number of specially approved internal structural modifications designed to strengthen the airframe. The Carter photos show that new-style single wingtip lights replace the Electra's original top and bottom nav lights. More significantly, several changes have been made to the airplane's antenna system. The dorsal mast supporting the forward terminus of the vee antenna has been moved forward approximately 48 inches to Station 129, thereby providing for a considerably greater length of wire. On the belly, only the starboard antenna is present. The masts and wire of the port side unit are gone, as is the entire trailing wire assembly. Folklore has long held that the trailing wire antenna

was removed several days later in Miami but Carter's photos confirm that the device was not present on May 20 and, most probably, had simply not been reinstalled after its unceremonious removal by the runway at Luke Field.

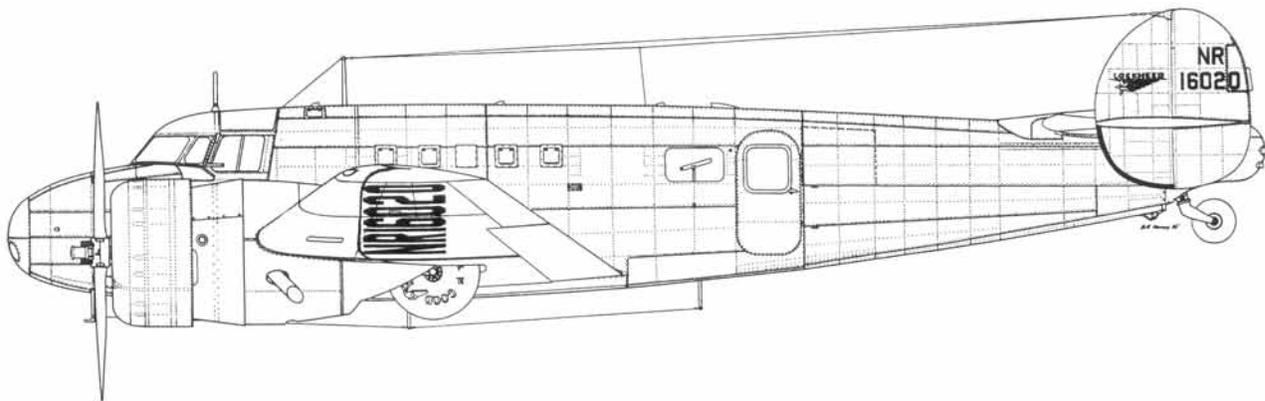
World Flight Electra - Second Attempt - June 1, 1937

second world flight attempt was made from Miami on June 1, 1937. As can be seen in the photo at the bottom of the page, taken as the airplane taxied for takeoff, the most apparent change made to NR16020 during its eight day stay in Florida was the replacement of the starboard rear window with a patch of new aluminum skin. Again, legend has often described this feature as a removable hatch but the photographic record indicates otherwise.

The opening first appears in early 1937 and is present as a window in every known shot of the airplane's starboard side until Miami, when it becomes shiny metal which grows gradually duller in photos taken at progressive stops in the world flight.

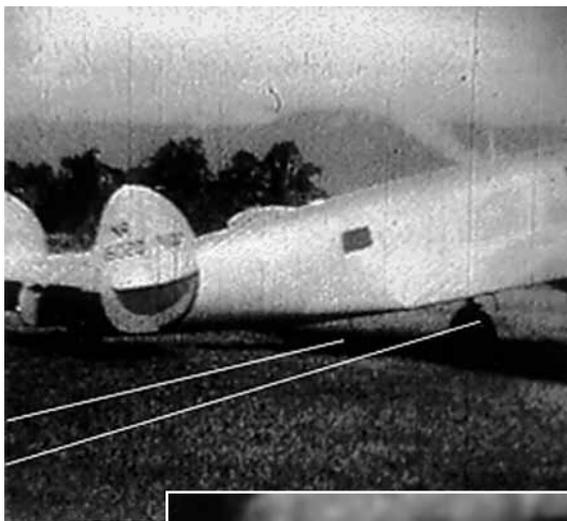
INDEPENDENT ANALYSIS OF MOTION PICTURE FILM showing Earhart's July 2, 1937 takeoff from Lae, New Guinea has recently confirmed that there was one last and accidental modification to NR16020 before it began its final flight. According to Photek, a highly regarded forensic image processing laboratory headquartered in Champaign, Illinois, state-of-the-art digital examination of the film bears out TIGHAR's earlier suspicion (see *TIGHAR Tracks* Vol. 9, No. 4, "For Want of a Nail...") that the airplane suffered damage to its belly antenna while still on the ground at

Rear Antenna Mast

Forward Antenna Mast

Lae. Frame by frame examination revealed both belly masts to be present as the aircraft taxied past the camera, but as it came back by on the actual takeoff, neither mast could be seen although both "roof antennas" (the dorsal mast and the loop) were clearly visible. Because the exact internal radio configuration of NR16020 at the time of its final takeoff is still being researched (and
