TIGHAR TRACKS

Research Report

Analysis of Recovered Material

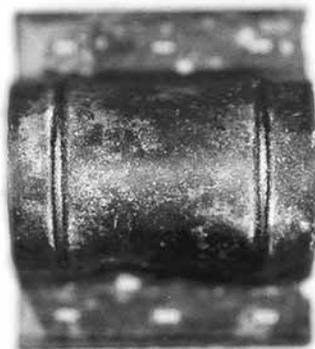
2-6-S-43

These objects appear to be damaged components associated with large radio vacuum tubes of the type used at U.S. Coast Guard Unit 92, the Loran station at the southeast tip of Gardner Island. Because we have collected 20 shell casings from .30 caliber M-1 Carbine ammunition, several pieces of broken ceramic dinnerware (one of which bears the Coast Guard logo), and an anecdote from a veteran describing informal target practice at the site, we conclude that these artifacts are all probably attributable to a limited number of Coast Guard visits to the site between July 1944 and May 1946.

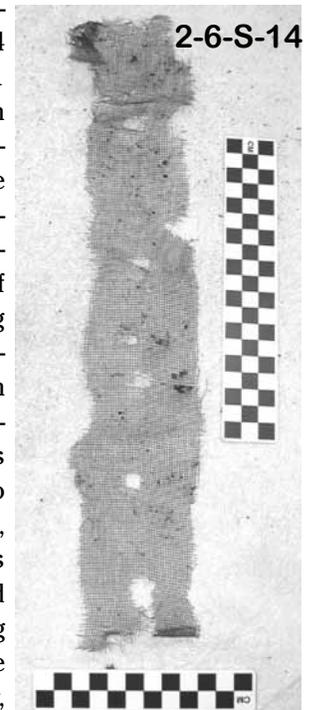
2-6-S-14

Fine copper screening, usually found in strips roughly 4 inches wide by as much as 21 inches long, and occasionally in larger sheets, was found distributed along a line from the ridge to the southern end of the examined area. A total of approximately 414 square inches of screen was recovered. Flying insects are not generally a problem on Nikumaroro and even the windows on the (still standing) cookhouse of Gallagher's residence in the village have no screens. Screening was used, however, to keep leaves, birds and rats out of stored water and we suspect that the screening found at the Seven Site was once used for that purpose. However, the screening found at the Seven Site is lighter in weight and has a slightly more open weave than examples of screening found at the Loran station and in the settled areas at the west end of the island.

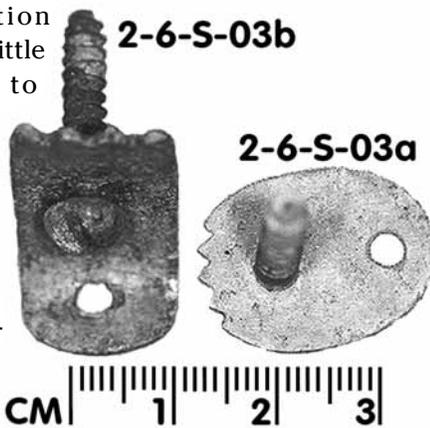
A firm identification on these fascinating little objects continues to elude us but a few facts we have been able to nail down make them all the more interesting. Each is comprised of a plate and a screw. According to engineer Angus Murray of Sheffield, England, the screws are brass American No. 8, $\frac{15}{16}$ " length woodscrews meeting specifications that were current from the 1930s up until 1970. The plates, however, appear to be aluminum (but apparently not "aircraft" aluminum) and are definitely amateur-made, rather than manufactured. A number of theories have been advanced to describe how they might work and some people have said that they look vaguely familiar, but no one has yet been able to produce an example of a similar device. They might be associated in some way with the sextant box that was found by Gallagher in 1940, but without an example of a very similar manufactured item of known utility their purpose remains a mystery.

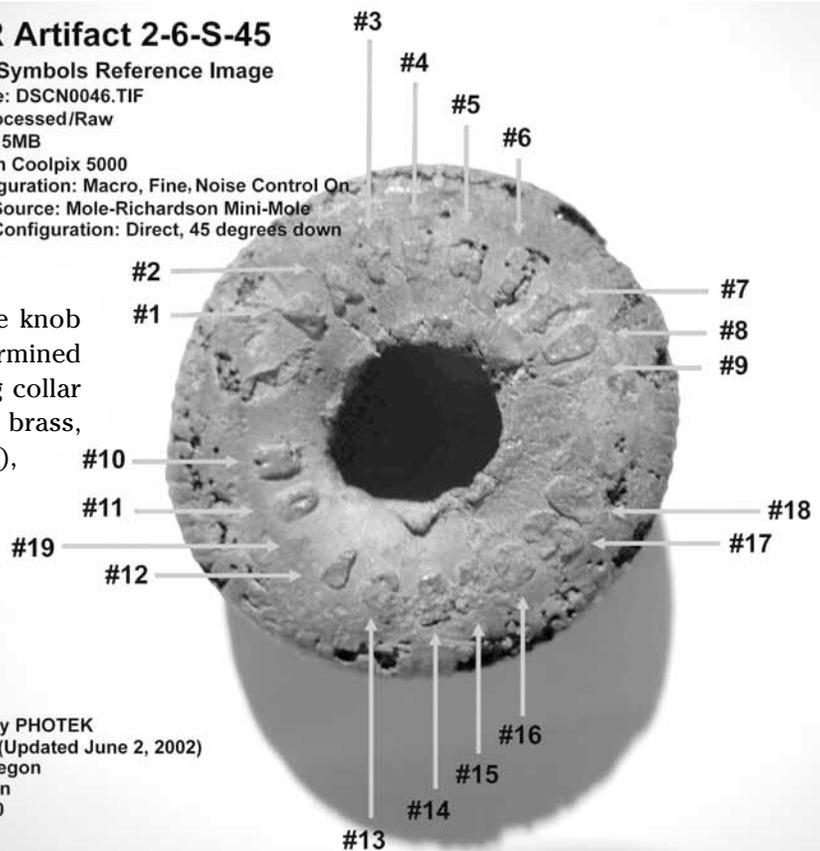
TIGHAR Artifact 2-6-S-45

Candidate Symbols Reference Image

Source Image: DSCN0046.TIF
 Image: Unprocessed/Raw
 Image Size: 15MB
 Imager: Nikon Coolpix 5000
 Imager Configuration: Macro, Fine, Noise Control On
 Illumination Source: Mole-Richardson Mini-Mole
 Illumination Configuration: Direct, 45 degrees down

Processed by PHOTEK
 May 8, 2002 (Updated June 2, 2002)
 Portland, Oregon
 Jeff Glickman
 503-949-6200

deciphered. We then sent the knob to our old friend Jeff Glickman at Photek Forensic Imaging in Portland, Oregon. Jeff experimented with a variety of techniques and found that the best results were achieved by working with digital photography in the visible spectrum using very precisely controlled lighting and then processing the acquired imagery with highly specialized software. Taking it one symbol at a time, Jeff has so far been able to establish that the letters on the knob are:

Symbol #	1	2	3	4	5	6	7	8	9	10	11	19
Letter	P	A	T	E	N	T	E	D	:	N	O	.

and then a seven digit number beginning with **18**. That was as far as he had gotten when we went to press, but from that much we can say with considerable confidence that whatever device or appliance the knob was attached to received a United States utility patent between 1931 and 1933.

Ironically, the smallest metal artifact recovered from the Seven Site has been the object of the most intense research. The Nondestructive Testing Laboratory at the United States Naval Academy in Annapolis, MD examined the knob using a scanning electron microscope and determined that it was made of lead with a steel reinforcing collar inside. That was surprising. We expected it to be brass, aluminum, or even "pot metal" (a cheap alloy), but not lead. There are raised symbols cast into the face of the knob but they are illegible due to "insults" to the soft lead surface – in other words, the knob has been banged around – and a build up of what is probably lead oxide corrosion product.

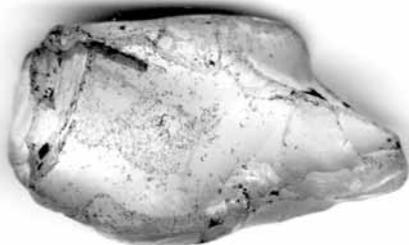
2-6-S-16:

length: 0.95 in.
width: 0.53 in.
thickness: 0.29 in.
weight: 0.11 oz.

Colorless, broken, glass, thickness indicates glassware. There are no sharp edges on the entire shard, and all surfaces exhibit tiny, exfoliated cones of force and degradation, particularly along the margins. This piece of glass spent considerable time in a relatively high-energy water environment where granular/pebble sands were washed against it with sufficient force to microfracture the glass hundreds of times. This action obliterated the edges and any other physical evidence that may have been on those edges. This small piece of glass is the only one in the examined assemblage that appears to have spent considerable time in the surf.

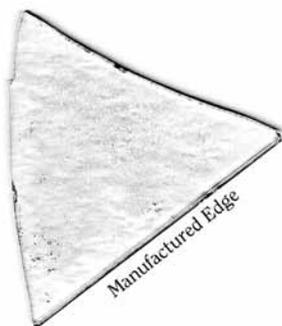
2-6-S-18:

length: 2.72 x 2.76 x 2.51 in.
thickness: 0.06 in.
weight: 0.30 oz.

Colorless, broken, flat plate glass fragment, triangular in shape with one manufactured edge. The glass fragment was exposed on one surface to the sun for a long time, resulting in an iridescent patina on that surface. No such patina is present on the opposite surface. The thin, uniform thickness of the plate glass suggests that it was a window or casing of some kind. There are small microflake scars on the fractured edges, but these are commonly created during bending fracture, as adjacent edges of the glass make contact during breakage. Examination of the edges under magnification by a stereo zoom microscope ranging from approximately

20x–200x failed to reveal any small striations or evidence of contact between glass and hard materials.

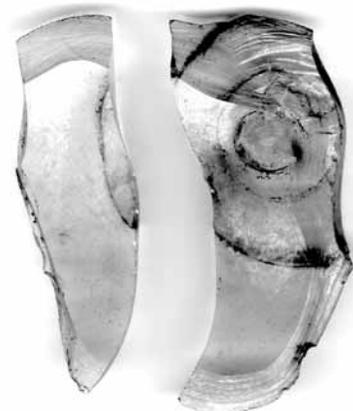
2-6-S-21a:

(two pieces)
1: length: 2.62 in.
width: 0.79 in.
thickness: 0.42 in.
weight: 0.54 oz.
2: length: 2.80 in.
width: 1.07 in.
thickness: 0.52 in.
weight: 1.10 oz

Two conjoinable, light amethyst, broken glass shards, once part of a glass fishing float. The two conjoinable pieces were broken in a bending fracture that split the original shard roughly in half, lengthwise. The reconstructed diameter of the fishing float, based on curvature of the glass shard, appears to be approximately 165 mm. The glass is relatively free of the air bubbles that are reported as typical of Japanese glass fishing floats made of recycled glass. The glass shards exhibit most of the pontil portion of the float, and the fracture around the perimeter of the shard is radial, forming an acute angle from the outside to inside surface of the float. This acute angle forms a sharp edge on the two distal ends of the roughly oval-shaped glass shard. The surface of the fracture exhibits a laminar appearance, reflected on the exterior surface of the float as thin concentric lines etched in the glass. This may reflect turning of the molten glass as it was being hand-blown. Cross-cutting these laminar lines is a series of radial striations that reflect the fracture of the shard from the larger float. The nature of the fracture suggests to me that a sharp blow **may** have been delivered at the opposing side of the float, resulting in a radial fracture, although this is speculative. The fishing float must have broken several decades ago, as the fractured surfaces have formed a light iridescent patina. Such patina is common on glass artifacts that have been exposed to direct sunlight for a significant amount of time. The rate of such patination

There is no evidence of purposeful secondary flaking of the edges of the shard. The edges were examined under a stereo zoom microscope at magnifications ranging from approximately 20x–200x (relatively low power). The edges exhibited tiny microflaking that was intermittent and bifacial. This microflaking is scarcely visible to the naked eye, and would take only light pressure to produce. Such flaking is not uncommon during large flake detachment (i.e., when the fishing float was struck and broken). In fact, such microflakes can be observed along the surface of the shard at the edges of the conjoinable, perpendicular fracture. Because the edges are 90 degrees, the edges of the conjoinable pieces would not be suitable for effective cutting, and it is likely that the microflaking is a consequence of the shard breaking into two pieces. This does not preclude the possibility that the microflaking of the sharp distal edges were created in another way. Such damage could be the result of trampling or even light use of the edge for cutting, but the microflaking evidence is inconclusive.
