Wheel of Fortune

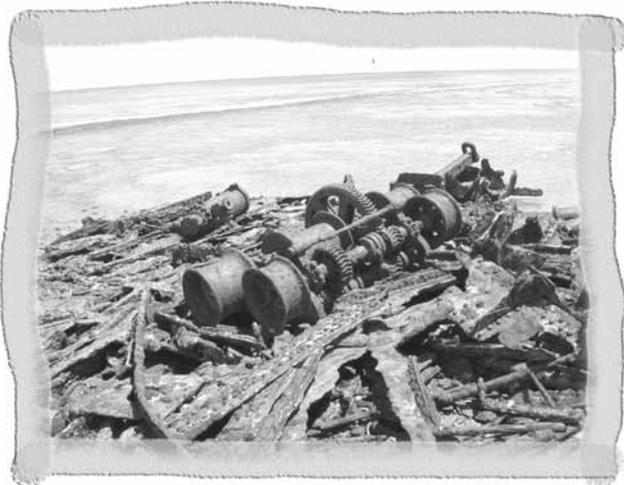
Some of the *Norwich City* debris resembles Greg Stone's sketch in general shape but is much larger and rust covered. TIGHAR photo by R. Gillespie.

iar with the shipwreck, feels strongly that the "wheel" is not *Norwich City* debris.

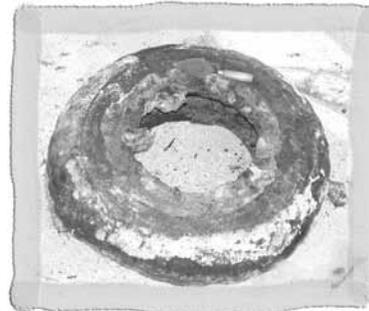
During the *Niku III* expedition in 2001 we found a Goodyear U.S. military rubber tire in the lagoon near the village which appears to be consistent with the tires used on Weapons Carriers. The metal wheels for these vehicles were steel and of much larger dimensions than the object reported by Greg Stone. TIGHAR photo by R. Gillespie.

The WWII tire found in the lagoon suggests that rubber survives well in the Niku environment but no rubber was present on or near the "wheel" that Greg saw. The heavy duty Goodyear Airwheel tires were extremely durable and are not likely to have come off the wheel during the breakup of the aircraft nor could they have been cut off the rims without great difficulty. The wheel almost had to have been intentionally disassembled. It would therefore seem most likely that if the object Greg saw is from the Electra it is not simply a piece of debris that washed up but is, rather, a discarded component from a wheel and tire that washed ashore and was taken apart, possibly so that the rubber tire could be used for some local purpose.

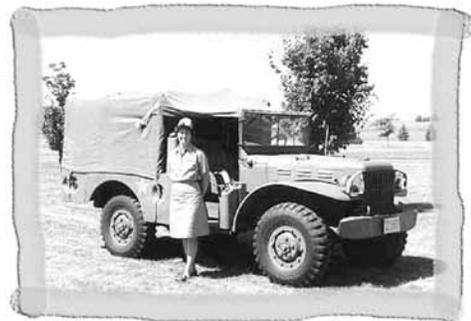
The U.S. Coast Guard Loran station that was located at the southeast end of the island from 1944 to 1946 had a four-wheel drive pick-up truck type of vehicle known as a Dodge WC51 Weapons Carrier. Photo courtesy RobertsArmory.com

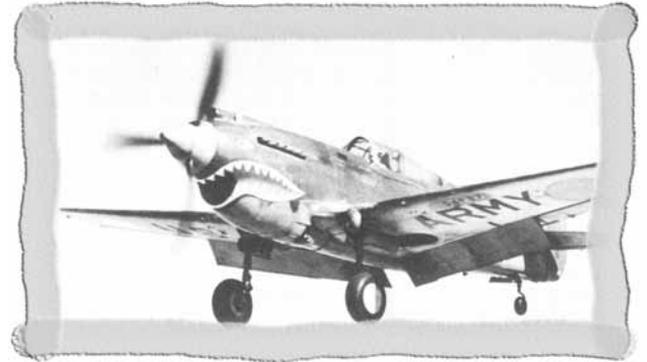
The wheels on most of the World War Two aircraft that were based on Canton Island were far too large to be what Greg saw, but even the wheels of smaller aircraft, such as those on this Curtiss P-40 were relatively “thin” because they were designed to retract flat into the wing. USAF photo.

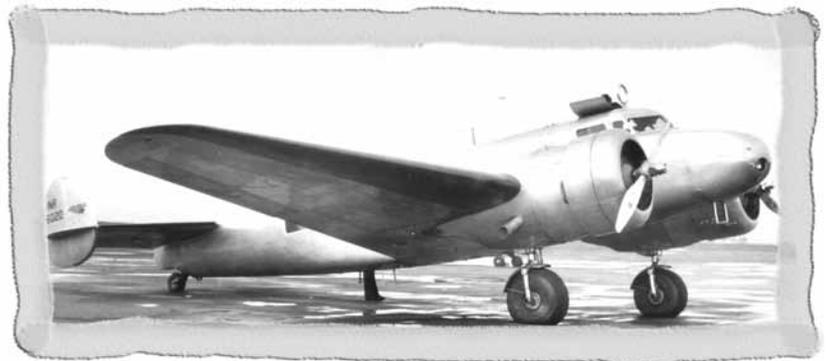
Earhart’s 10E Special NR16020 featured Goodyear Airwheels. TIGHAR collection courtesy W. Larkins.

10 Electras. The size was 35x15-6. The 35 refers to the uncompressed height of the tire, the 15 refers to the width across the face of the tire, and the 6 is the diameter of the opening in the middle of the tire, all in inches. (*Lockheed publication EE1135 revised 5/1/36.*)

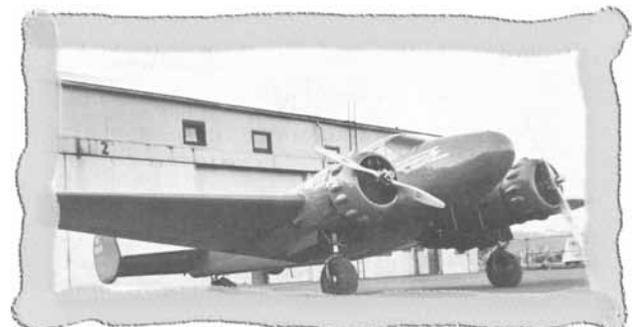
This 1937 Beech 18a features “fat” Goodyear Airwheels which retract rearward into the engine nacelles. U.S. Civil Aircraft, Vol. 7

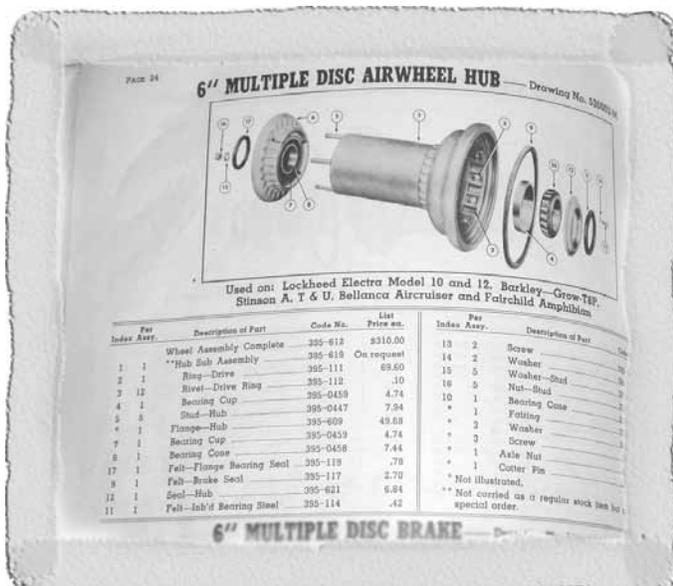
STANDARD EQUIPMENT ON LOCKHEED "ELECTRA" MODEL 10E

- 1 Fuselage, complete with windshield, windows (with curtains) and door.
- 1 Wing, complete with ailerons and engine nacelles.
- 1 Wing Flap System (air brakes), with complete electrical operating mechanism.
- 2 Fins, non-adjustable, and 2 rudders with controllable tab.
- 1 Stabilizer, non-adjustable, and 2 elevators with controllable tabs.
- 1 Surface Control System, complete with lock (dual wheel type).
- 1 Parking Brake System, complete.
- 1 Landing Gear, retractable, with complete high speed electrical operating mechanism auxiliary hand mechanism, **Goodyear 35x15-6 Airwheels with 35x15-6 Heavy Duty Tires,** hydraulic brakes, fenders and Aerol struts.
- 1 Tail Wheel, with Goodyear 16x7-3 Airwheel and Aerol strut.
Pilot Seat with adjustable, vertically, with safety belts.

Goodyear 35x15-6 Airwheels with 35x15-6 Heavy Duty Tires.

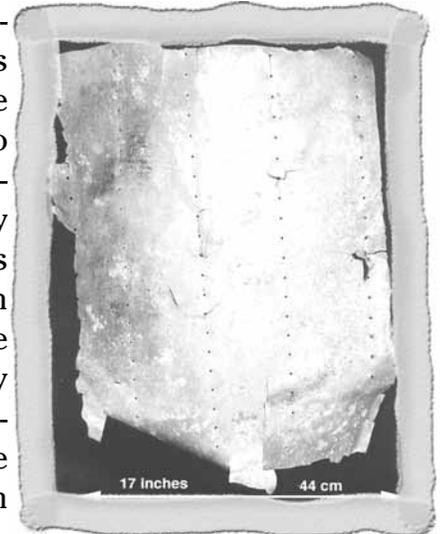
Artifact 2-2-V-1. TIGHAR photo by F. Lombardo.

colored objects, visible in both photos, lying on the reef-flat in perhaps three feet of water. In one photo the southern-most object is exhibiting a specular reflection typical of sunlight reflecting off metal. Although there is no way to know what the objects were, their appearance in the photos is consistent with a debris field of sections of aluminum sheet nominally three to four feet square – somewhat larger, but not unlike, the section of aluminum aircraft skin found by TIGHAR (Artifact 2-2-V-1) just inland from the blasted channel.

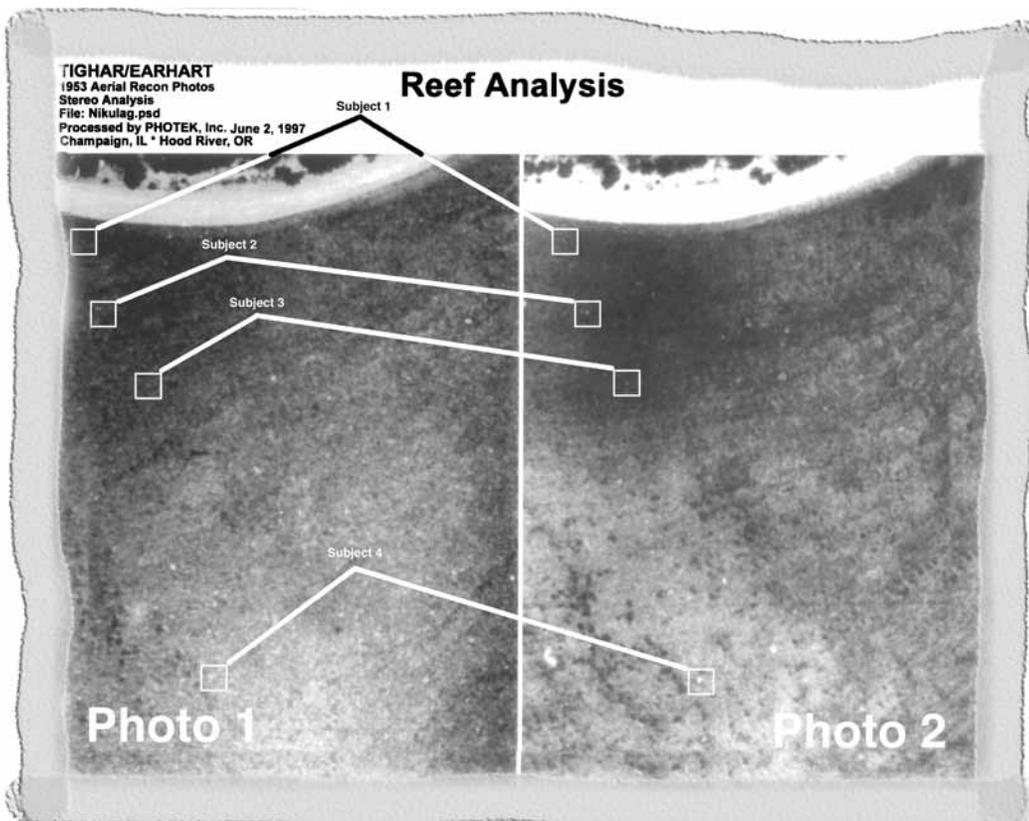
Reef analysis photos courtesy PhotekImaging.com.

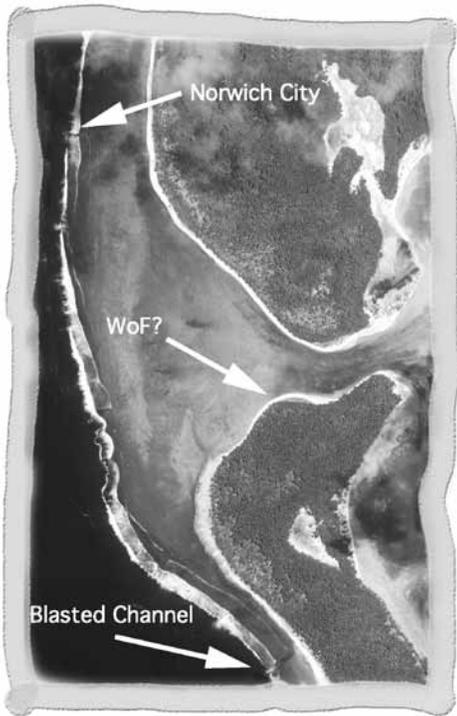
The "Wheel of Fortune" (WoF) was reportedly seen near the south shore of the main lagoon passage. Satellite photo by Spacemaging.com.

there. However, a comparison of the putative 1953 debris field with the location of the "wheel" indicated by Greg Stone and the place onshore where TIGHAR found another suspected Electra component – Artifact 2-1-V-8, the dado – in 1989 raises the possibility that all might be part of the same debris field.

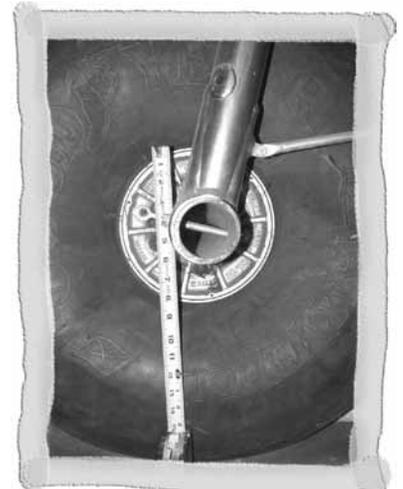
Greg's recollection is that the diameter of the rim was approximately 12 inches. As shown in this photo of the Goodyear Airwheel on Lockheed 10A c/n 1052 at the New England Air Museum, the diameter of the "outboard" side of the Electra wheel is 8 inches in diameter and is, in Greg's opinion, a bit too small.

If the wheel was disassembled, the rim that Greg saw would have to be the "inboard" side that carried the brake assembly. The diameter of that rim is greater and more in line with what Greg remembers. The outboard rim of the Airwheel features identifying numbers and letters cast into the metal. The inboard side, unfortunately, may not.

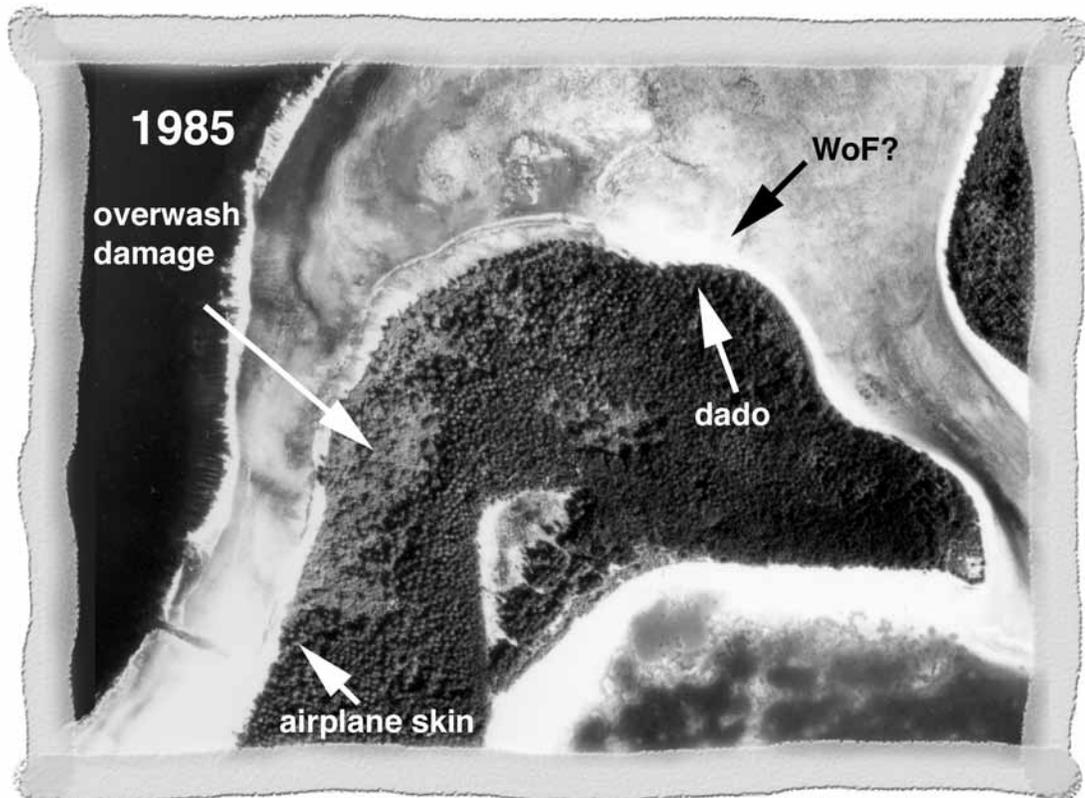
TIGHAR's failure to notice it on previous trips is probably due to the fact that the sand depth on that part of the reef-flat varies greatly from year to year and even month to month. During periods of calm weather, the sand level near shore and on the beach tends to build up. Storms strip the sand from the bottom and from the beach and deposit it inland. The WoF was probably buried at the times when we walked past that spot. The incursion of sand and seawater also kills the beachfront vegetation causing the effect seen in this 1985 aerial photo. The vegetation grows back to dense underbrush rather than the open

Photo courtesy Kiribati National Archive, Tarawa.
