EXAMPLE OF SUGGESTED PLAN
FROM ARTICLE ON TRAMP STEAMERS

HOW TO PAINT S.O.S ON OUTSIDE
OF SHIP FROM AN INSIDE DECK

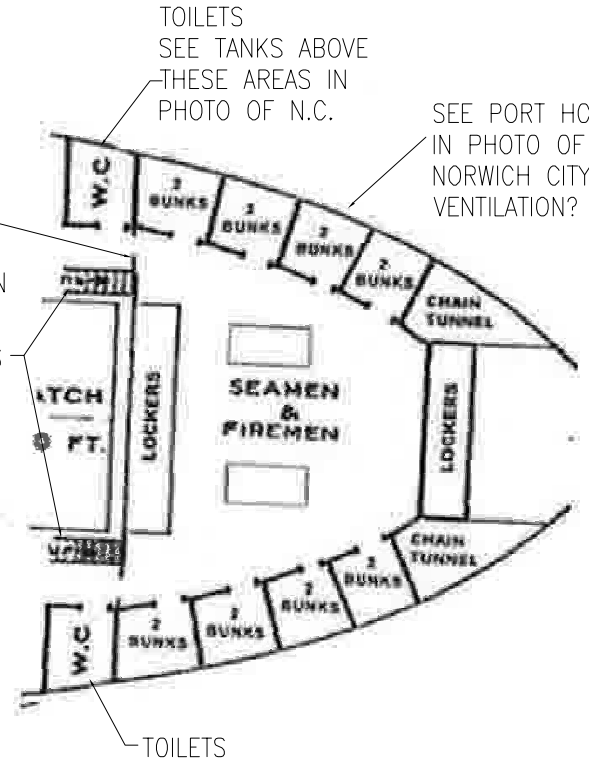
A COLLISION
BULKHEAD
COULD HAVE
STOPPED FIRE

HOLD WAS EMPTY
NO CARGO TO BURN

TOILETS
SEE TANKS ABOVE
THESE AREAS IN
PHOTO OF N.C.

SEE PORT HOLES
IN PHOTO OF
NORWICH CITY
VENTILATION?

STAIRS

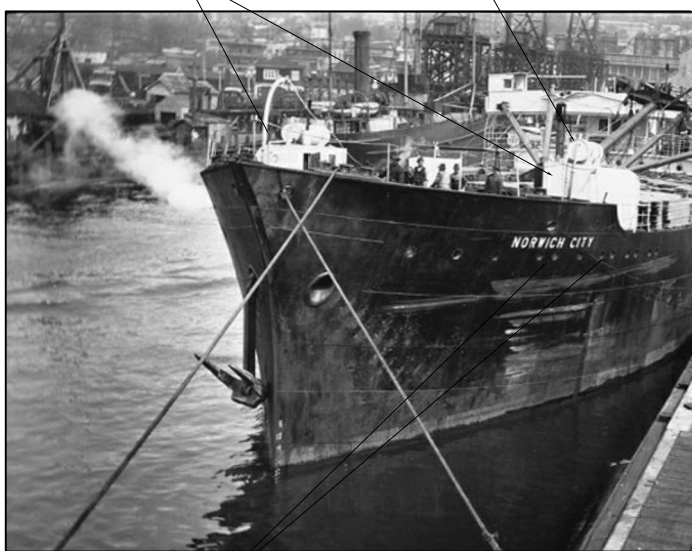
STRUCTURE
POSSIBLY
OVER STAIRWAY

POSSIBLE SEA WATER TANK
FOR FLUSHING TOILETS
SEE TYPICAL PLAN

CREW QUARTERS

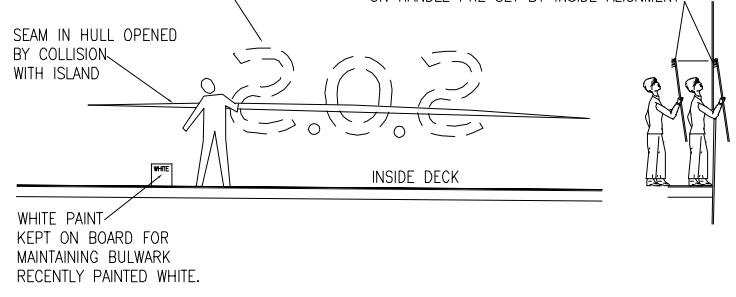
S.O.S MARKED MIRRORED ON
INSIDE OF SHIP
TO BE USED AS A GUIDE
FOR PAINTING OUTSIDE S.O.S.

SEAM USED AS GUIDE HORIZONTALLY
VERTICAL DISTANCE ADJUSTED BY GRIP
ON HANDLE PRE SET BY INSIDE ALIGNMENT

SEAM IN HULL OPENED
BY COLLISION
WITH ISLAND
